**ENGINEERING INVESTIGATION & ANALYSIS  
GEOTECHNICAL & STRUCTURAL  
ASSESSMENT REPORT**

**93 GLENROY ROAD EAST  
FAIRFIELD, NEW JERSEY 07004**

Matrix No. 20-1052

September 2021

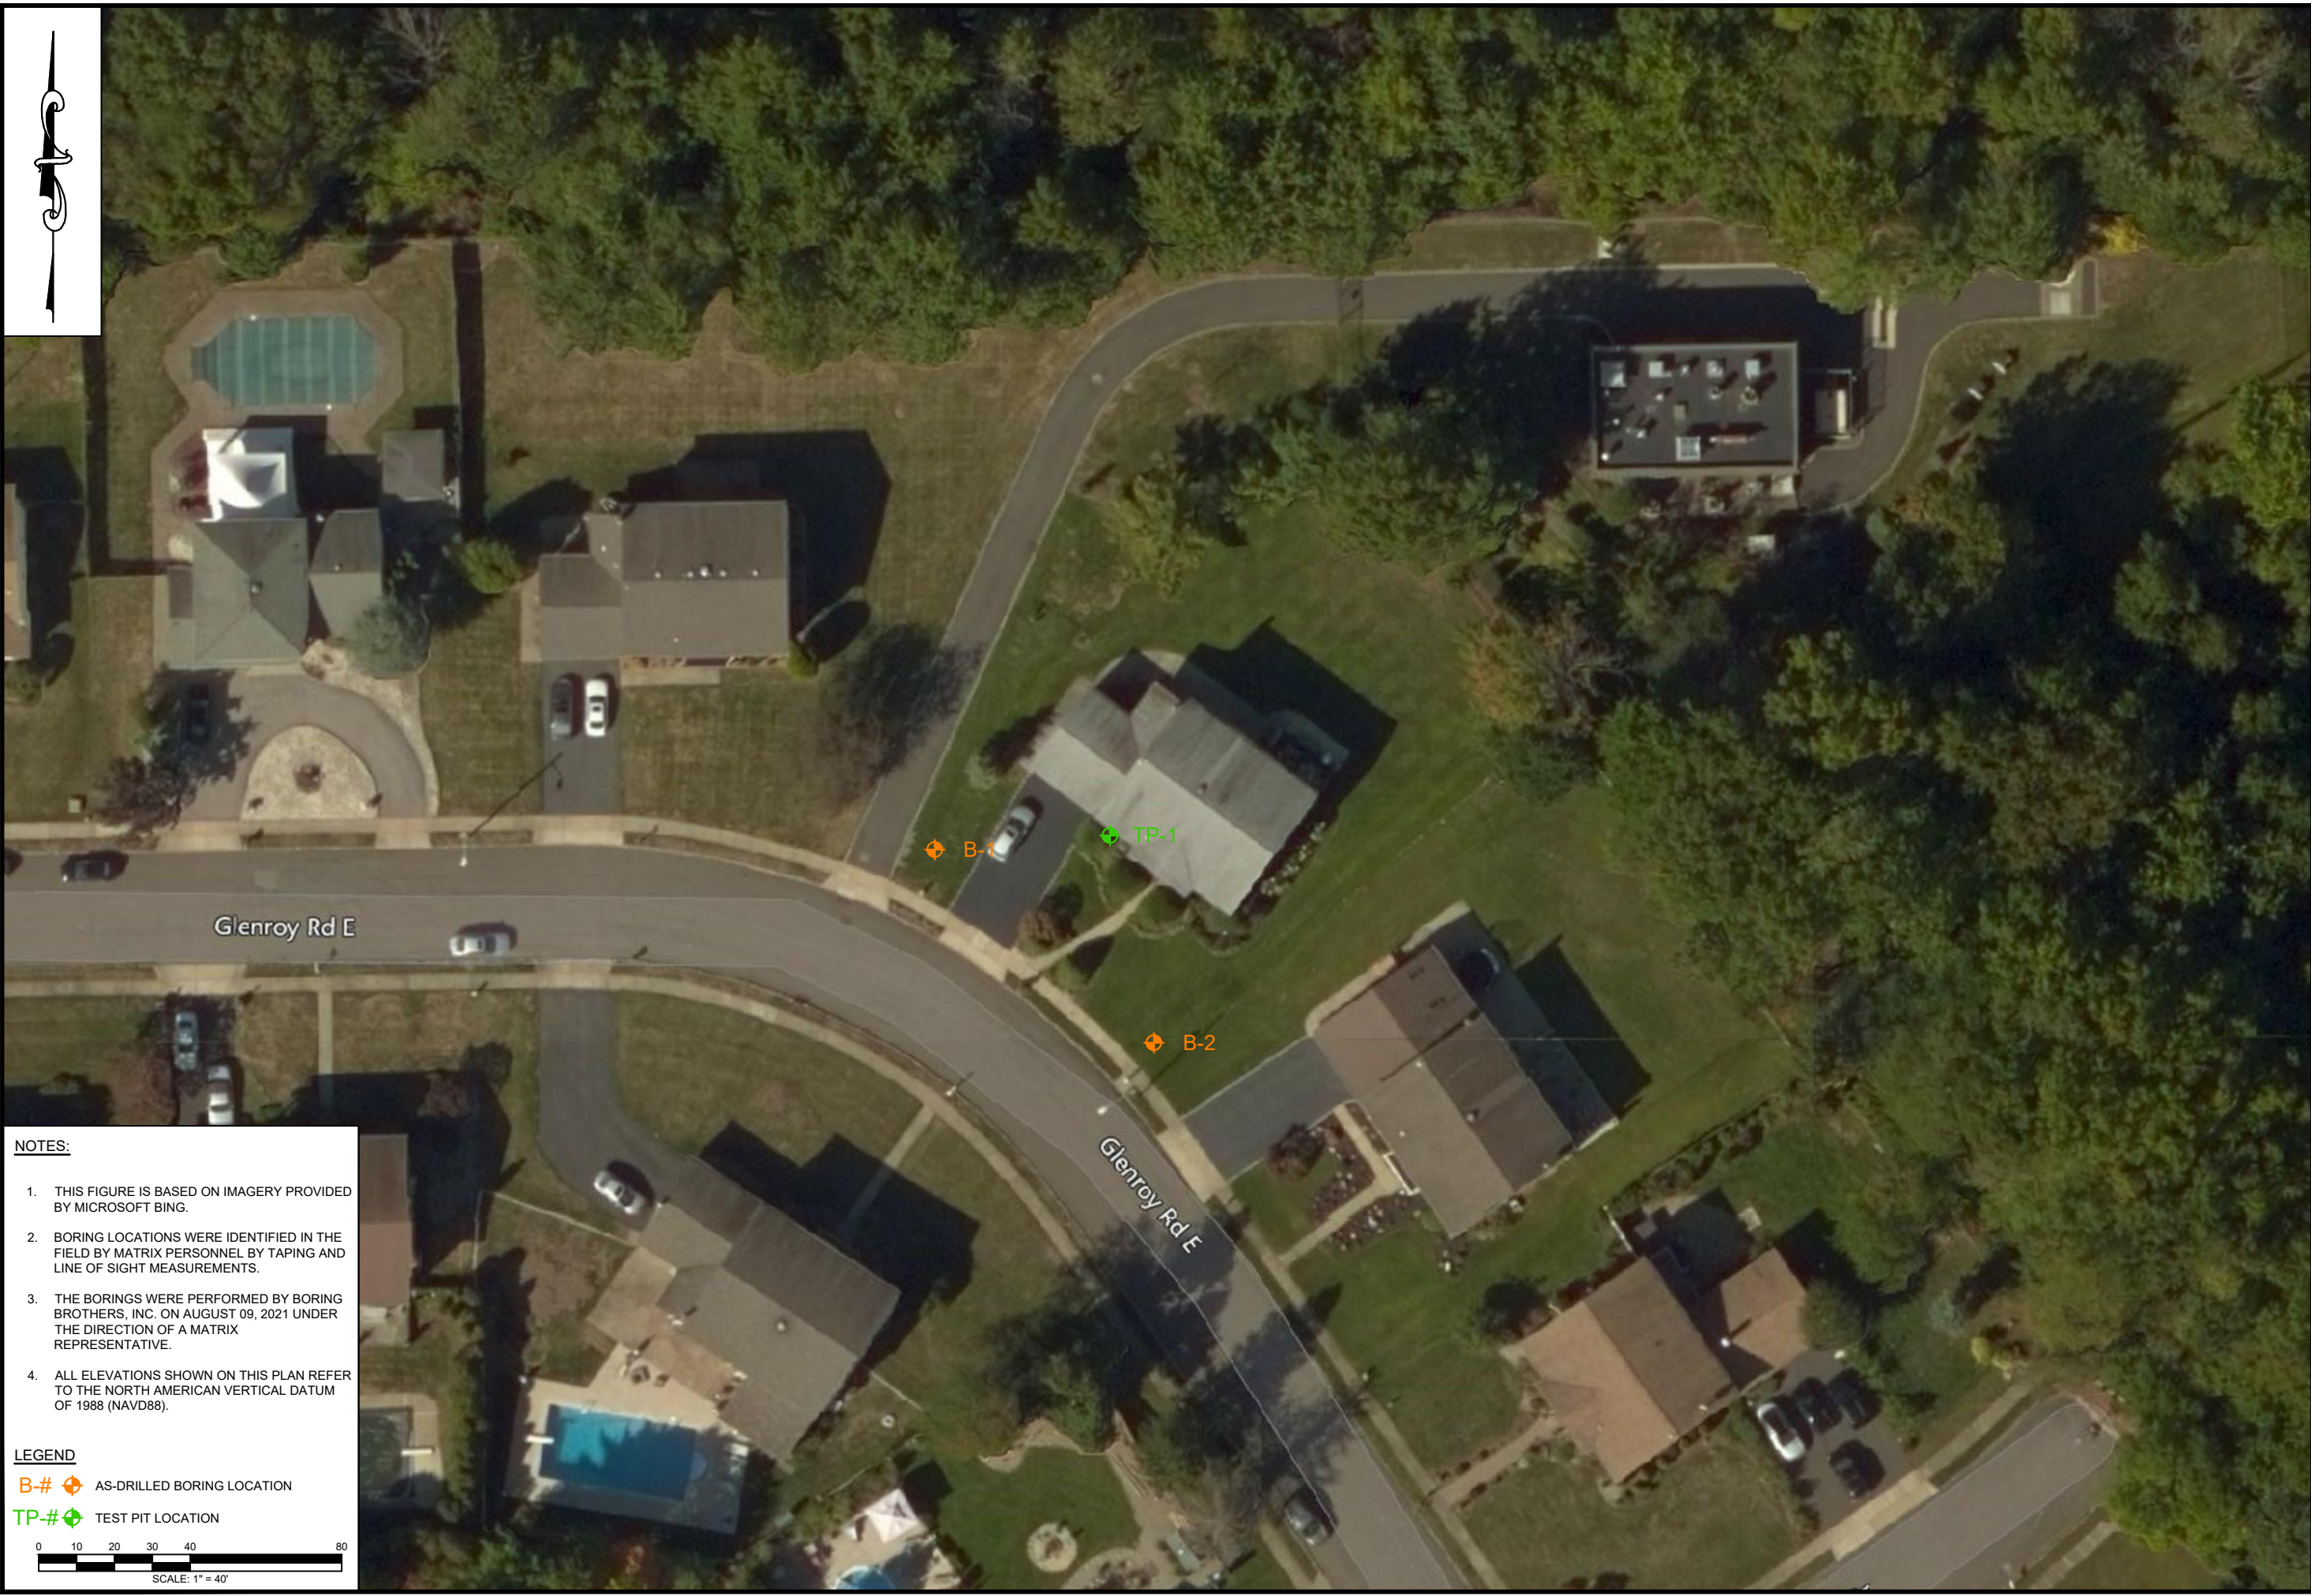
**2**

To assist with the geotechnical and structural evaluation, test pits and geotechnical borings were advanced in areas around the residence to obtain information regarding the soil's structural properties and building's existing foundation. The test pit and 2 borings were located to provide the most useful information about the subsurface conditions. Refer to Figure 2 of this report for a map of the test pit and boring locations.

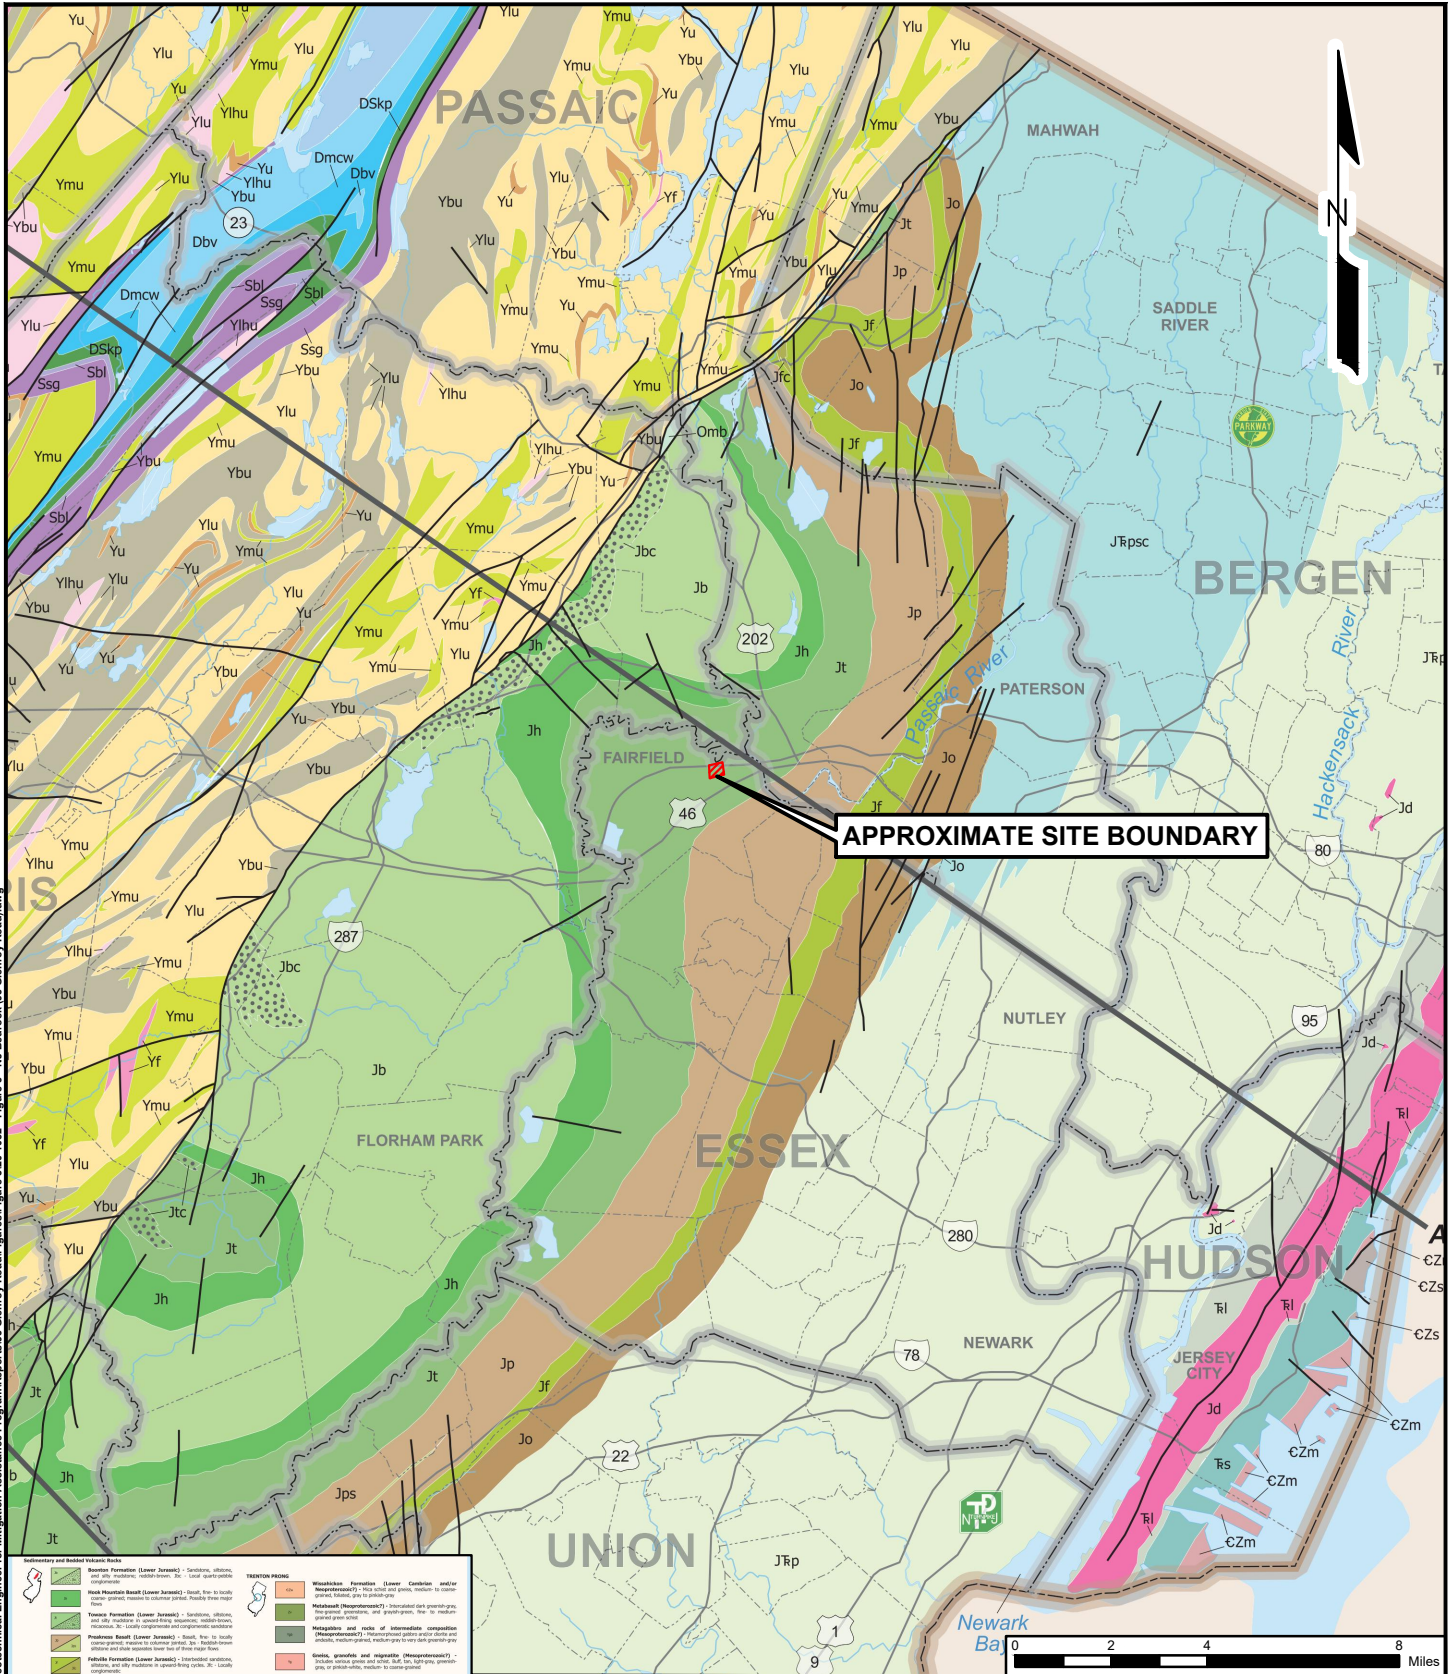
FIGURE NO.:  
3

According to the 2014 Bedrock Geologic Map of New Jersey, the Site is underlain by the Sedimentary and Bedded Volcanic Rocks Towaco Formation. Specifically, the subsurface consists of micaceous, reddish-brown sandstone, siltstone, and silty mudstone in upward-fining sequences. The Bedrock Geologic Map is shown in Figure 3.

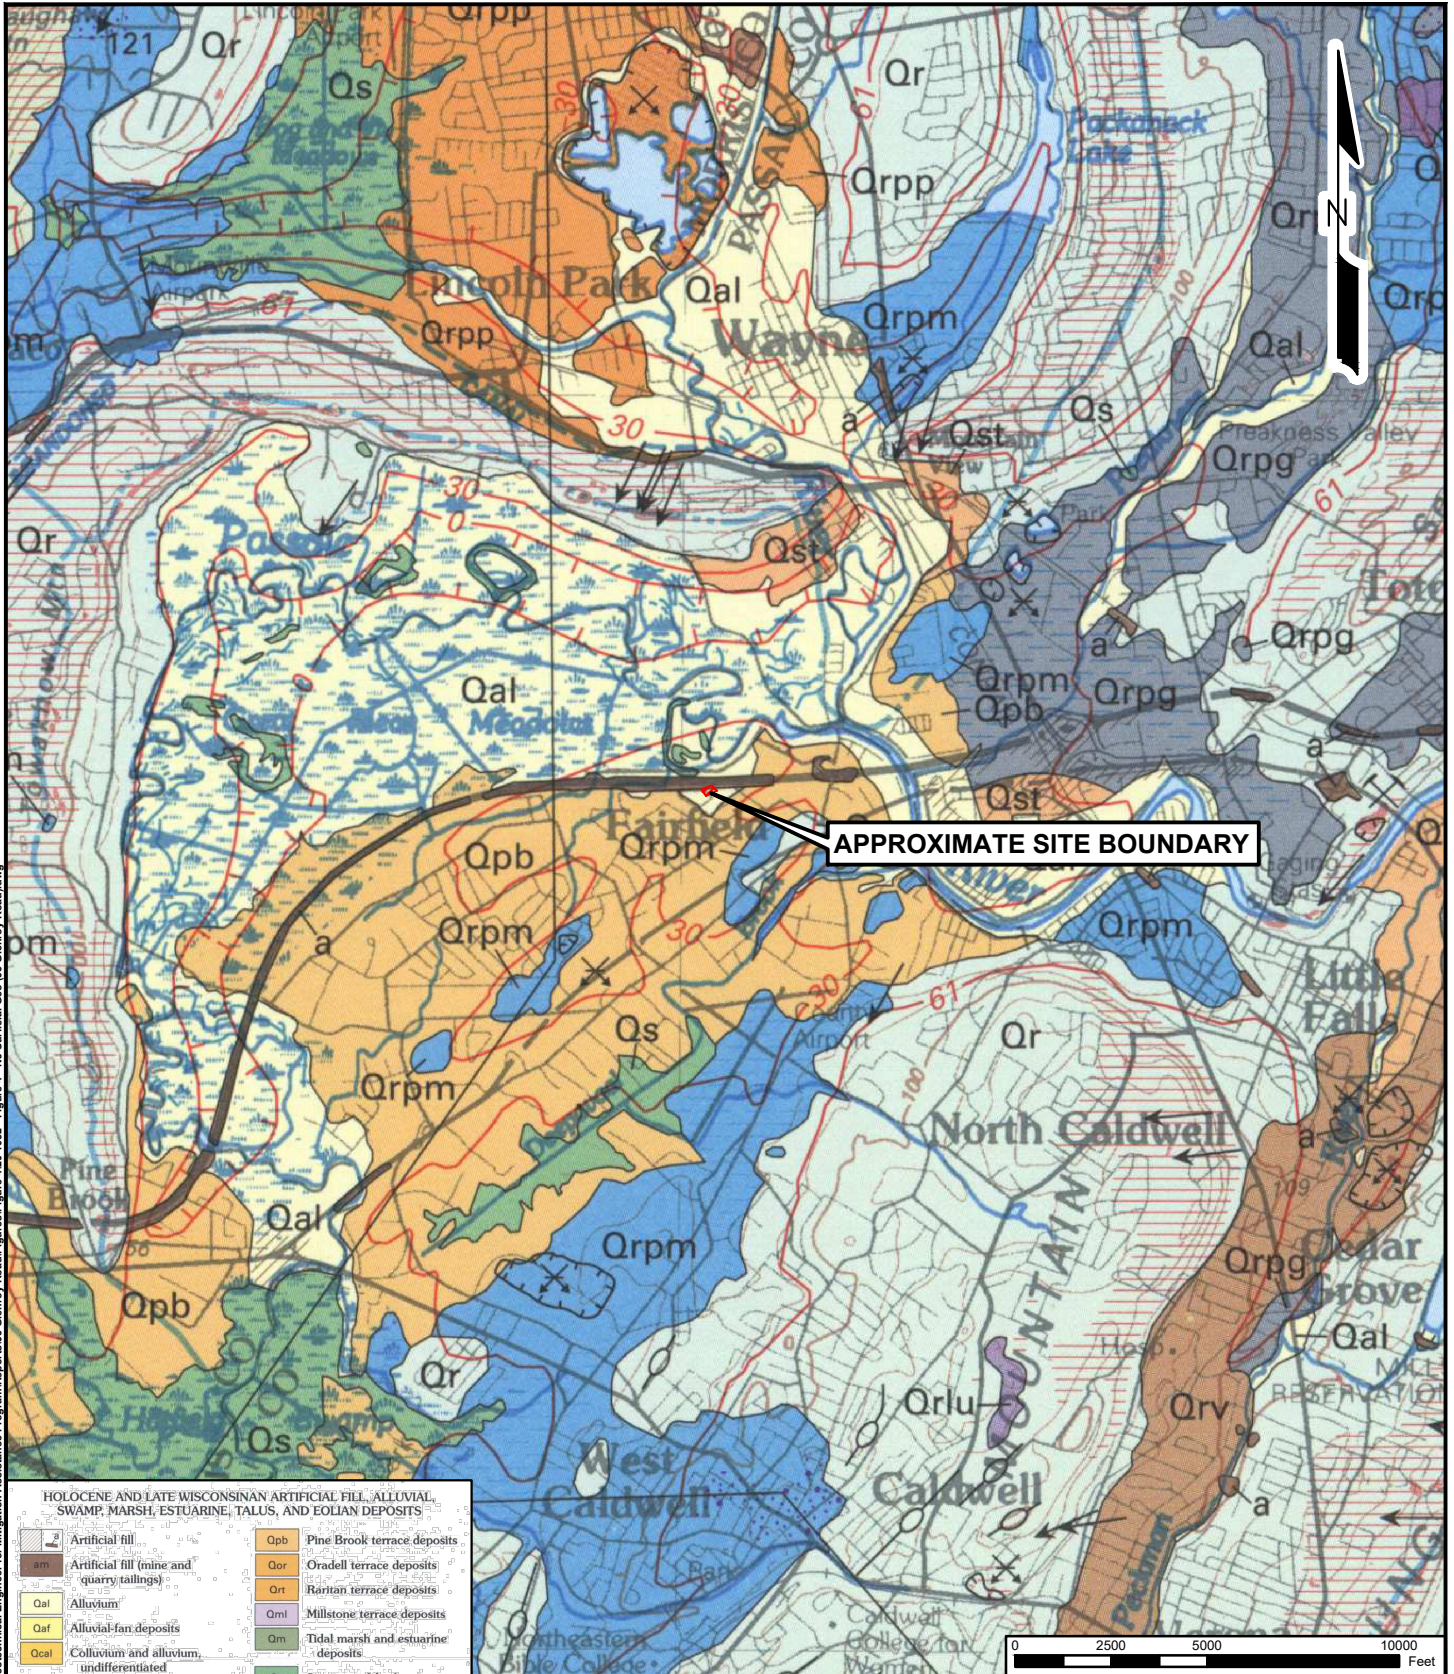
From the Surficial Geologic Map of Northern New Jersey, compiled by and edited by Byron D. Stone, Scott D. Stanford, and Ron W. White in 2002, the natural surface material (beyond fill) is suggested to be in the Alluvium deposit, which consists of poorly sorted Gravel and Sand overlain by laminated and thinly bedded Sand, Silt and Clay. The Surficial Geology map is shown in Figure 4.
