Conrail Freight Train Derailment with
Vinyl Chloride Release
Paulsboro, New Jersey
November 30, 2012

NTSB/RAR-14/01
PB2014-108820
Notation 8475A
Adopted July 29, 2014

Railroad Accident Report

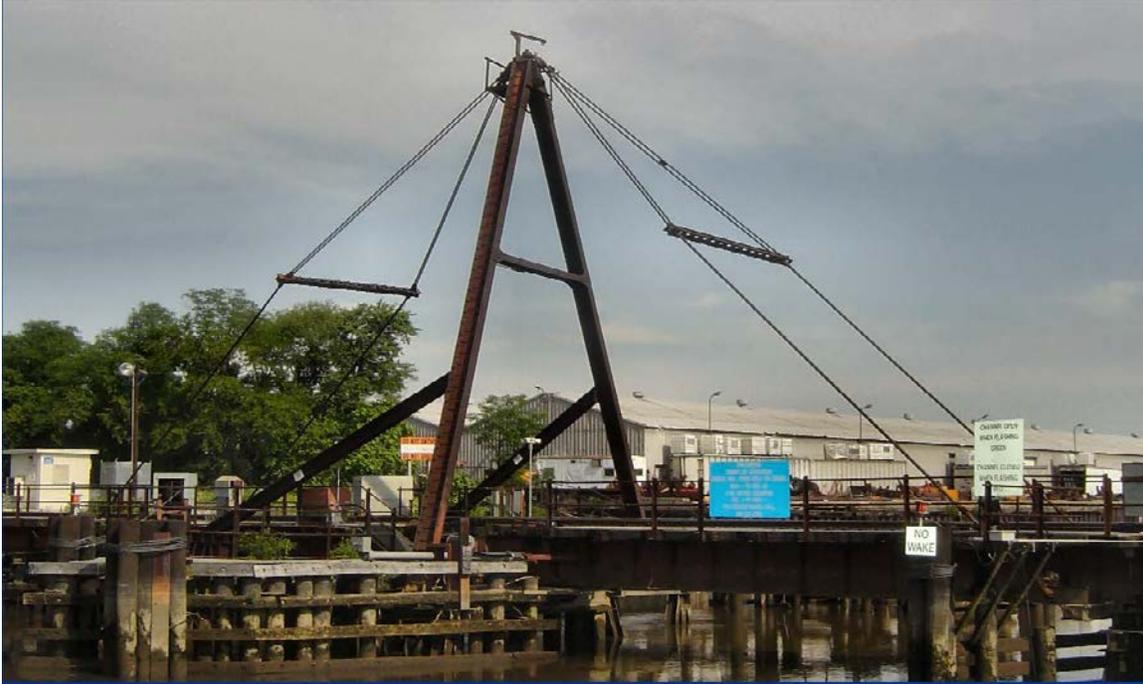
When closed, the east end of the swing span was supported on the steel piles. While open and during movement, the swing span was supported by rods and an A-frame structure (see figure 4). When commanded to open, the east end of the bridge was lifted about 3/8 inch by two motor-driven worm gears and tension rods attached to the A-frame superstructure. A hydraulic piston rotated the span on a center bearing with a flat ring plate and wheels about 90° to the open position. Since the accident, the bridge has been temporarily reconfigured in the closed position for continuous railroad operation. On July 2, 2014, construction began on a replacement vertical-lift moveable bridge. The new bridge will be controlled by the South Jersey dispatcher, with bridge status indications provided to the dispatcher's work station.

Figure 4. Preaccident photograph of the Paulsboro moveable bridge. (Photograph provided by Conrail.)

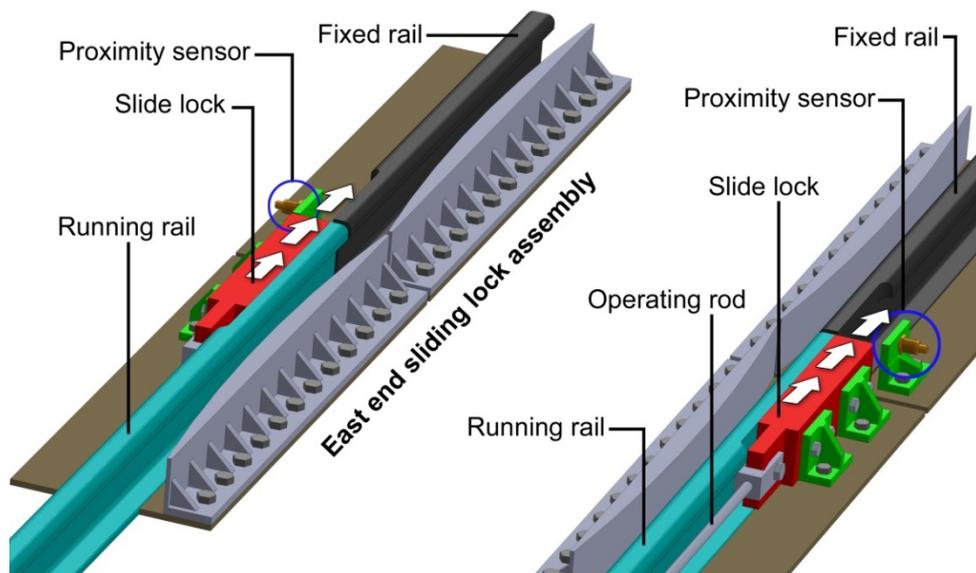
The A-frame lift mechanism lowered the swing span onto piles, which aligned the rails in the vertical direction. Slide locks then engaged at the four rail connection points to prevent the bridge from rotating while the train was crossing the bridge (see figures 5 and 6). The slide locks traveled across the gap between the rails of both ends of the bridge. The east end slide locks would have had to travel about 8 inches to fully engage and the west end slide locks would have had to travel 6 inches to fully engage. Slide locks needed to be within 1/2 inch of proximity sensors to be fully engaged.

Figure 6. East slide lock details.
