## WASTE EFFLUENT SURVEY

Plant Name: Atlas Refinery, Inc.  
Address: 142 Lockwood Street, Newark, N. J. Zip 07105  
Person and Title to whom any further inquiries should be directed: J. Bihun, Technical Director  
Phone No.: (201) 589-2002  
Number of Employees: 36  
Number of Working Days Per Week: 5  
Number of Shifts Per Day: 1  
Area of Property: 1.78 Acres, or Sq. Ft.  
Type of Industry and 4 digit U. S. Standard Industrial Classification No.: 2843  
Surface Active Agents, Finishing Agents, Sulfonated Oils and Assistants  
Finished Product(s): Oils for Leather, Textile and Paper Industry  
Average Production: 12,000,000 Lbs/Year  
Raw Materials Used: Animal, Vegetable, and Marine Oils, Mineral Oils  
Brief Description of Operations: Refining of Animal Oils, Sulfation and Sulfonation of  
Animal, Vegetable, and Marine Oils; Compounded Oils; Sulfation and Sulfonation  
of Straight Chain Unsaturated Hydrocarbons.

Violation and Elimination - Atlas Refinery, Inc., 142  
Lockwood Street, Newark, N.J.  
June 6- August 4, 1972 ( J. Mc Laughlin)

# POLLUTION ABATEMENT PROGRAM

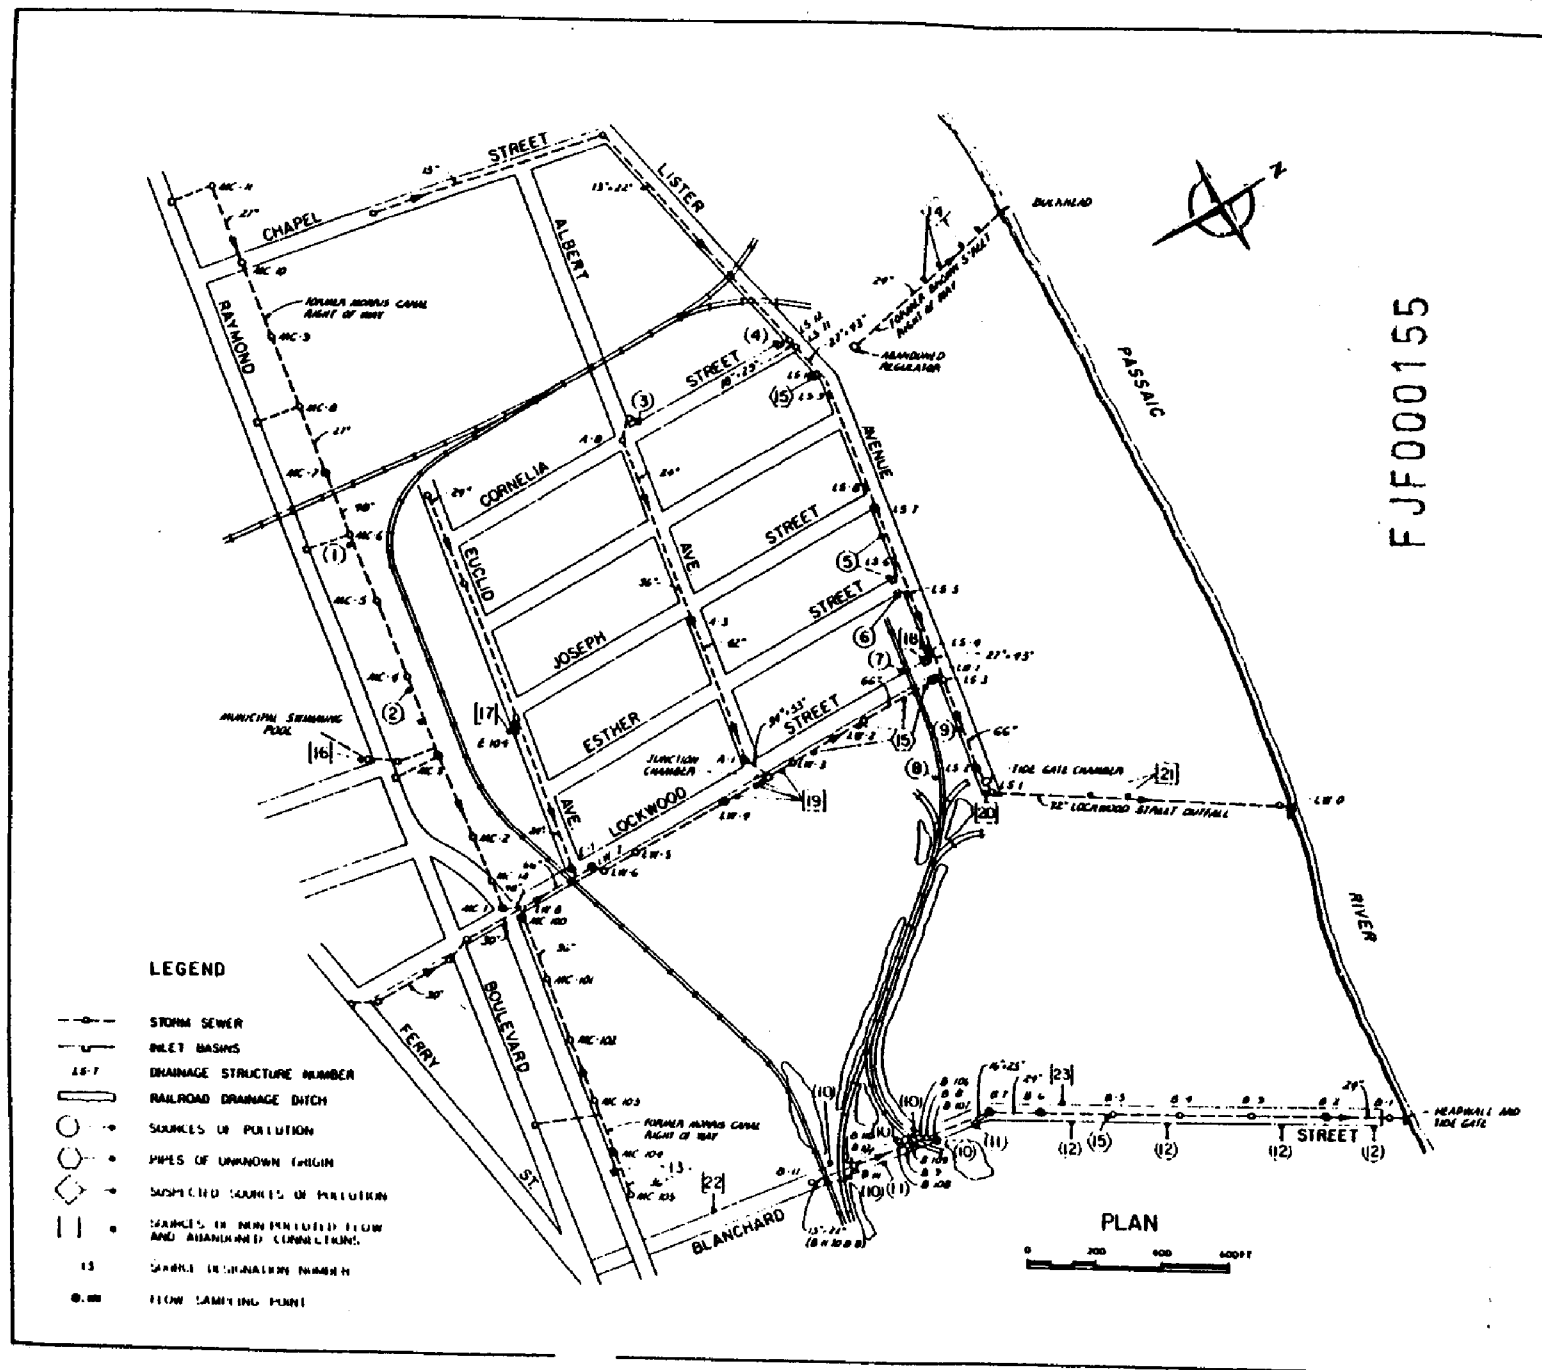
Blanchard Street is served by separate storm and sanitary sewers. The 24-inch storm sewer (see Plate 2), constructed in 1917, discharges to the Passaic River. In 1970, the storm sewer was extended and the sanitary sewer was rebuilt. The sanitary sewer connects to a trunk sewer in Raymond Boulevard. The sanitary sewer is clogged by grease, tallow, paper and black oily waste. Several sanitary manholes were observed to surcharge and overflow into the street. These overflows usually occurred between 11:00 a.m. and 3:00 p.m. on weekdays. The frequency of overflow varies depending on industrial discharge rates. It does not appear to be related to rainfall events. Overflows were observed at least once a week and were noted on ten consecutive weekdays in April 1978. Intermittent overflows may have occurred during the last few years. These sanitary overflows are a major source of pollutants in the Blanchard Street storm sewer. City forces had been cleaning the Blanchard Street sanitary sewer when backups and overflows were reported. Equipment breakdowns and manpower shortages caused a suspension of cleaning operations in 1978.
