### LACEY TOWNSHIP PARKS TREE INVENTORY AND EVALUATION

Project No. 92-172-09

September 1992

Revised December 1992

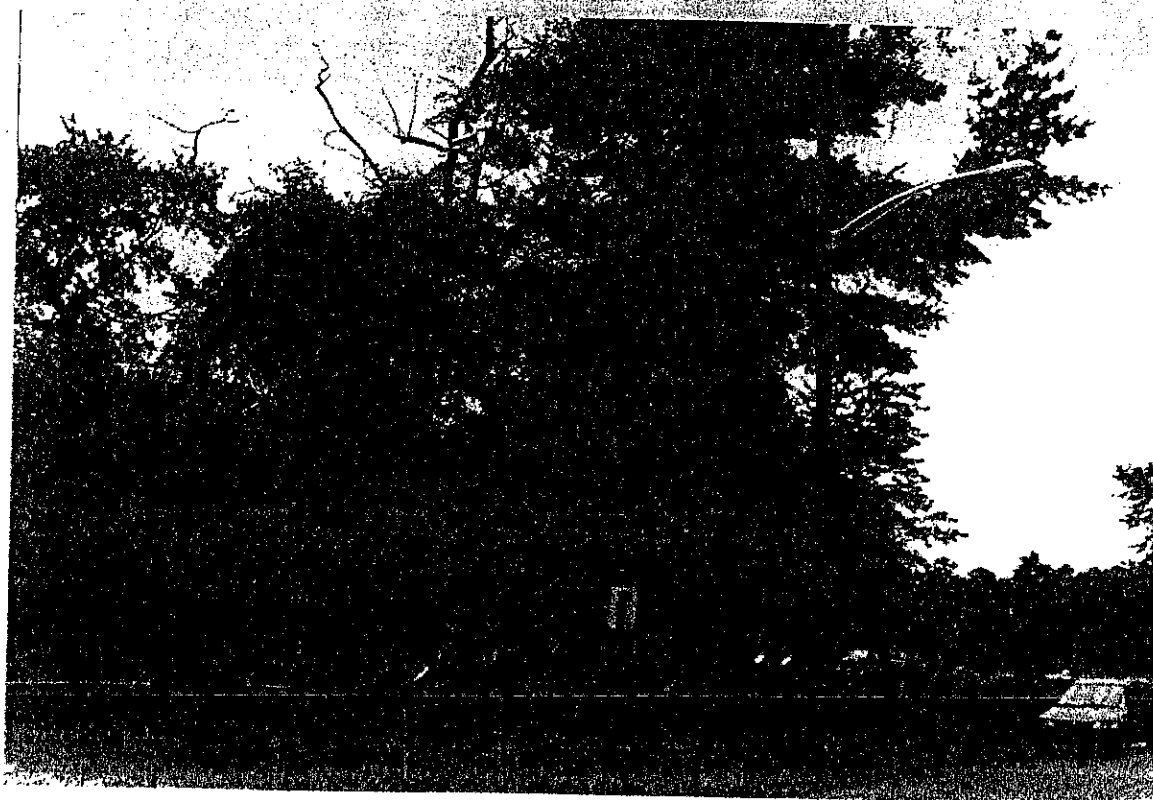
**Photograph #6. Specimen white pine BL #21**

The white pine (*Pinus strobus*) [BL 21] should receive a light pruning and have the trumpet vines (*Campis radicans*) removed. (Photograph #6). The ginko (*Ginko biloba*) [BL 20] should also have the trumpet vines removed from its limbs and trunk. These vines, although ornamental in nature, impose additional weight and can lead to limb breakage. The dead locust stem located approximately 10 feet southeast of BL 20 should be pruned to remove dangerous deadwood, leaving the trunk to remain as a "trellis" for the existing trumpet vine if desired.

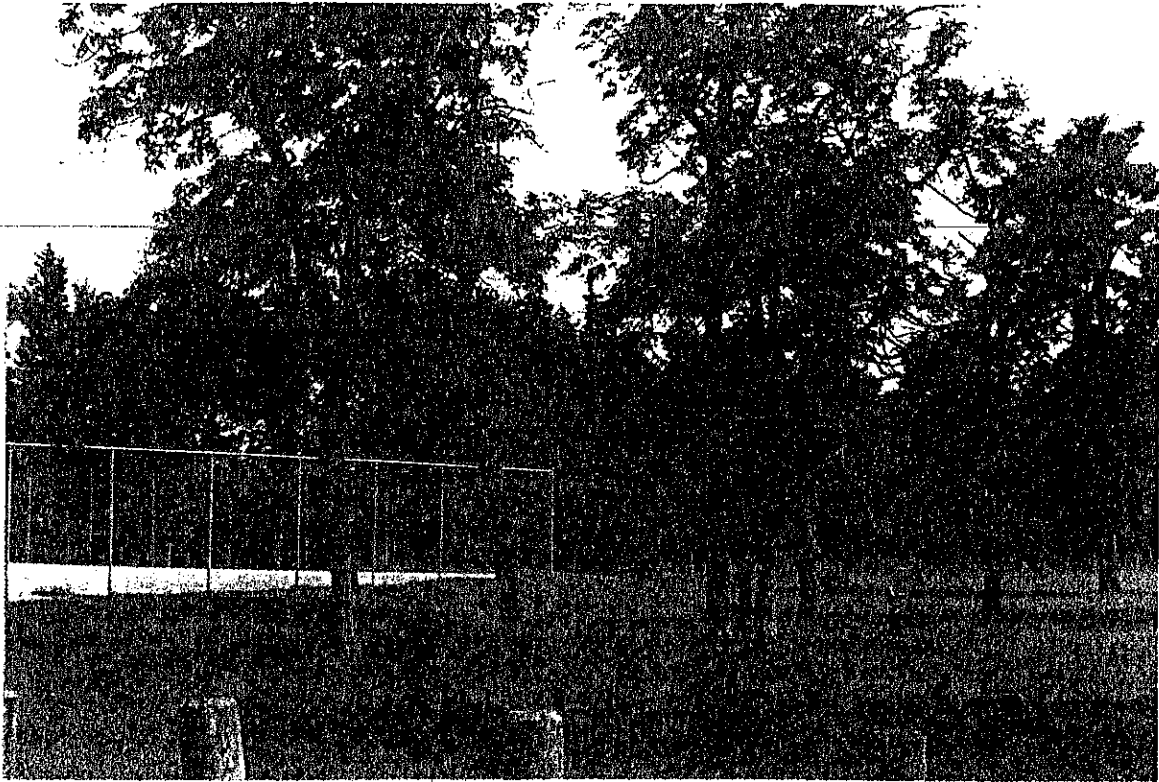
The black locust (Photograph #9) and eastern red cedars (*Juniperus virginiana*) (Photograph #10) located west of the tennis court and soccer field would benefit from a light pruning to remove the most obvious deadwood. The eastern red cedars should have their lower canopies raised up to about eight feet in height and have the remaining stubs properly pruned.

**Photograph #9. Black locust grove, west of tennis courts**

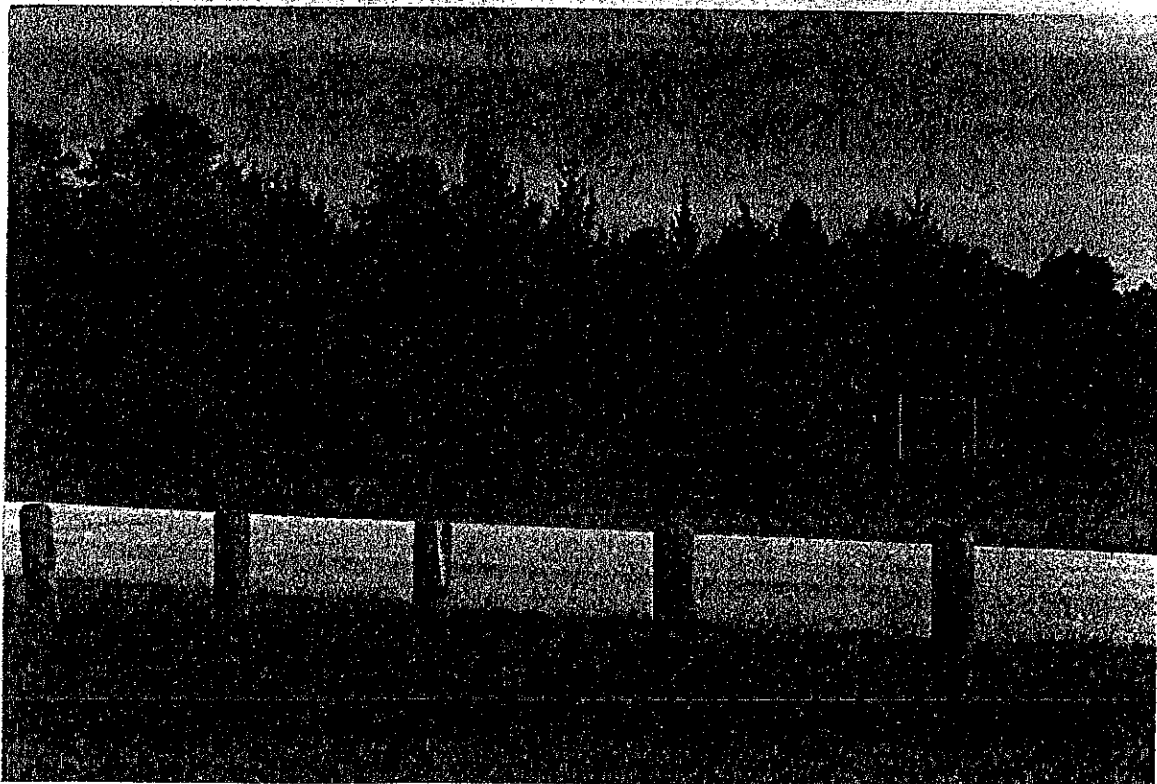
**Photograph #10. Eastern red cedars, west end of soccer fields**

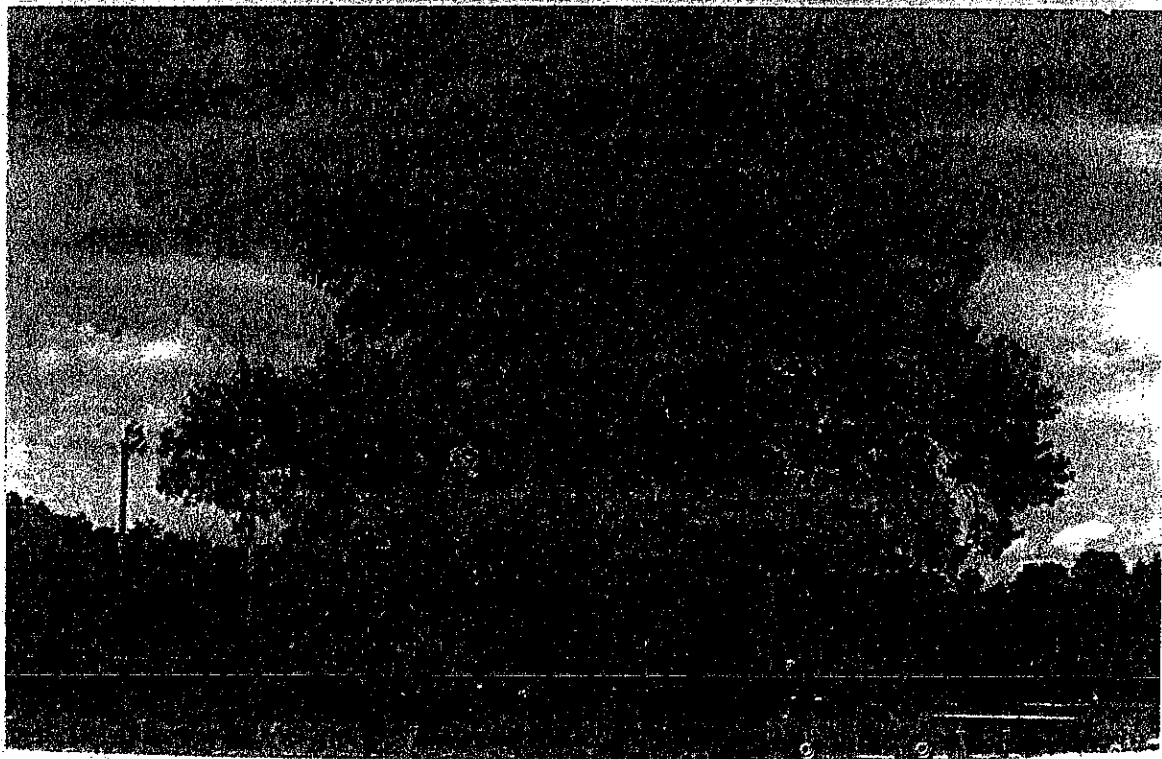
Black oak [WH 26] (Photograph #14), white oak (*Quercus alba*) [WH 28] (Photograph #15), and pin oak (*Quercus palustris*) [WH 29] (Photograph #16), are all located in prominent positions within WHP and are extremely valuable specimen trees. These trees should receive priority pruning. They each require a light pruning to remove obvious deadwood and correct structural problems and should have "stubs," the short dead branches that occur as a result of improper pruning techniques, properly pruned from the lower trunk. In addition, WH 29 should have its lower canopy raised four to six feet above the roof of the storage building. The other trees within this area (WH 31 through WH 38) should also receive some light pruning as this area is heavily utilized. Pitch pine (*Pinus rigida*) [WH 32] should be pruned to reduce the weight on the limb that hangs over the tennis court (Photograph #17).

**Photograph #14. Specimen black oak WH 26**

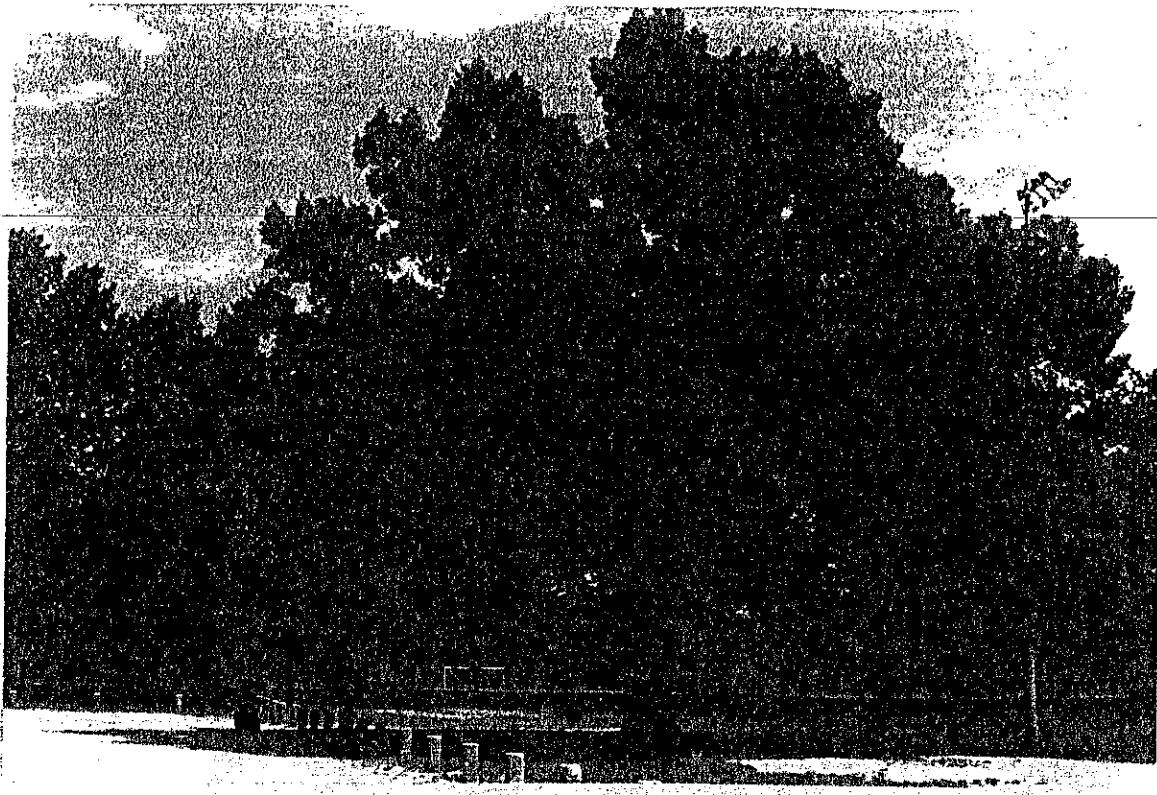
**Photograph #15. Specimen white oak WH #28**

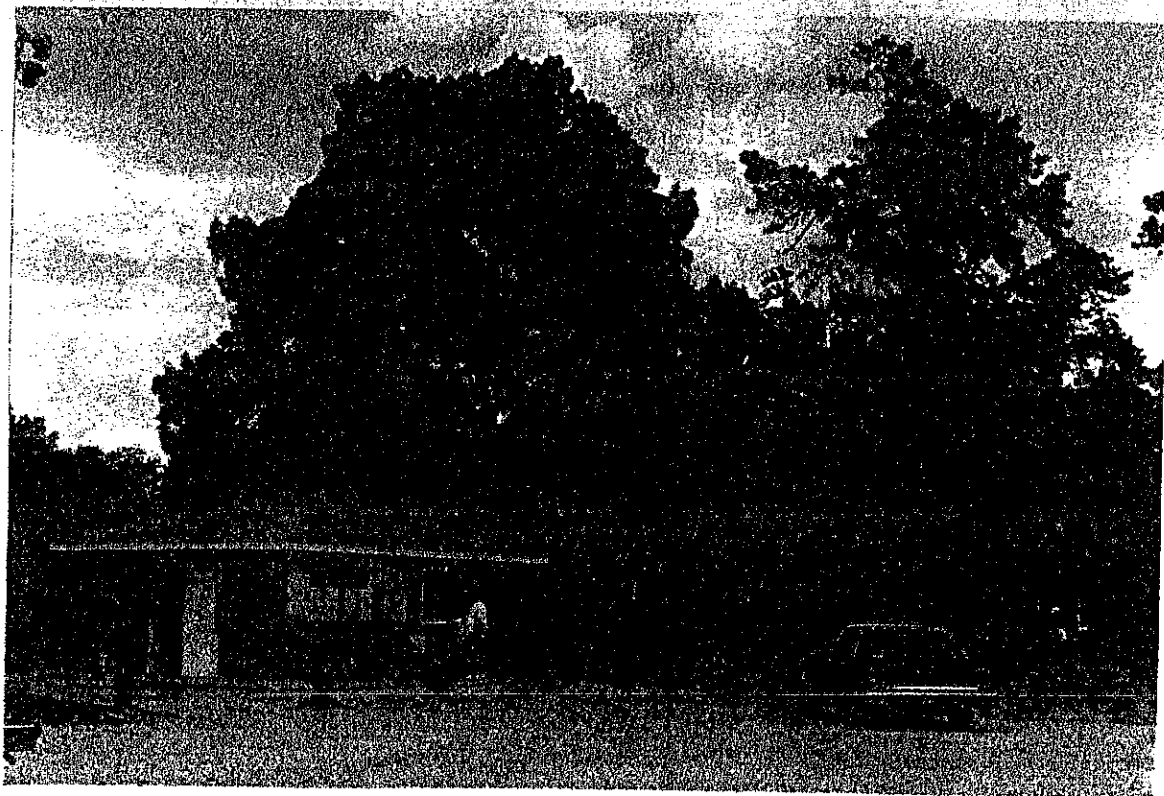
**Photograph #16. Specimen pin oak, WH #29**

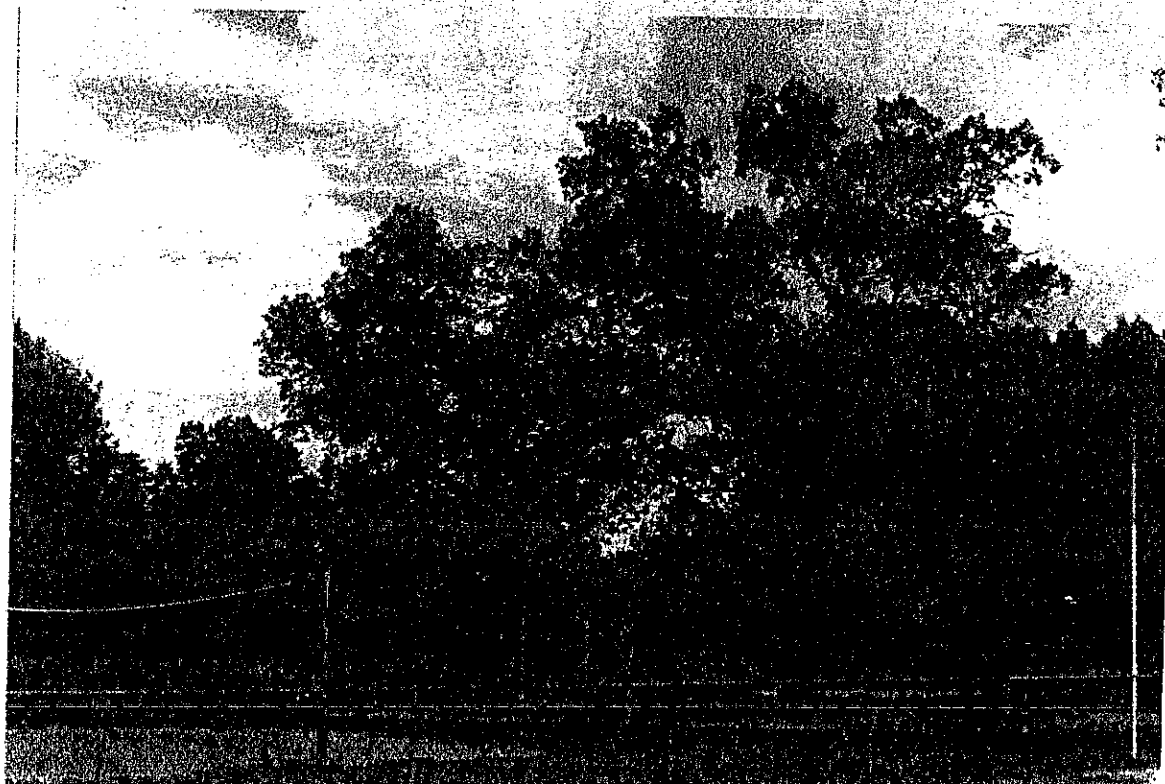
The white oak [WH 39] (Photograph #18) located in the center of the small children's play area should receive priority pruning as it contains approximately 15% deadwood and numerous dead branch ends.

**Photograph #18. WH #39 and WH #40 located in small children's play area**

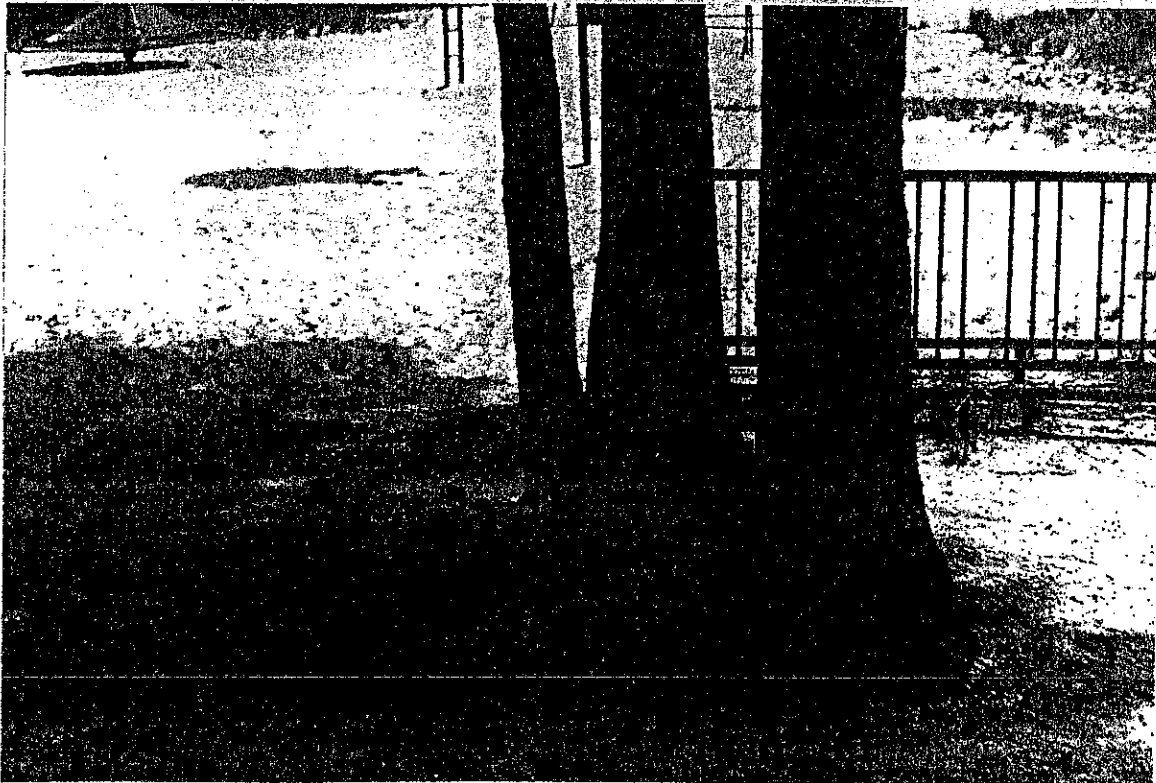
VC 20 and VC 21, located at the entrance to the small children's play area, both require light pruning and VC 21 should have the marked leader removed (Photograph #30). The wooded area located to the north side of the small children's play area is presently underutilized, but would benefit from the pruning of the large lower deadwood.

**Photograph #30. VC #20 and VC #21, with marked leader**
