ROCKFALL HAZARD MITIGATION REPORT

ROUTE 29
ROCKFALL MITIGATION
MP 27.31 TO MP 30.43

TOWNSHIP OF KINGWOOD
HUNTERDON COUNTY

April 24, 2015

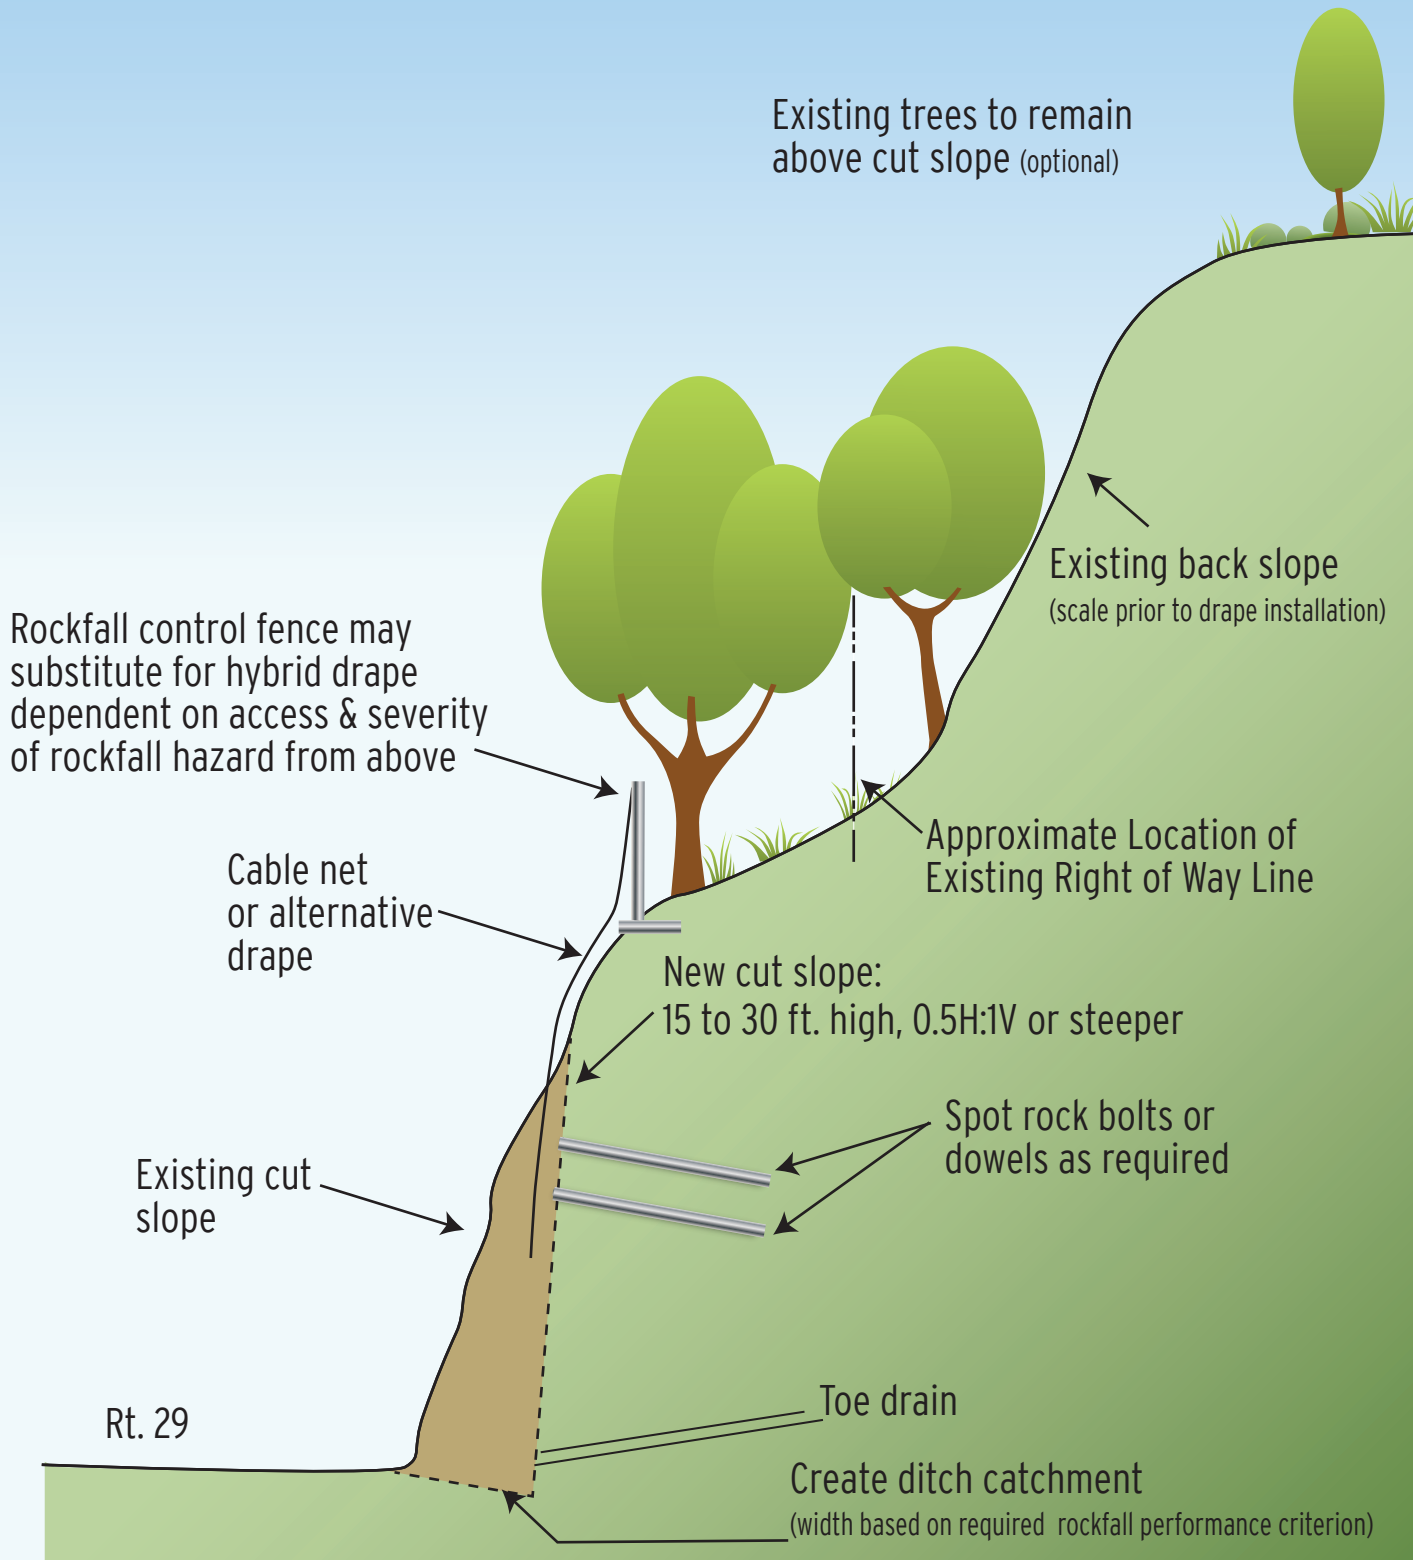
**Figure 6-1
(NTS)**

**Preliminary Preferred
Conceptual Mitigation Option
(Area "A" = Option V)**

Figure 6-1 is a conceptual figure of the recommended design. Activities required to finalize the design include:

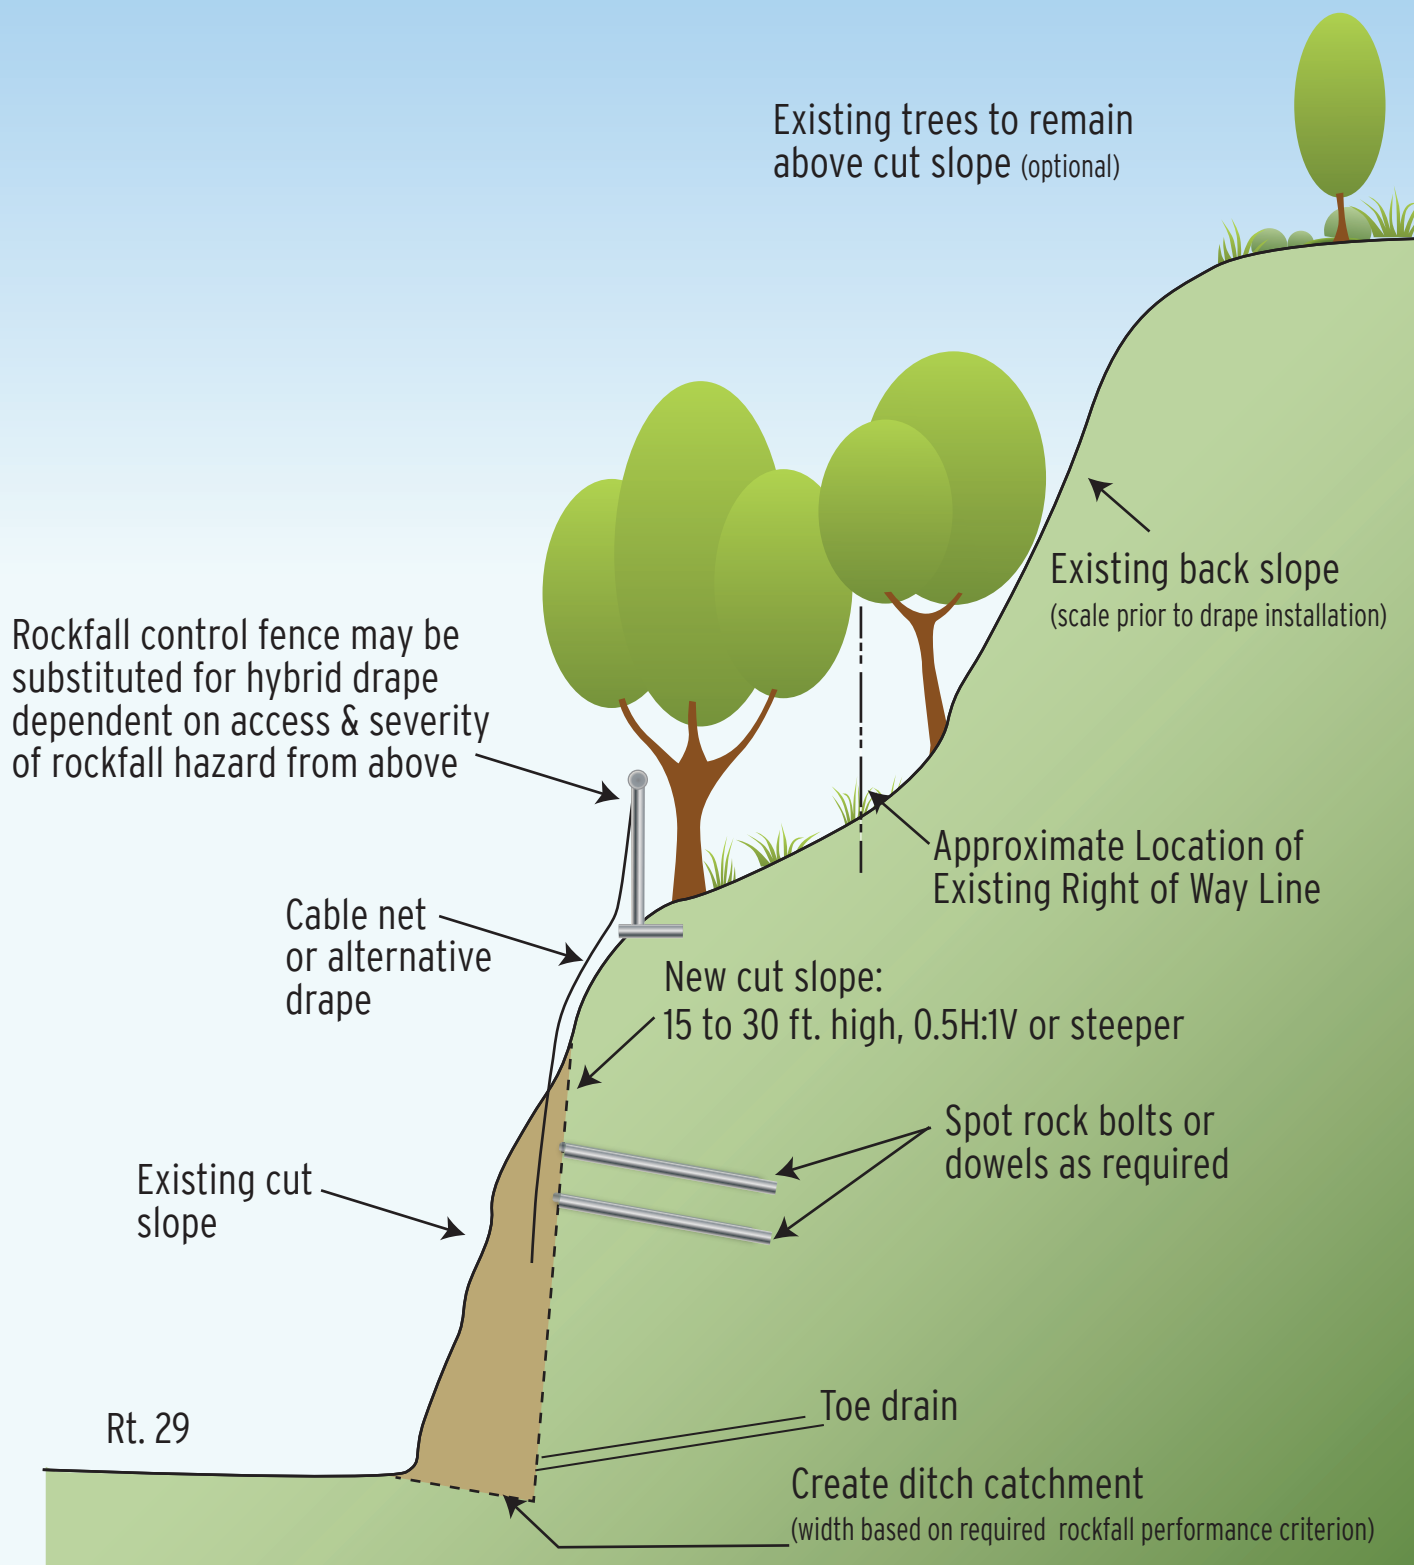
Figure 6-2
(NTS)

**Preliminary Preferred
Conceptual Mitigation Option
(Areas "B"+"C" = Option II)**

Figure 6-2 is a conceptual figure of the recommended design. Activities required to finalize the design include:

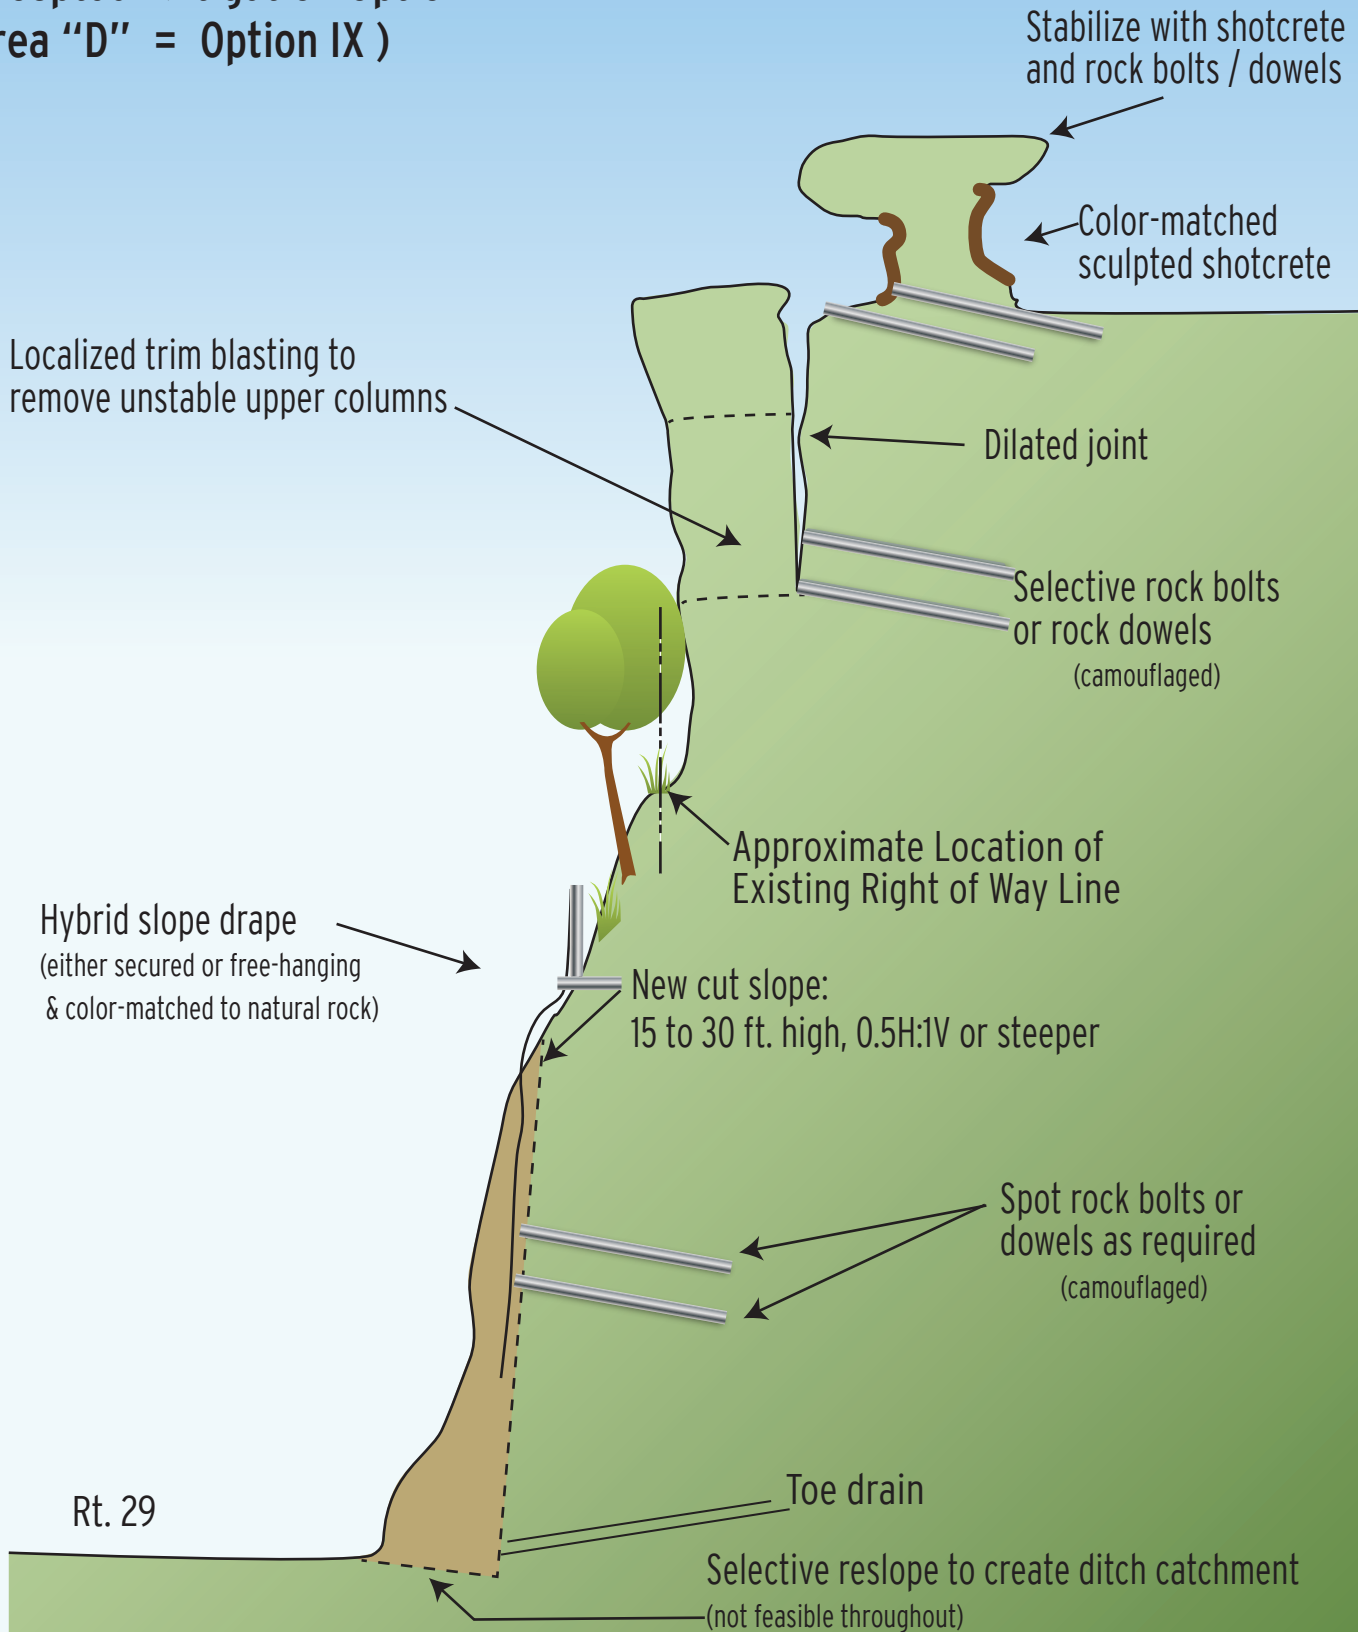
Figure 6-3
(NTS)

**Preliminary Preferred
Conceptual Mitigation Option
(Area "D" = Option IX)**

Figure 6-3 is a conceptual figure of the recommended design. To achieve the level of geologic and engineering understanding necessary to select and design feasible mitigation alternatives, the following activities will be required:

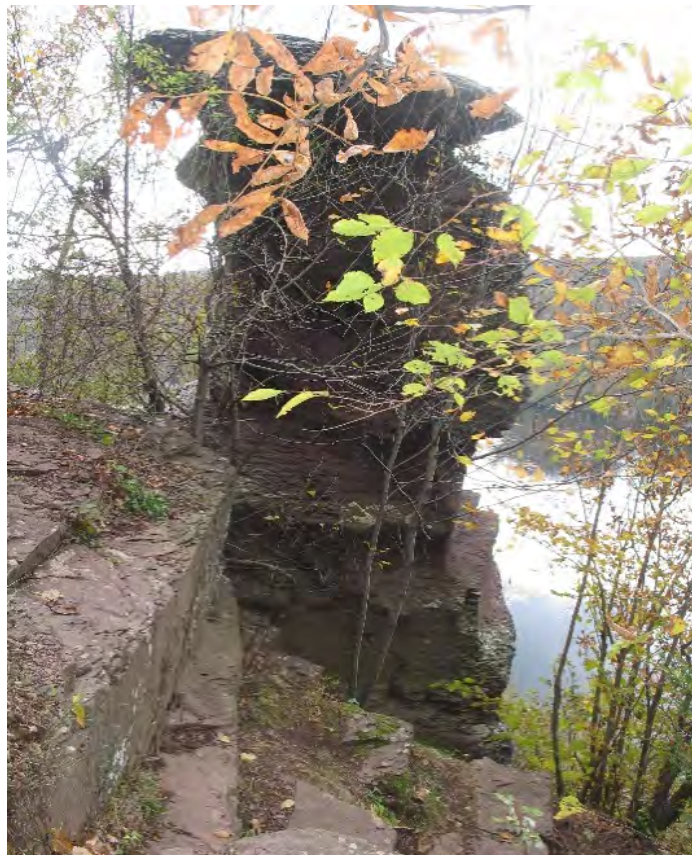
Composite cut slopes and back slopes reach estimated heights of over 260 feet in Area D. Along the crest of the back slope, large, detached columns are present. Devils Tea Table represents such a column. Evidence of instability at the base of this landmark topographic feature was observed (Photo 3, Appendix I). Ongoing differential weathering will cause the eventual failure of this or other columns and will potentially result in rockfall events of hundreds of cubic yards that would likely reach Route 29.

PHOTO 3 - S Shaped Crack in North Side of Block above Devil's Tea Table (Area D)

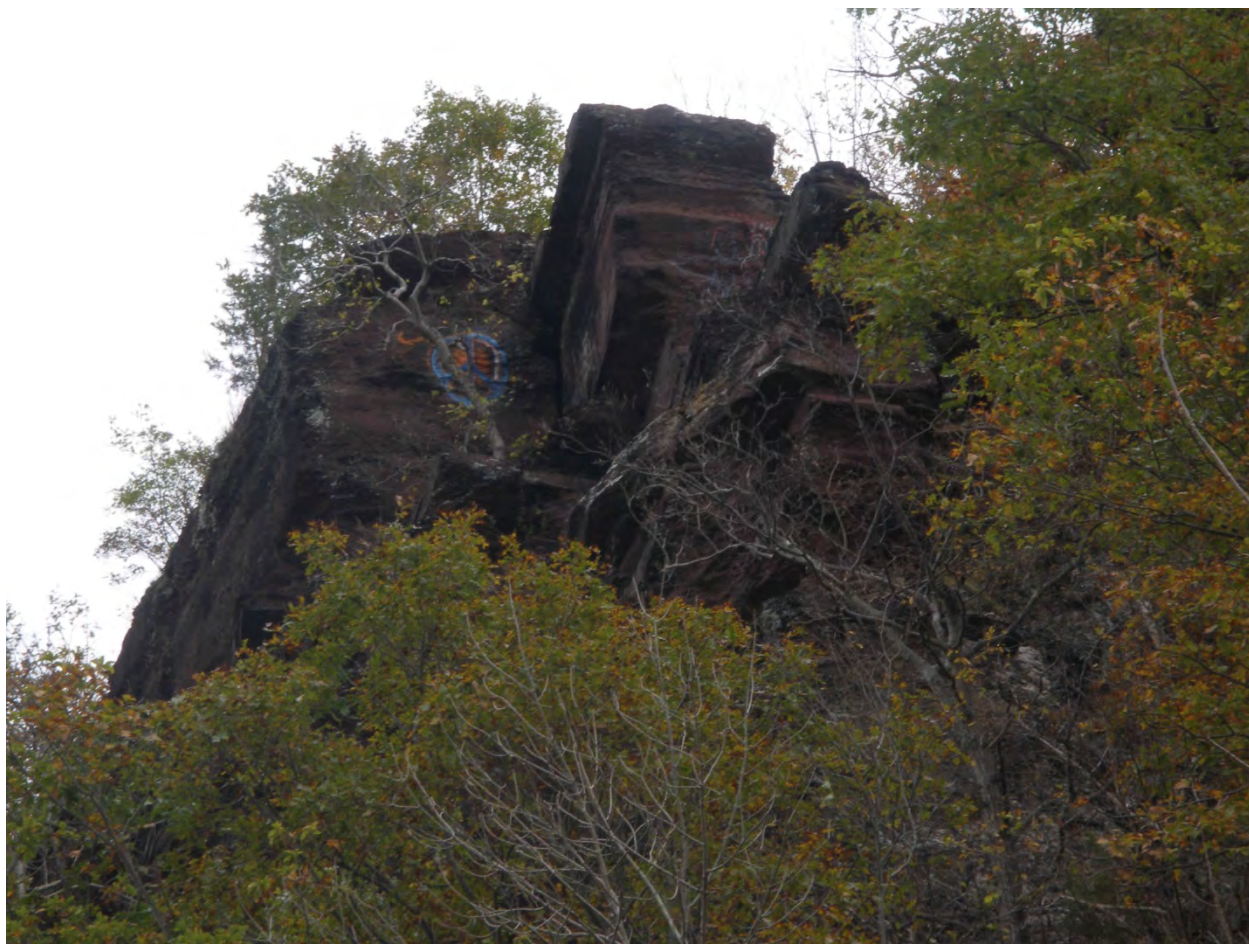
Photo 4 – Devil's Tea Table Looking Southwest from Top of Slope
