DELAWARE AND RARITAN CANAL COMMISSION
APPLICATION
for
INDIVIDUAL APPROVAL and WAIVER

SAFETY IMPROVEMENTS
to
BULL'S ISLAND RECREATION AREA
Delaware & Raritan Canal State Park
Delaware and Kingwood Townships, Hunterdon County
New Jersey

November 2013

Prepared by:
NJ DEP – Natural and Historic Resources
with
Civil Dynamics, Inc.
P.O. Box 760
109A Route 515
Stockholm, NJ 07460-0760

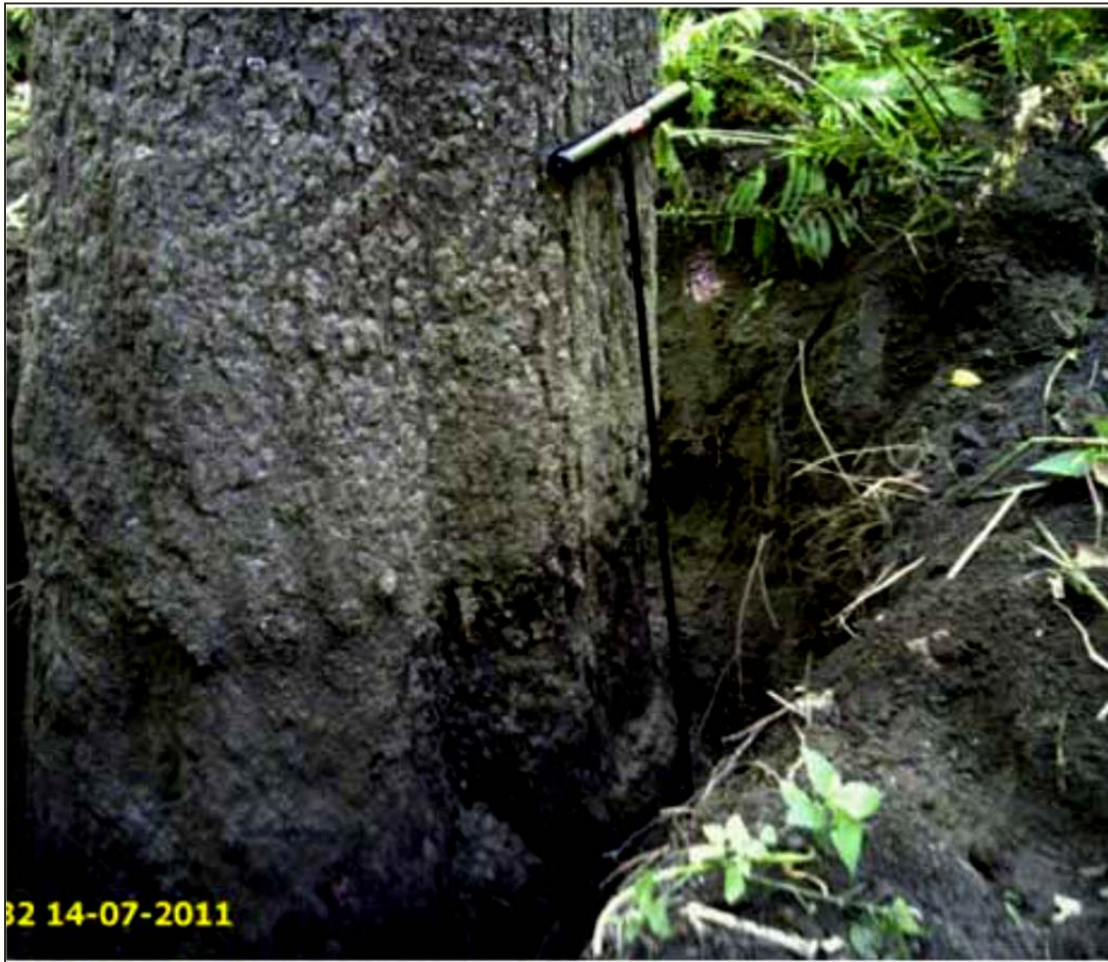
Picture 1. Soil removed 24 inches down a tree stem and no buttress roots were found.

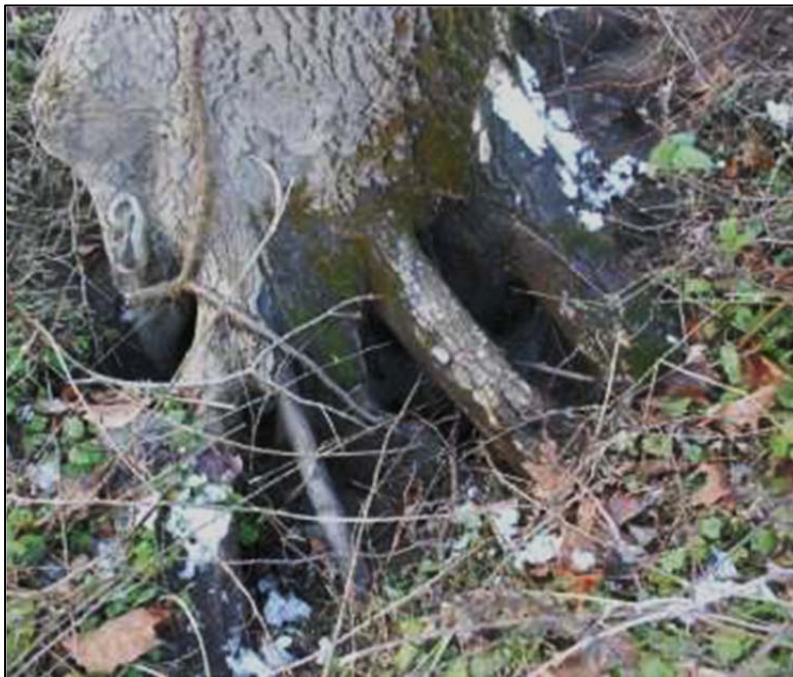
Picture 2. Adventitious roots present at the soil surface.

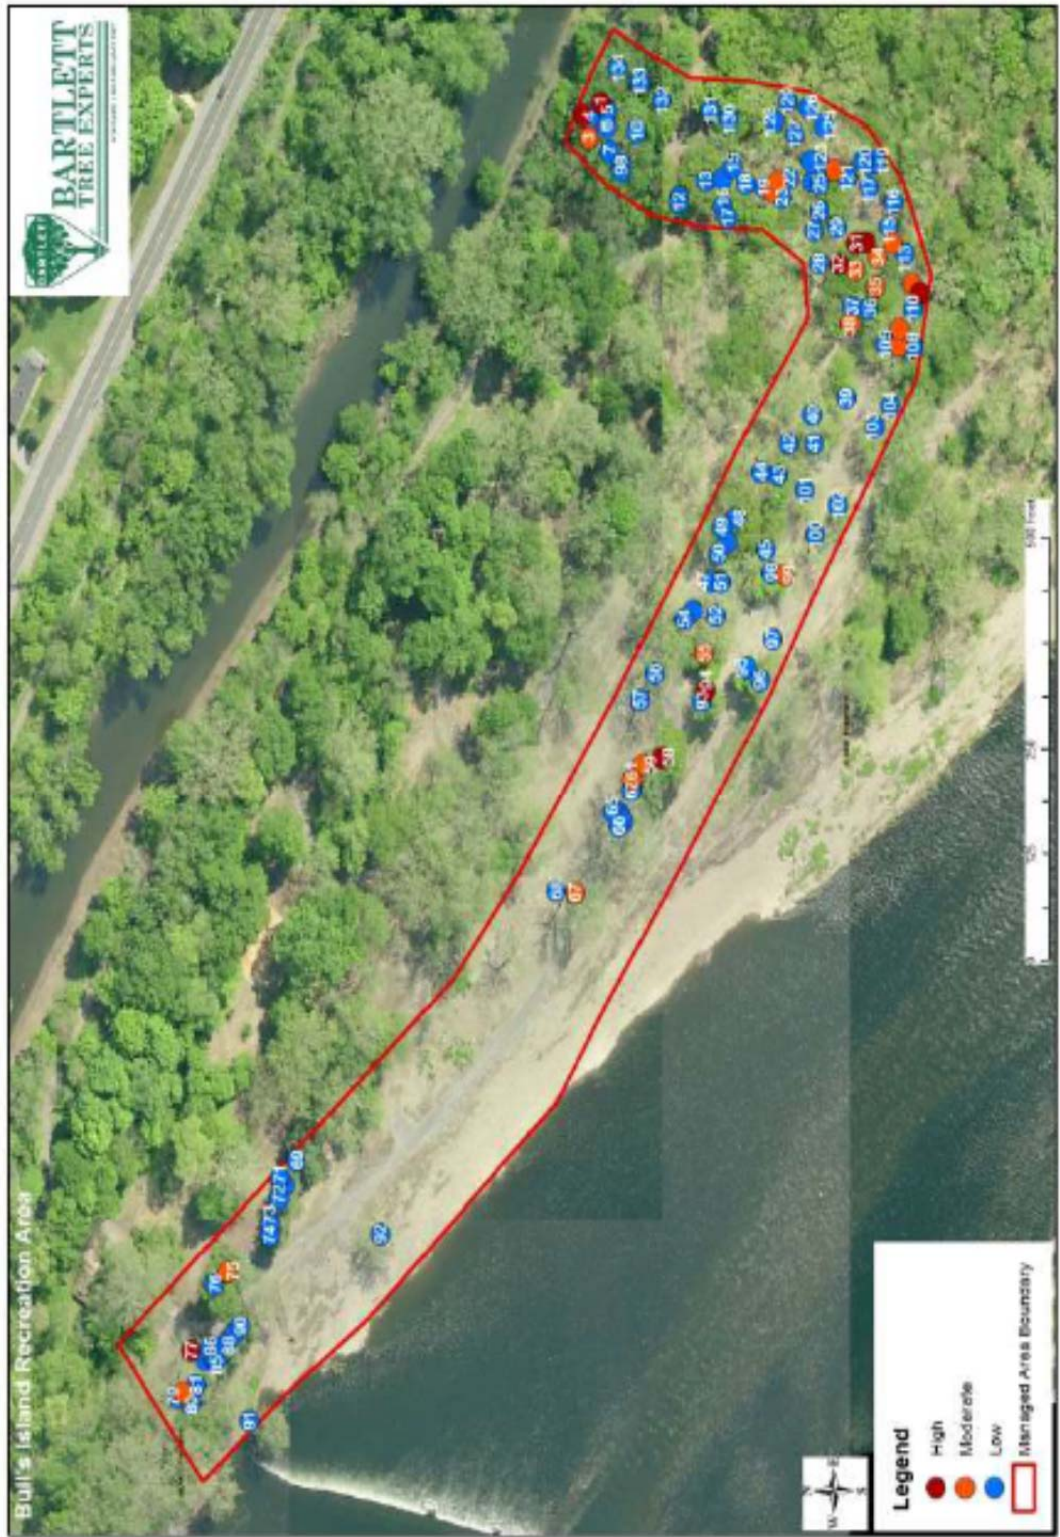
Map 3. Location of trees in the proposed pedestrian corridor.

A total of 134 trees were evaluated during a third tree risk assessment (November 2012) for the corridor (map 3) (table 1). Seventy-nine (79) were identified as possible to critical risk and listed for removal (table 2). This evaluation looked at all trees ≥ 6 inches diameter at breast height (dbh) within 55 feet on either side of the preserved roadway. Some trees identified have already failed since the assessment and additional trees may need to be considered for removal as conditions have changed in the last year. It may also be necessary to remove some risk trees from the remaining parking area at the southeast end of the corridor that were not part of the managed area tree risk assessment for the safety of the public and their vehicles. Any fluctuation in number is not anticipated to exceed a 12% difference from the current schedule.

Map 3 of this application shows the location of the existing trees in the project area. Table 1 details the all the species inventoried in the project area at ≥ 6 inches diameter at breast height. Fifty-five of those trees will remain and seventy-nine probable to critical risk trees are to be removed and are detailed in Table 2. Although visual impact is inherent in the removal of any tree, this project has planned for extensive compensatory planting with 1,865 native trees, shrubs and herbaceous plants. The natural quality of the area will be enhanced with the removal of existing structures (photo 3) and impervious surfaces (photo 2). The natural terrain, soil, stones, and vegetation will be preserved wherever possible.

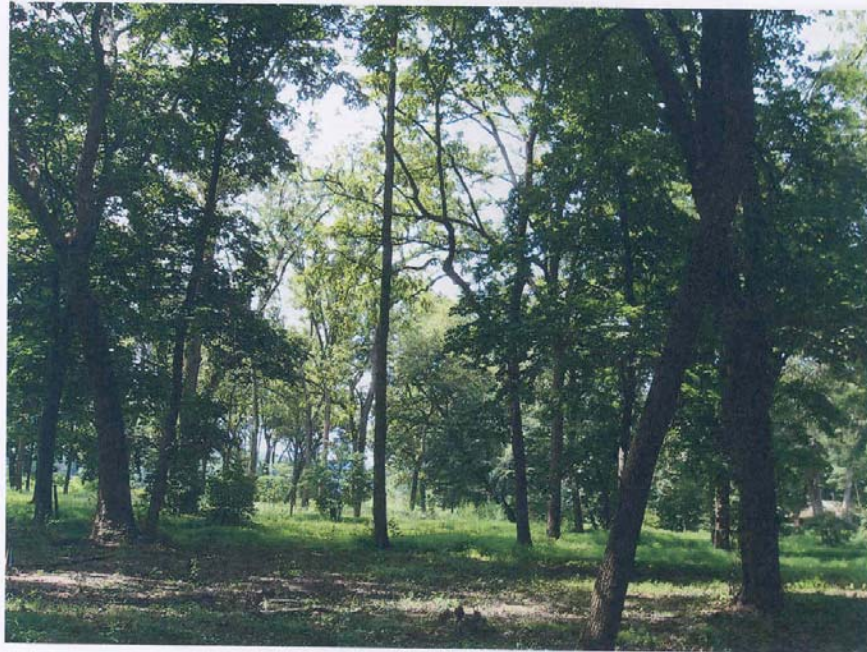
Photo No. 1: Typical view of large overstory trees throughout the campground area.

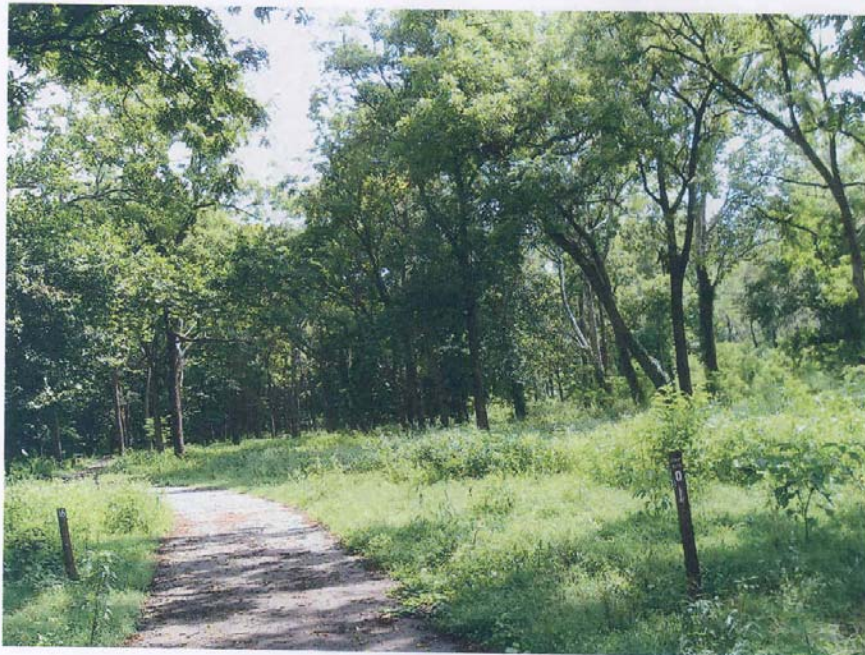
Photo No. 2: Typical view of interior roadway to be removed within the campground area.

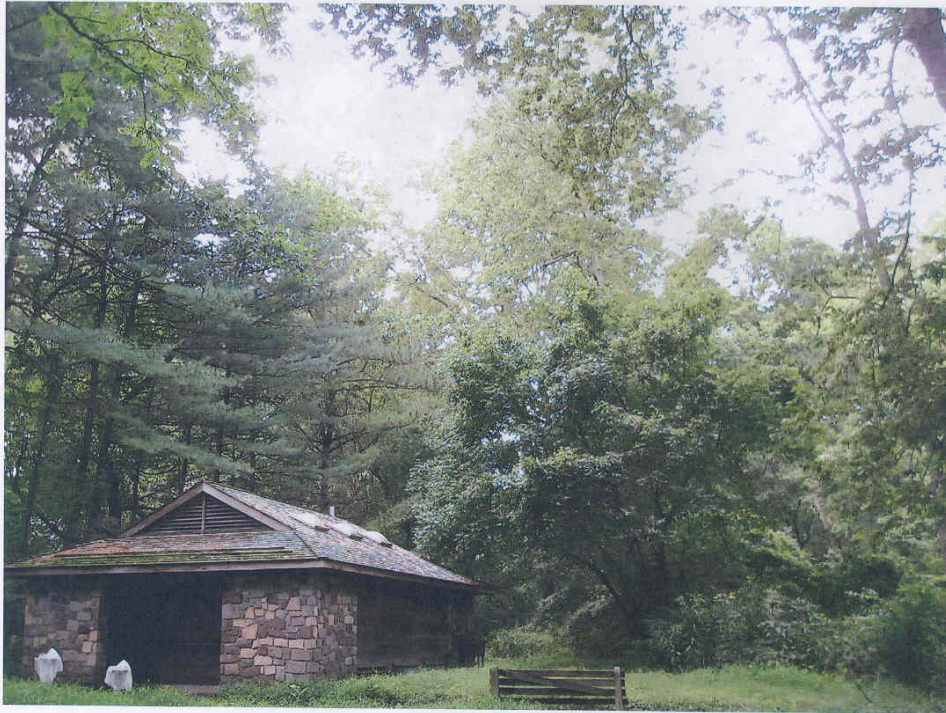
Photo No 3: One of two bath houses to be removed within the campground area.

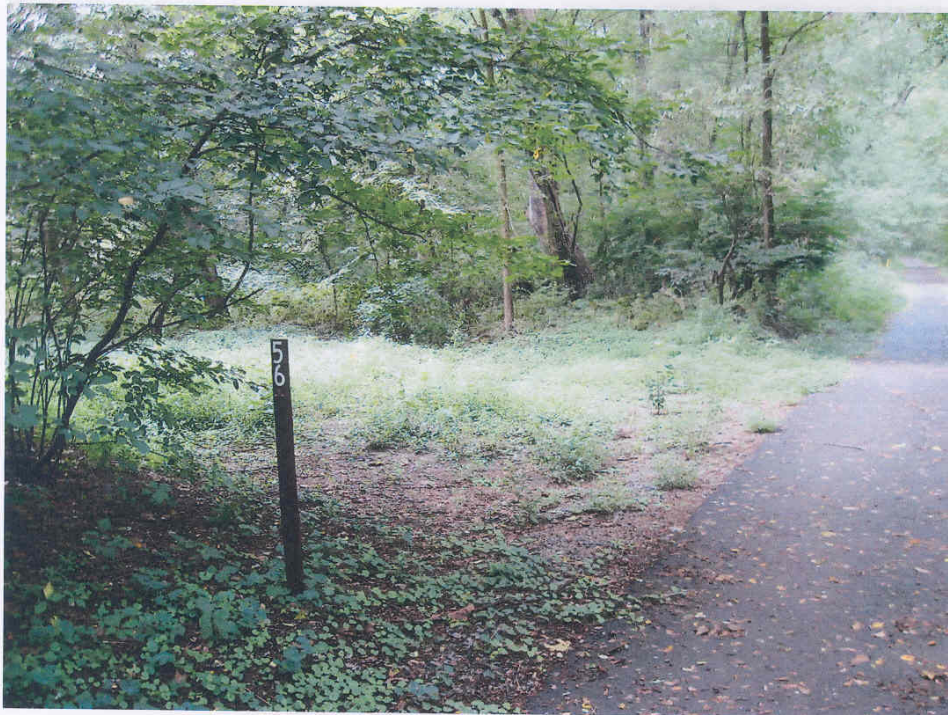
Photo 4: Typical view of campsite located along the Canal-side roadway, which will be gated to restrict access.

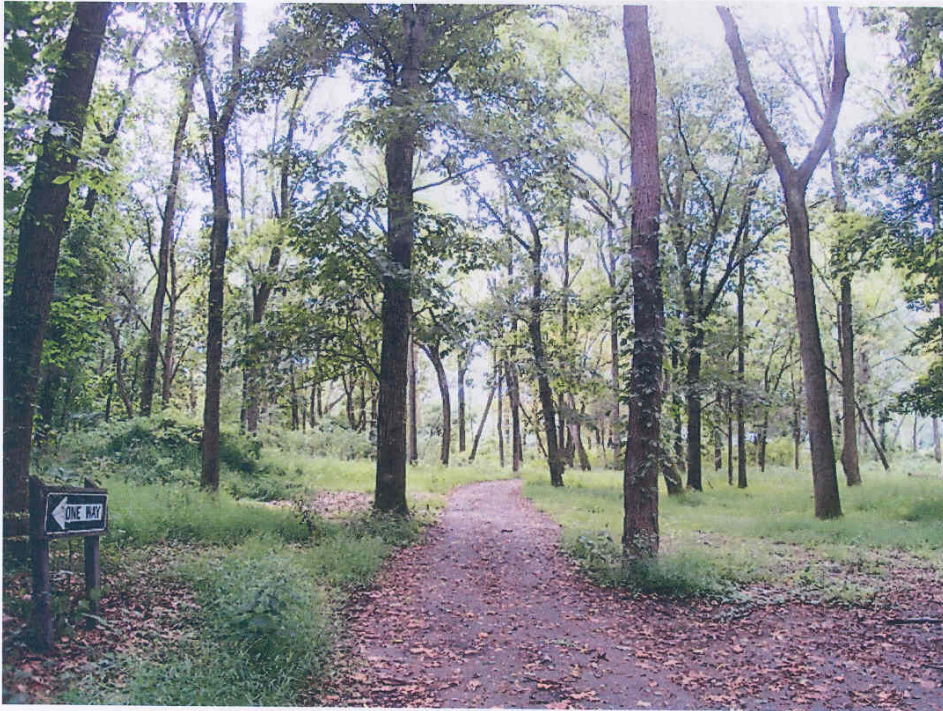
Photo 5: Eastern end of proposed recreational pathway corridor along the existing roadway along the south side of the campground.

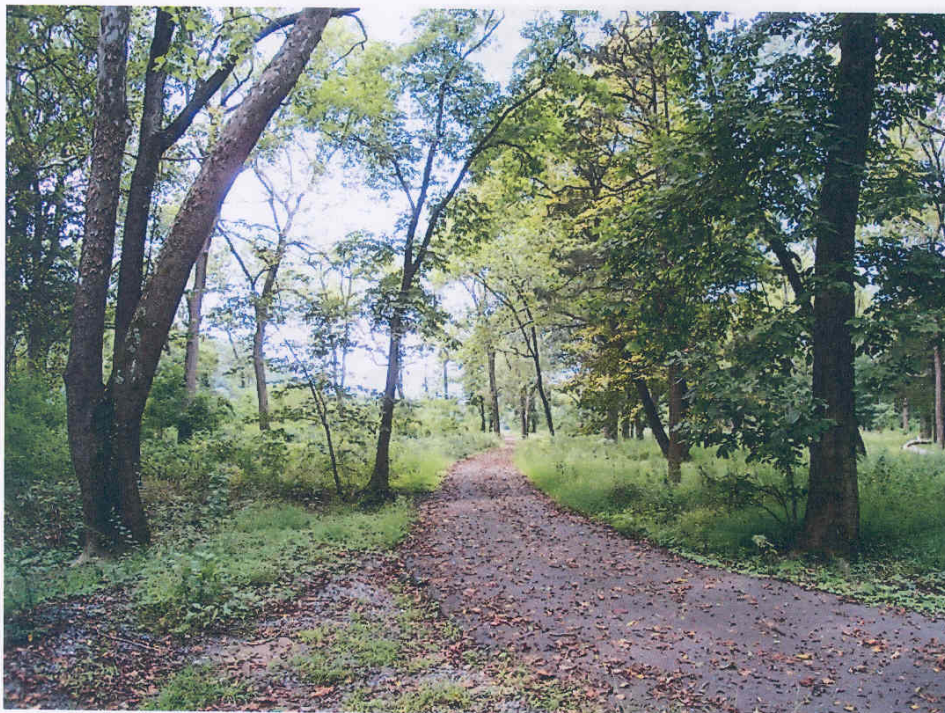
Photo 6: Proposed recreational pathway corridor along the existing roadway looking north from the curve.

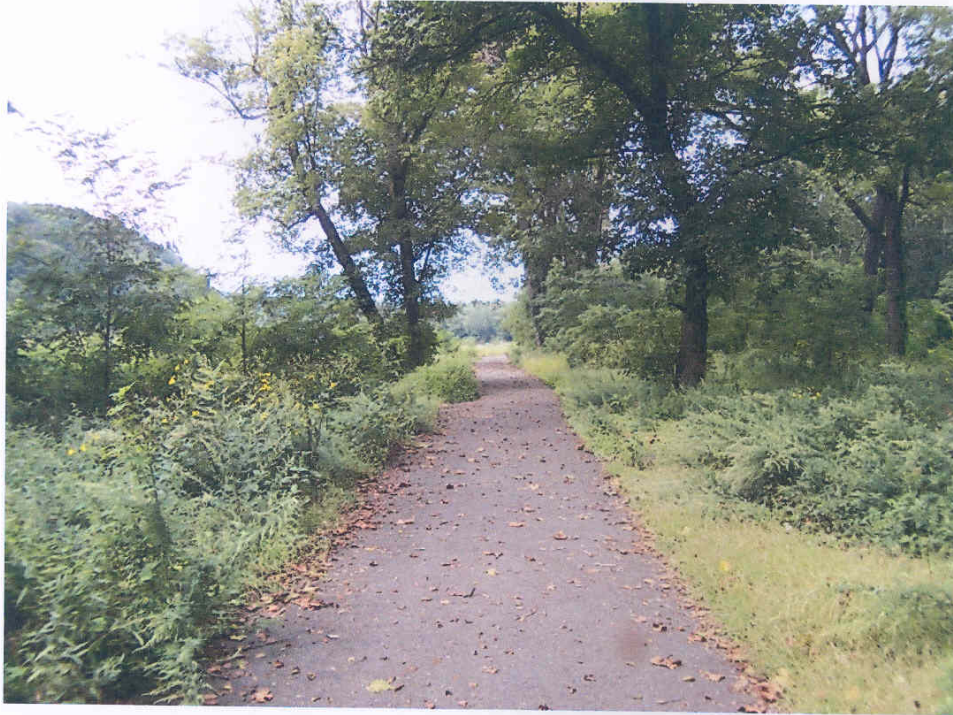
Photo 7: Proposed recreational pathway corridor along the existing roadway along the west side of the campground adjacent to the Delaware River.

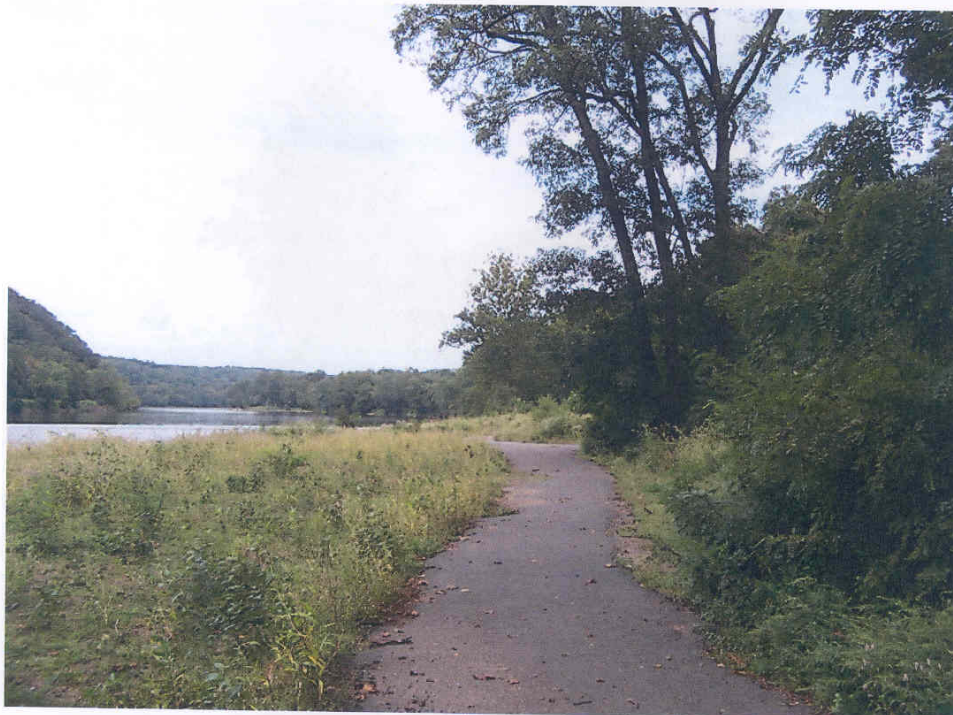
Photo 8: Proposed recreational pathway corridor along the existing roadway along the Delaware River.

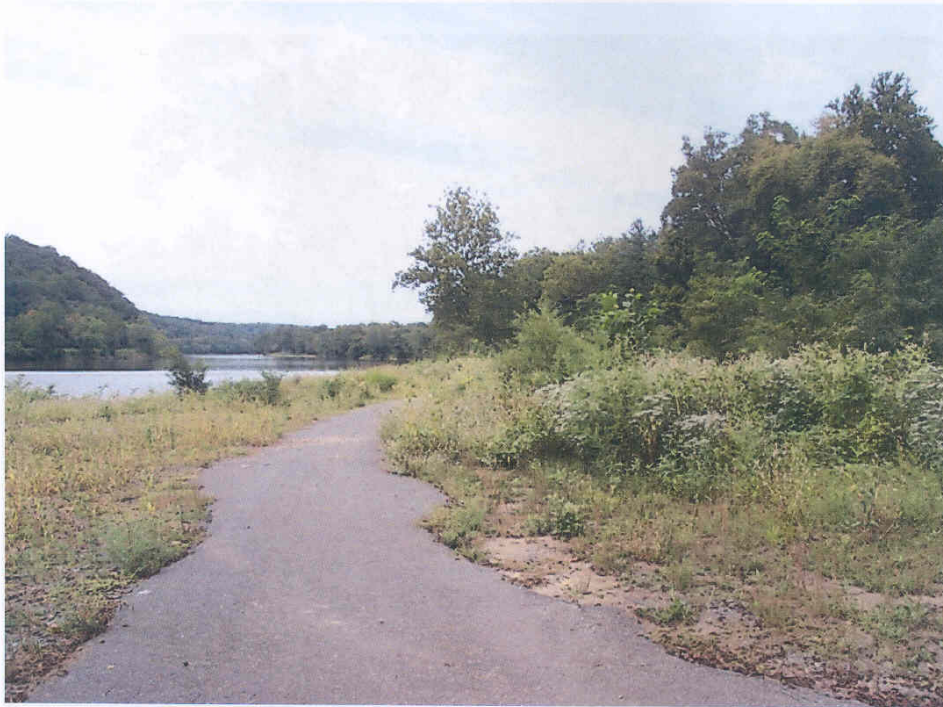
Photo 9: Proposed recreational pathway corridor along the existing roadway along the Delaware River.

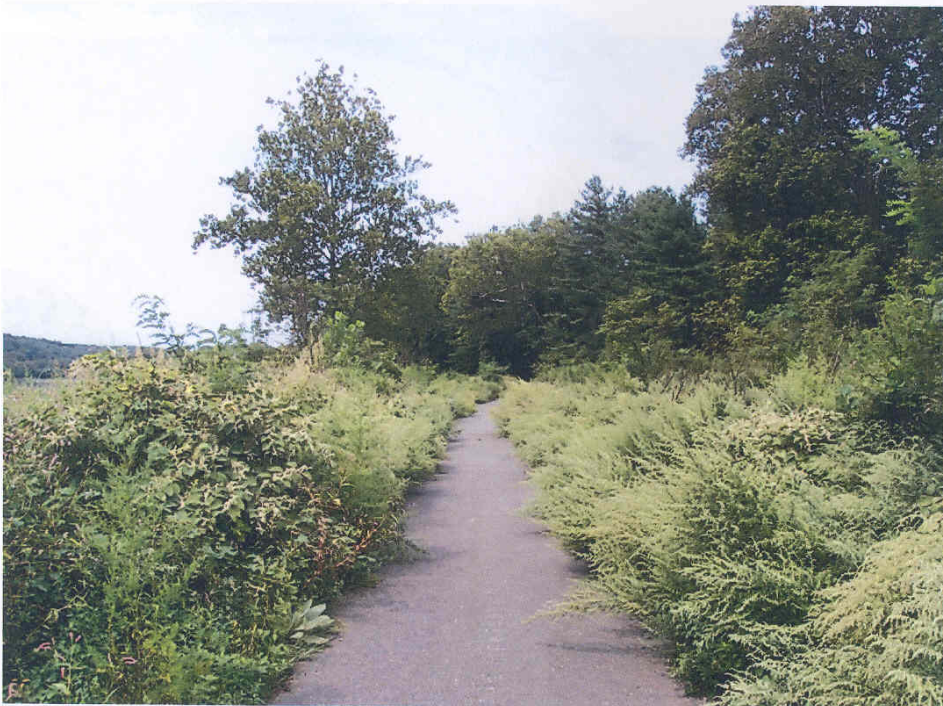
Photo 10: Proposed recreational pathway corridor along the existing roadway along the Delaware River.

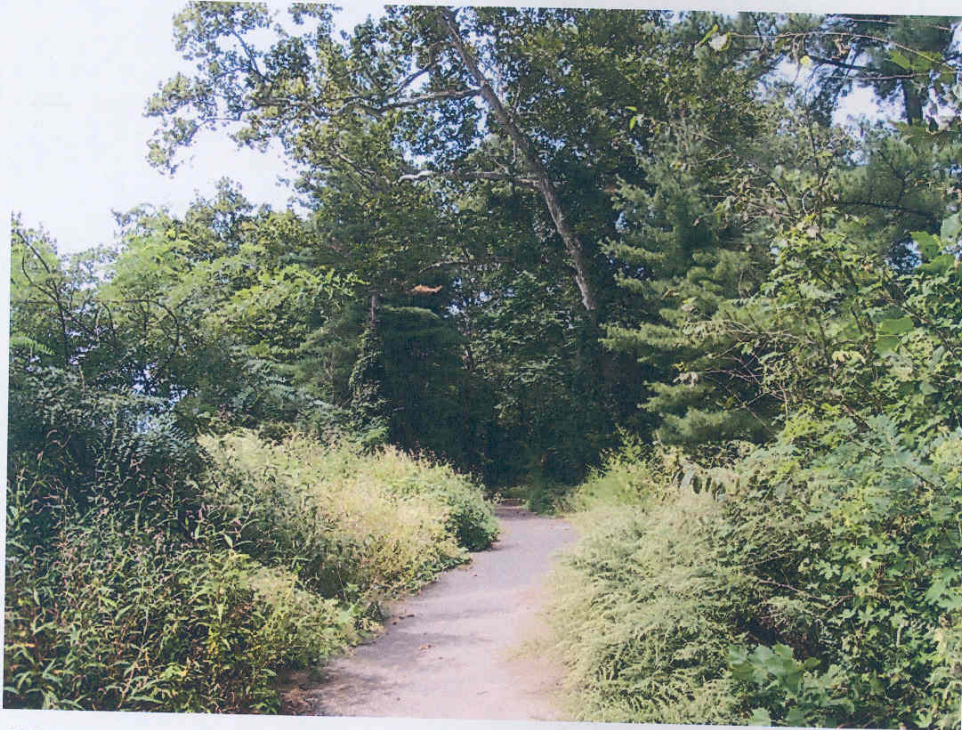
Photo 11: Northern end of proposed recreational pathway corridor along the existing roadway along the Delaware River.

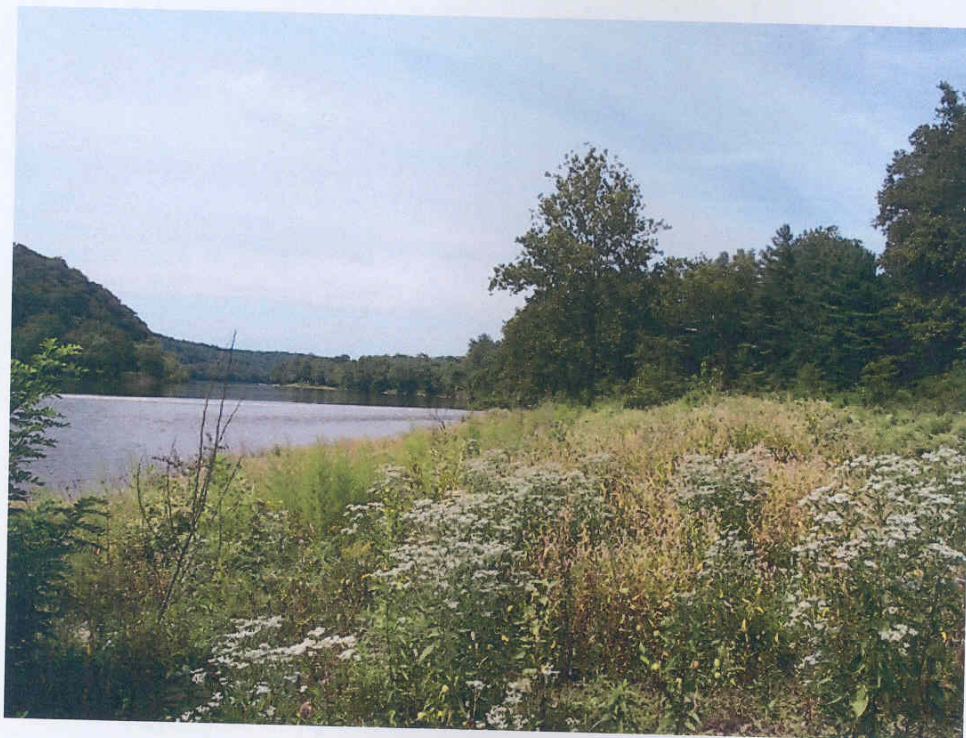
Photo 12: View of proposed public use area along the recreational pathway corridor and the Delaware River.
