# Ramapo River - FIBI052

## SUMMARY OF RESULTS – FIBI052

FIBI052  
RAMAPO RIVER  
CATHERINE AVENUE  
WEST MAHWAH, BERGEN COUNTY

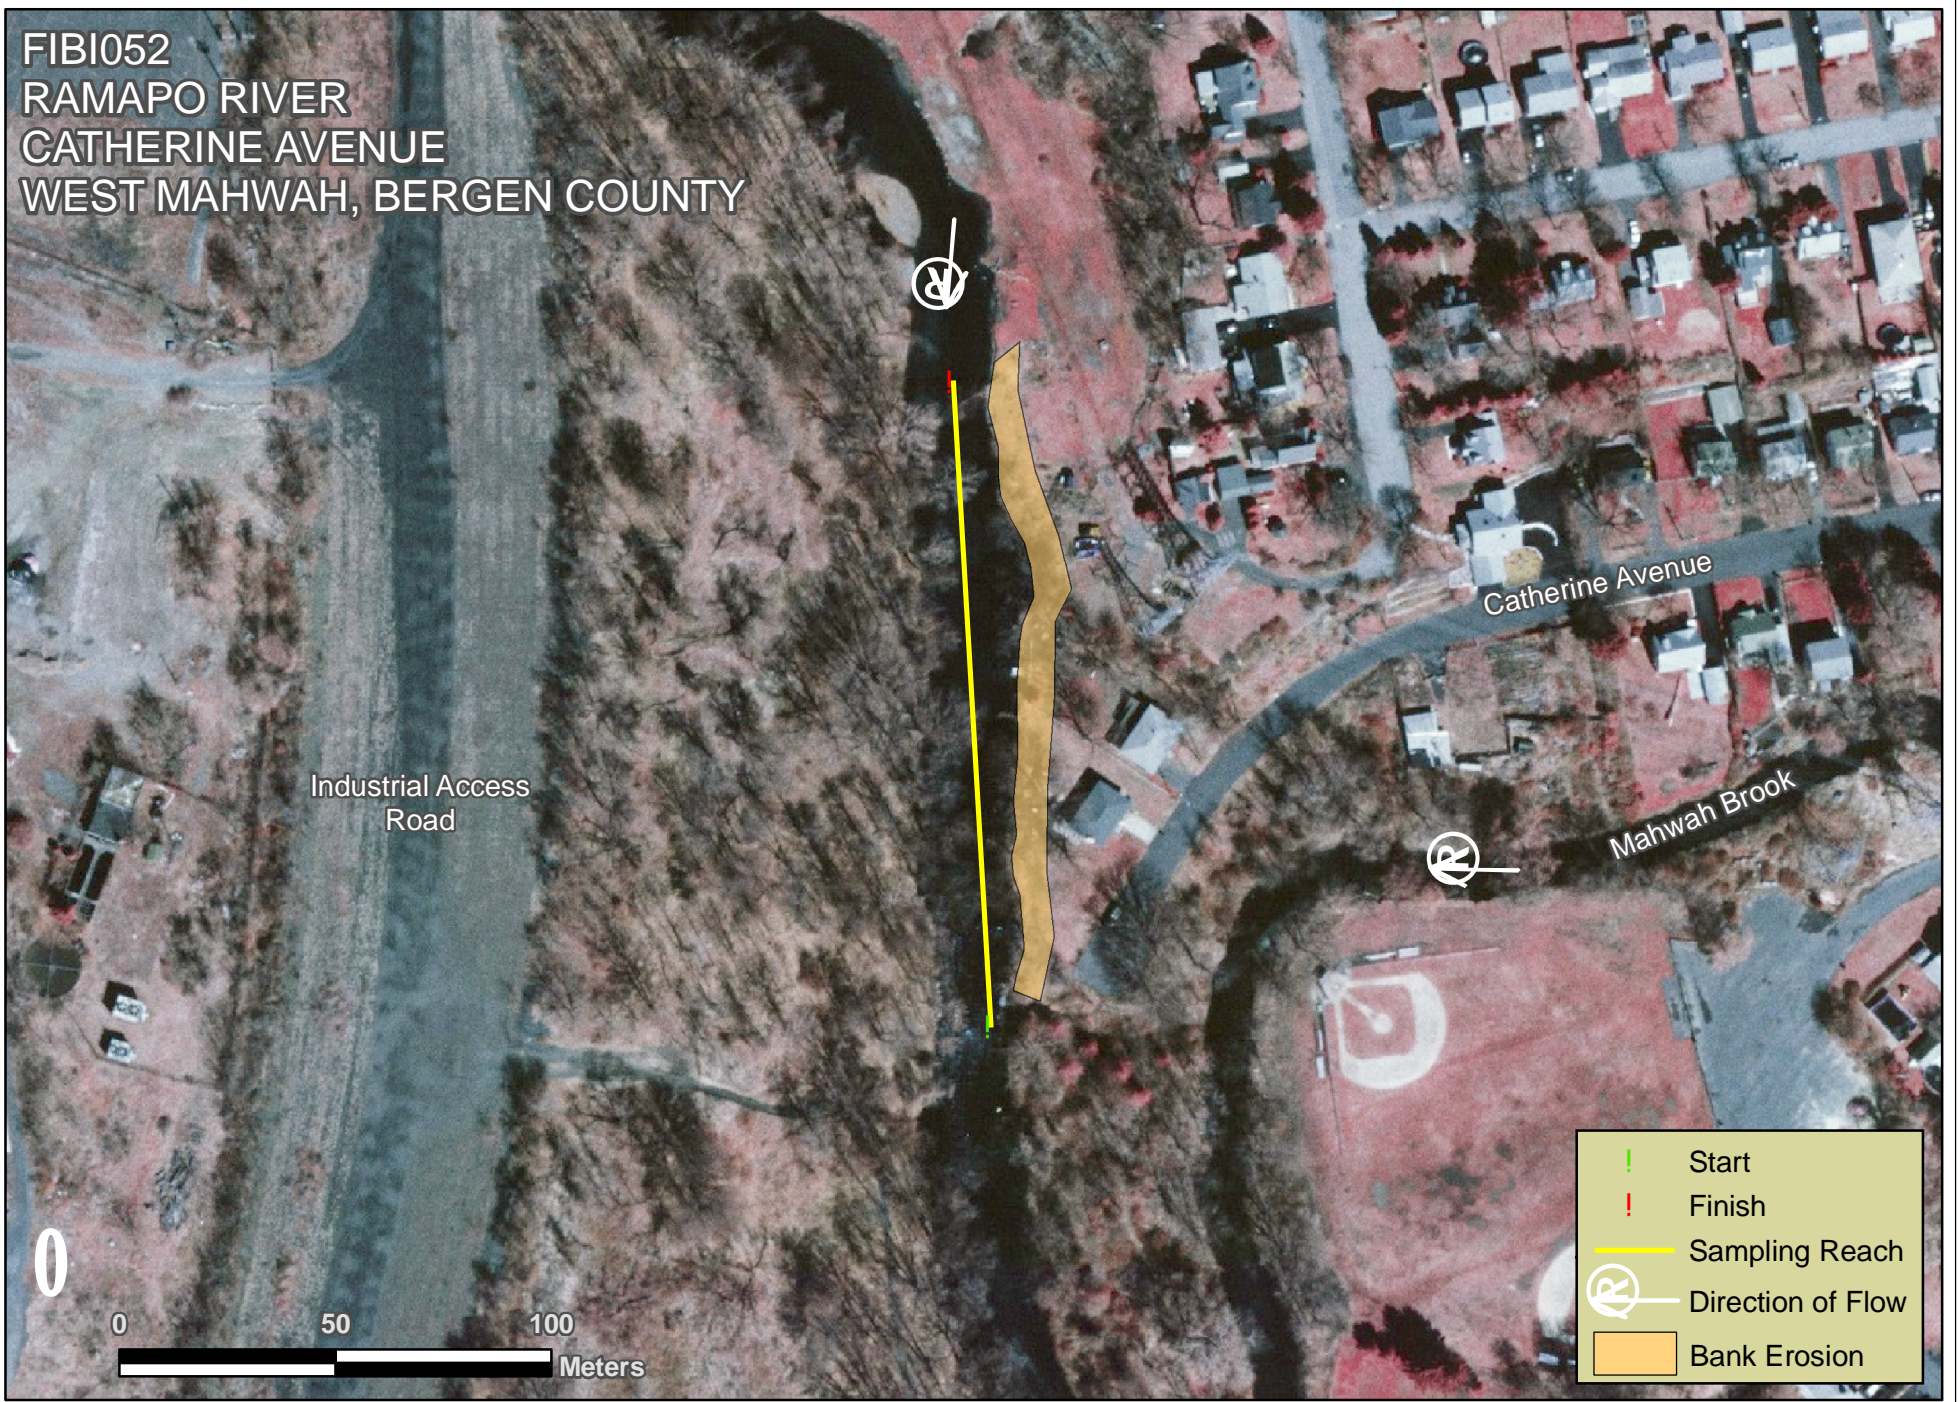
- ! Start
- ! Finish
- Sampling Reach
- Ⓜ Direction of Flow
- Bank Erosion
