Saddle River

FIBI090

SUMMARY OF RESULTS – FIBI090

FIBI090-Saddle River @ Grove St
Date Sampled - 7/16/2009

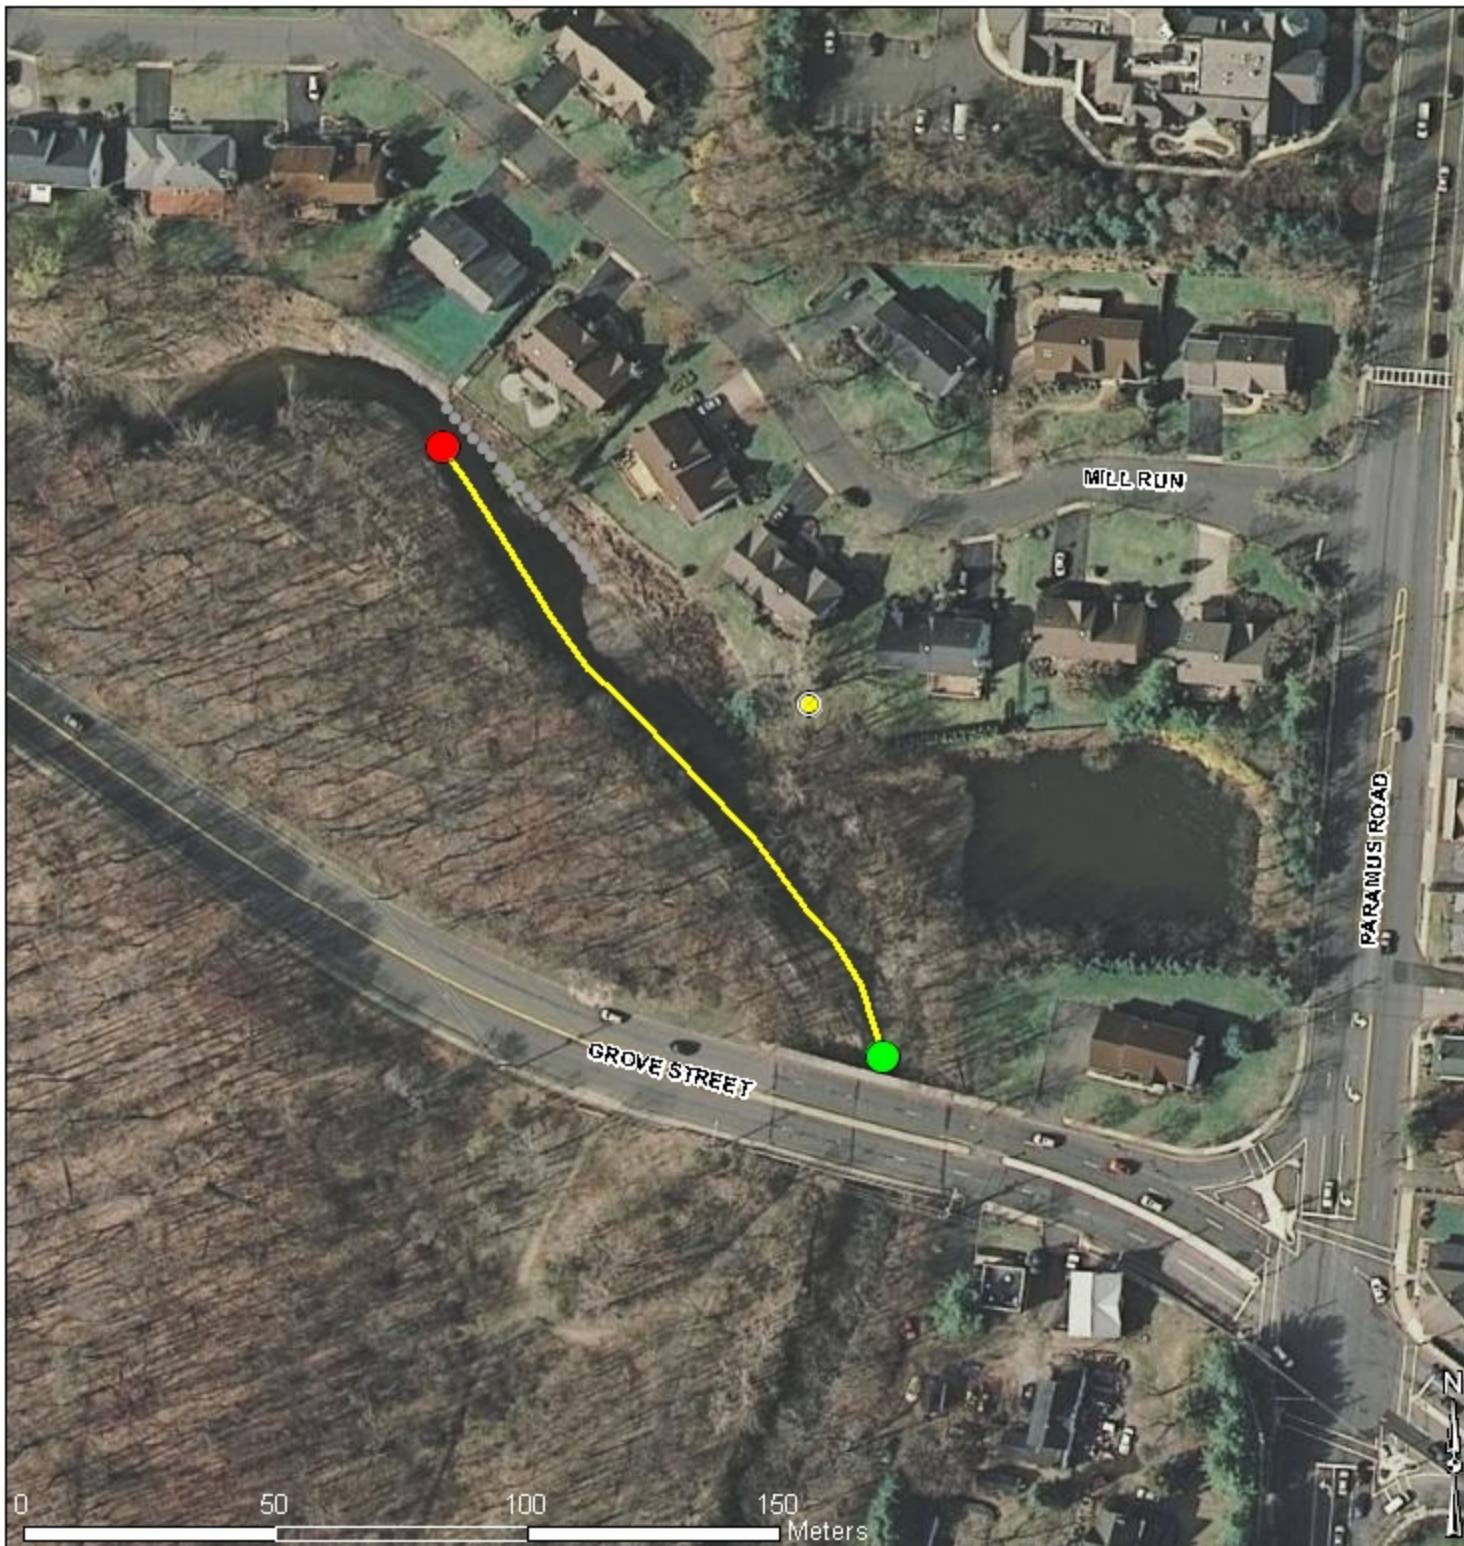
FIBI090-R2

Legend

- Finish
- Start
- Outfall
- RipRap
- FIBI Reach
