NEW JERSEY OFFICE OF CULTURAL AND ENVIRONMENTAL SERVICES  
HISTORIC PRESERVATION SECTION  
INDIVIDUAL STRUCTURE SURVEY FORM

HISTORIC SITES INVENTORY NO. 1301-1-1

LOCATION: 1 Allen Ave.

MUNICIPALITY: Allenhurst

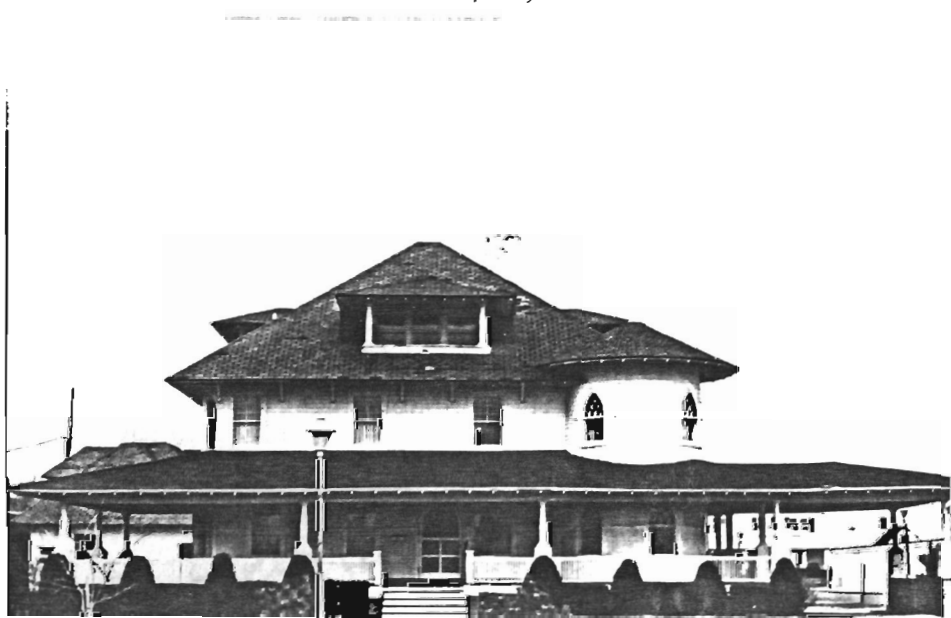
PHOTO Negative File No. 2/12,13

Style: Victorian Vernacular

Roof/Chimneys: Hip with turret; interior chimney

Pointed arch doorway.  
Pointed arch windows on turret with label molds.  
Large brackets on oversized eaves.  
Porch on three sides plus porte-cochere.

Faces south on rectangular corner lot.

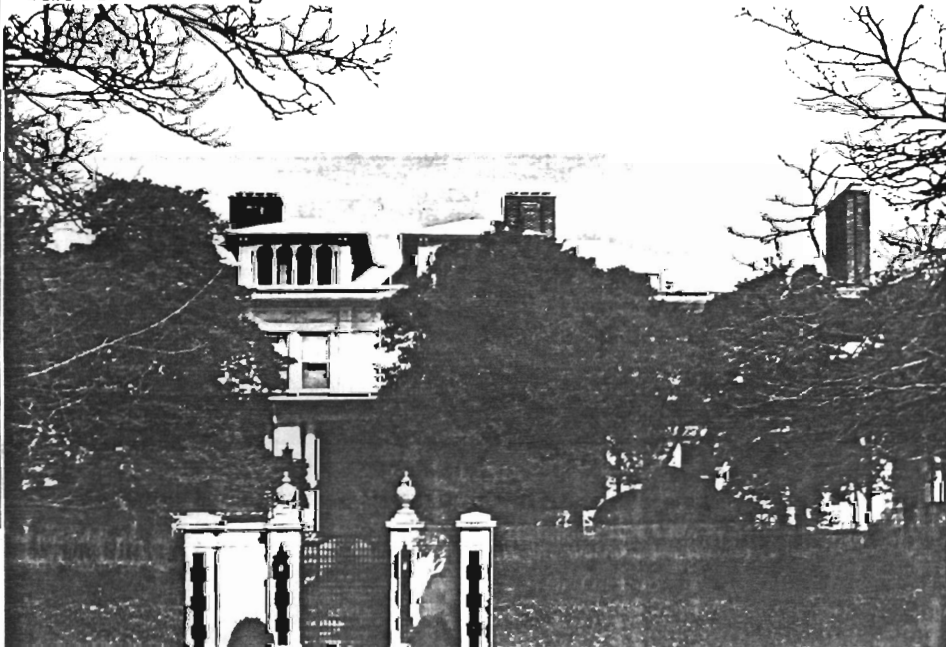
PHOTO Negative File No. 1/13-15

Construction Date: c. 1900      Source of Date: Ref. 1  
Architect:      Builder:  
Style: Colonial Revival      Form/Plan Type: Rectangle  
Number of Stories: 2½  
Foundation: Brick  
Exterior Wall Fabric: Clapboard  
Fenestration: Generally symmetrical; 1/1 sash windows  
Roof/Chimneys: Hip; four massive interior chimneys.

Dormers with ogee arcade are not Colonial Revival features.  
Large paneled frieze with dentils, medallions, and swags.  
Pilastered facade.  
Large porches on S. and E. sides with square posts and Doric columns.

Faces south on corner lot.

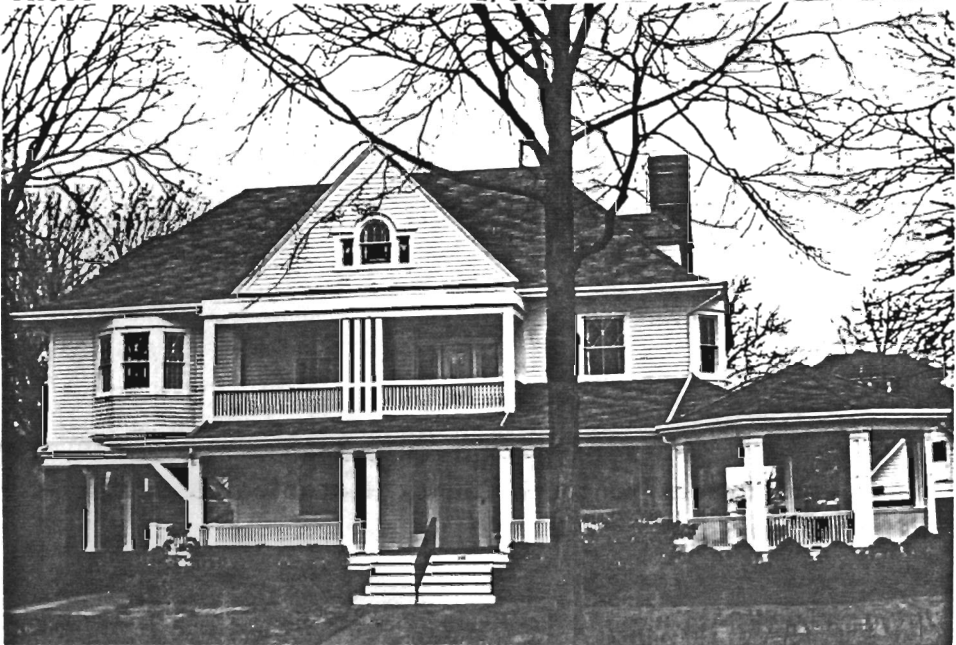
PHOTO Negative File No. 1/8.9

Construction Date:	c. 1896	Source of Date:	Ref. 1 & 2
Architect:		Builder:	
Style:	Colonial Revival	Form/Plan Type:	Rectangle with ell; porch on two sides
Number of Stories:	2½		
Foundation:	Brick		
Exterior Wall Fabric:	Clapboard and wood shingles		
Fenestration:	4 over 3 bays, variety of window treatments.		
Roof/Chimneys:	Hip with cross gable; interior end chimney.

Palladian window in gable.  
 Porch has square posts and polygonal SE corner.  
 Porte-cochere on W. side.  
 Diamond lights in upper story windows.  
 Pilastered entry with tracery in sidelights.

Faces south on rectangular borough lot.  
Large carriage house in rear (partially visible in photo).

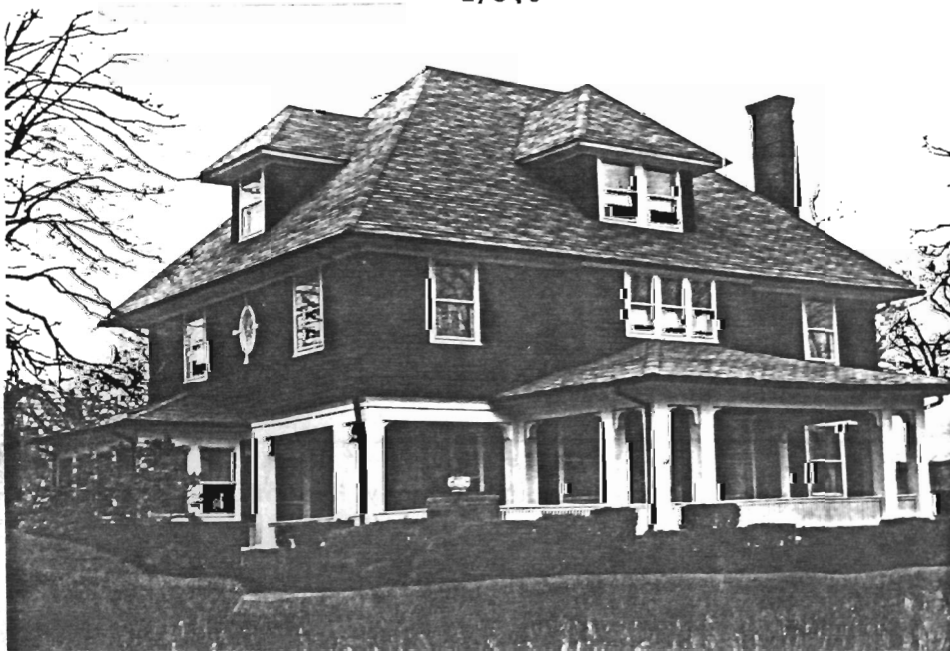
PHOTO Negative File No. 2/5,6

Construction Date: c. 1900      Source of Date: Ref. 1  
Architect:      Builder:  
Style: Colonial Revival/Shingle Style      Form/Plan Type: Rectangle  
Number of Stories: 2½  
Foundation: Brick  
Exterior Wall Fabric: Wood shingles  
Fenestration: 3 over 6 bays  
Roof/Chimneys: Hip; exterior end chimney

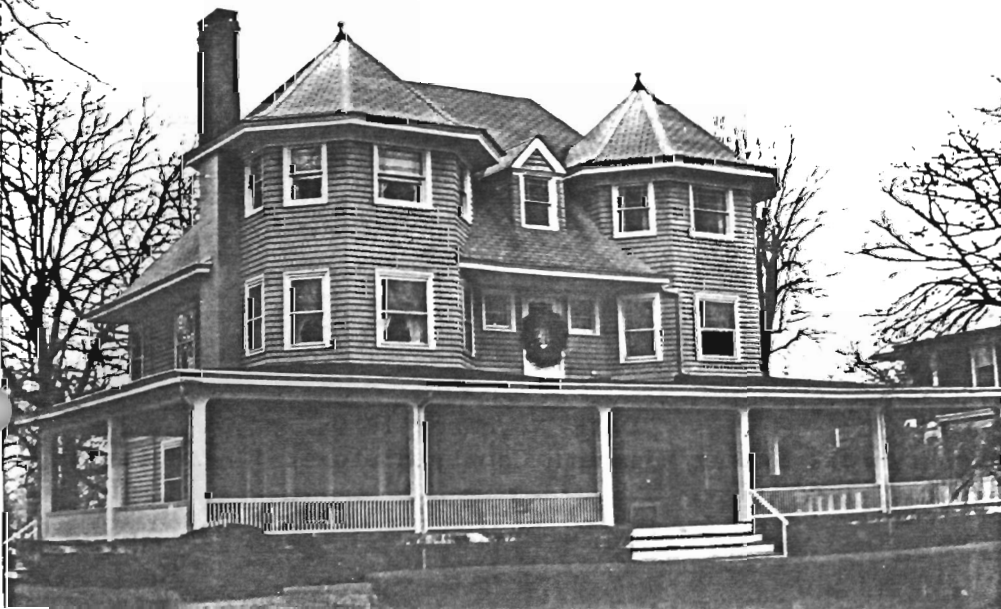
PHOTO Negative File No. 1/36

Construction Date: c. 1900      Source of Date: Ref. 1  
Architect:      Builder:  
Style: Queen Anne\*      Form/Plan Type: Rectangle with twin turrets  
Number of Stories: 2½  
Foundation: Brick  
Exterior Wall Fabric: Wood shingles (painted)  
Fenestration: Symmetrical  
Roof/Chimneys: Hip with twin turrets; exterior end chimney

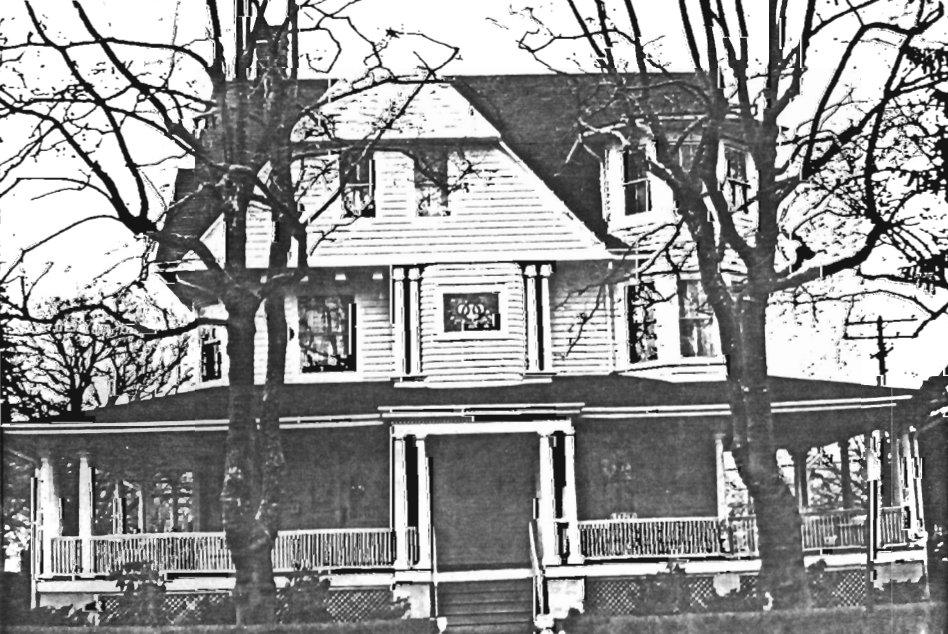
PHOTO Negative File No. 1/34.35

The turret roof, which was probably either conical or a polygonal spire, has been removed. Rounded central bay in the second story is flanked by colonnettes and features a fixed rectangular light with lovely art glass. Fenestration includes multiple projecting bays and 3/2 and 4/1 (vertically divided panes) sash windows. Slender Doric columns with brackets on porch. Doorway has pointed arch glass with tracery; same motif is repeated in sidelights.

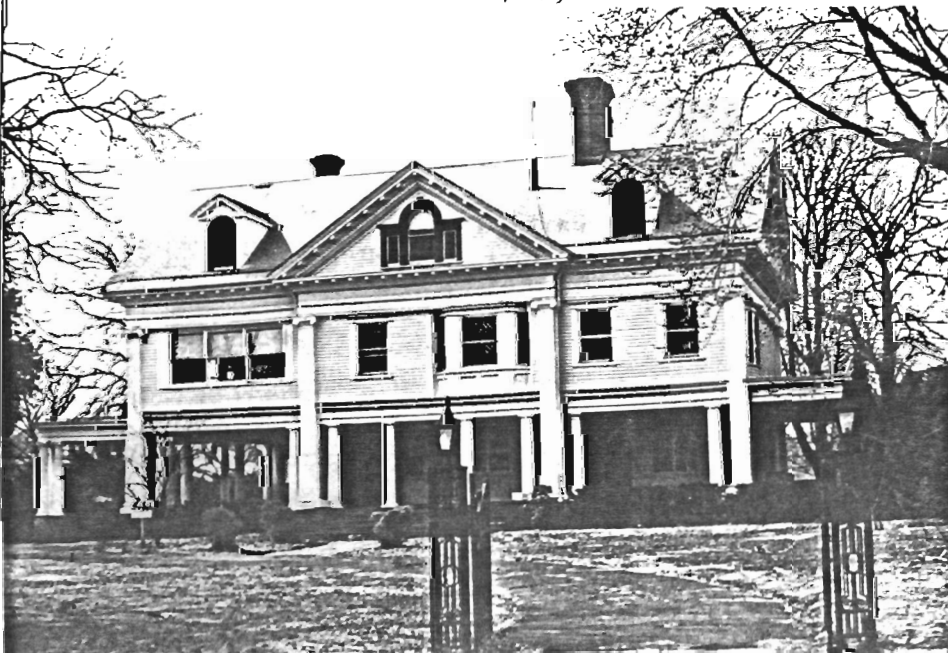
PHOTO Negative File No. 2/27,28

Construction Date:	c. 1898	Source of Date:	Ref. 1,2,3
Architect:		Builder:	
Style:	Colonial Revival	Form/Plan Type:	Rectangle with overstory and rear wing
Number of Stories:	2½		
Foundation:	Brick		
Exterior Wall Fabric:	Clapboard		
Fenestration:	5 over 3 bays, variety of window treatments		
Roof/Chimneys:	Gable; ridge chimney and interior chimney

Faces east on large corner lot.

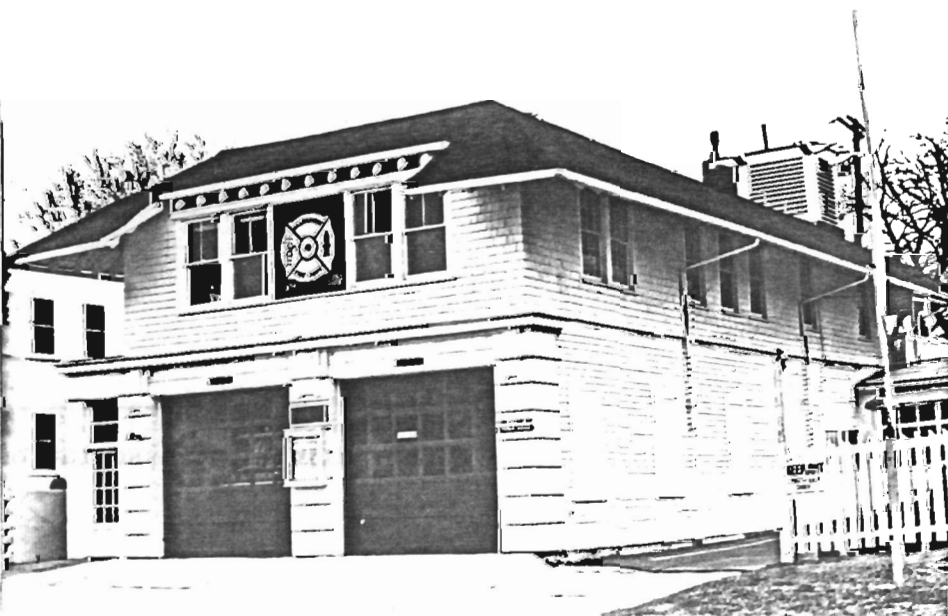
Negative File No. 3/11,12

Construction Date:	1905	Source of Date:	1
Architect:		Builder:	
Style:	Bungalow elements	Form/Plan Type:	Rectangle
Number of Stories:	2		
Foundation:	Concrete		
Exterior Wall Fabric:	Clapboard and wood shingles		
Fenestration:	2 by 6 bays (with some grouped windows)		
Roof/Chimneys:	Truncated hip; interior chimney

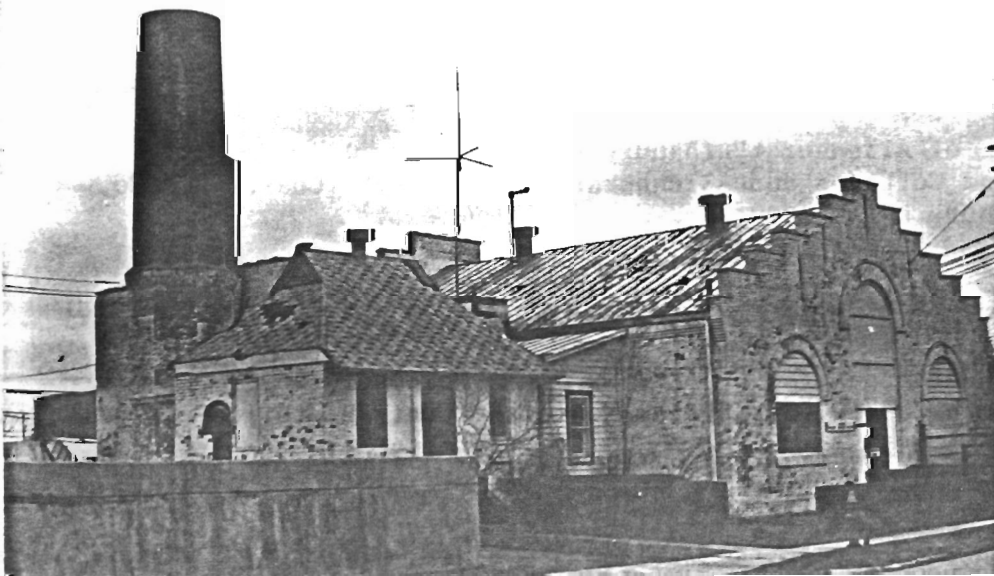
PHOTO Negative File No. 3/13,19 Map (Indicate North)

Construction Date:	c. 1898	Source of Date:	Ref. 1,2,3
Architect:		Builder:	
Style:	Elements of Romanesque Revival	Form/Plan Type:	Irregular
Number of Stories:	1		
Foundation:	Concrete		
Exterior Wall Fabric:	Painted brick		
Fenestration:	Varied (round arch windows on large building)		
Roof/Chimneys:	Gable (large building); hipped gable (small building).

Consists of two buildings; the small structure was originally the office and the large one was the waterworks. Large building has sheet metal roof with stepped gable parapet. Sections of the three round arches on the main facade have been closed up.

Faces north on a rectangular lot.

Chipped paint and deterioration of brick.

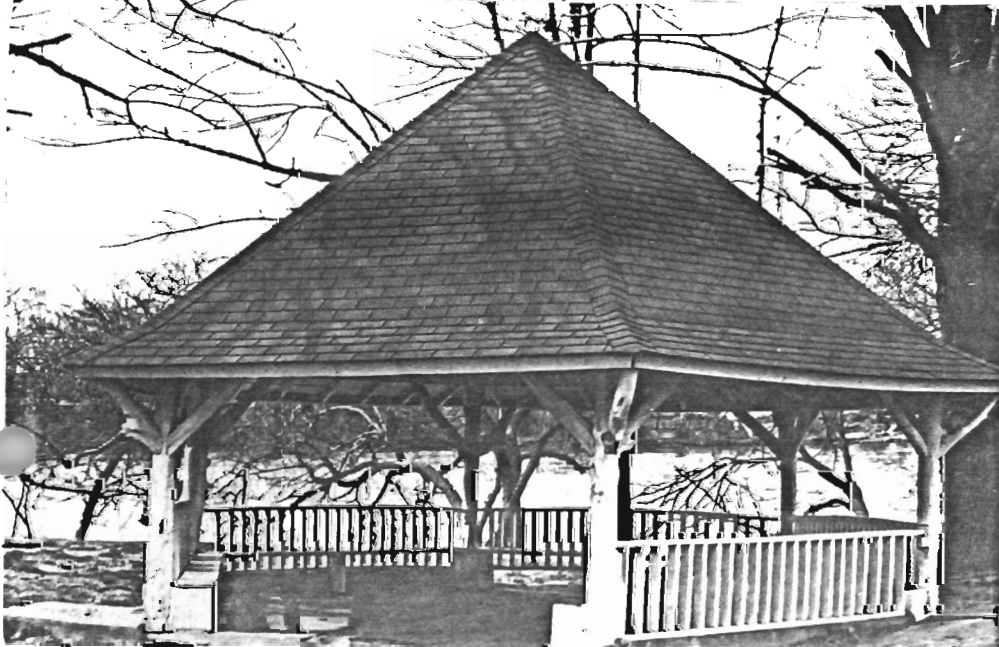
2/35

A small wood-frame park pavilion with pyramidal roof, rustic posts and brackets, and interior benches. Replaced an earlier wooden pavilion (shown on the 1905 Sanborn map) which was hexagonal in shape.

South side of Deal Lake, at end of Spier Ave., in Borough of Allenhurst park.

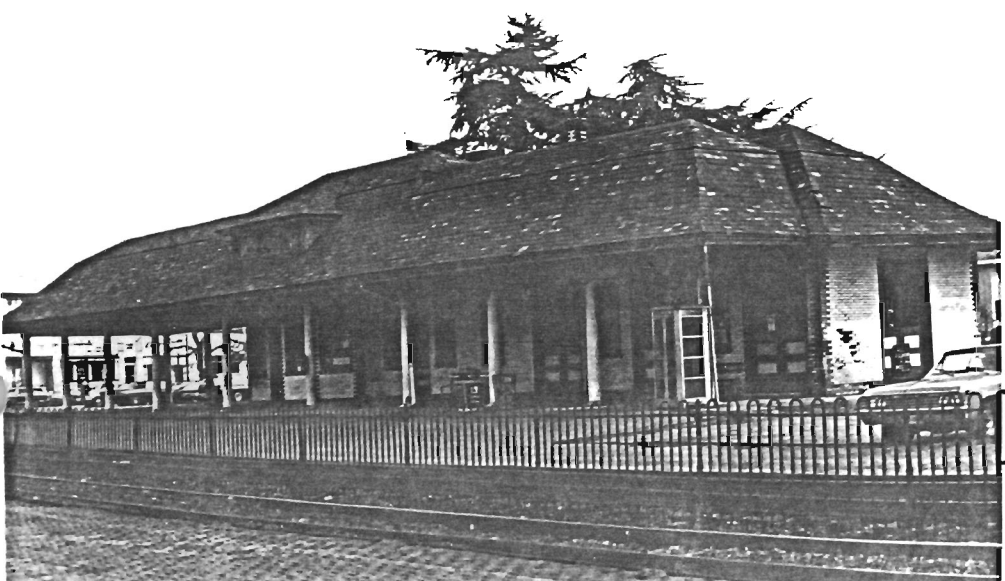
PHOTO Negative File No. 1/3-7

Construction Date:	1897, 1900	Source of Date:	NRHP
Architect:		Builder:	N.J. Central Railroad
Style:	Elements of Queen Anne	Form/Plan Type:	Rectangle
Number of Stories:	1½		
Foundation:	Brick		
Exterior Wall Fabric:	Cream enameled brick with red brick trim		
Fenestration:	Irregular		
Roof/Chimneys:	Double hip with flared eaves; exterior chimney on E. facade.		
Additional Architectural Description:	See N.R.H.P. form.

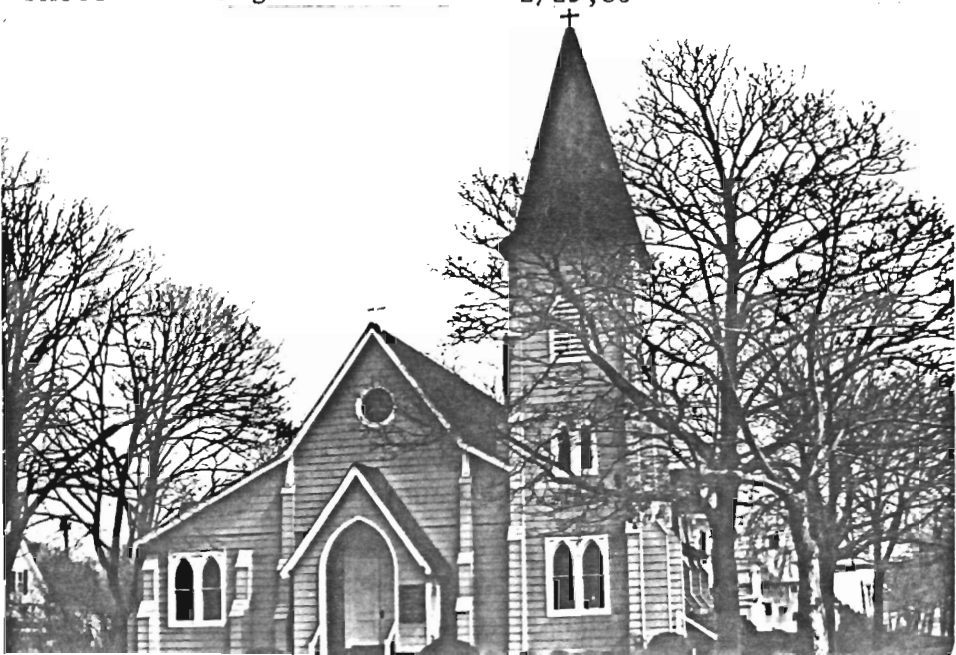
PHOTO Negative File No. 2/29,30

Construction Date:	1903	Source of Date:	Ref. 1,2
Architect:		Builder:	
Style:	Late Gothic Revival	Form/Plan Type:	Rectangle with corner tower.
Number of Stories:	1		
Foundation:	Brick		
Exterior Wall Fabric:	Gray asbestos shingles		
Fenestration:	3 symmetrical bays (front)		
Roof/Chimneys:	Gable (polygonal spire on tower)

Lancet windows set in rectangular enframements. Buttressed facades. Paneled double doors in gabled entrance porch. Asbestos shingles are a later addition to what was probably originally a wood shingle exterior. New hand-blown stained glass window (above altar, east end) dedicated in 1966; designed by Pere A. Bergthm of George L. Payne Inc. of Paterson.

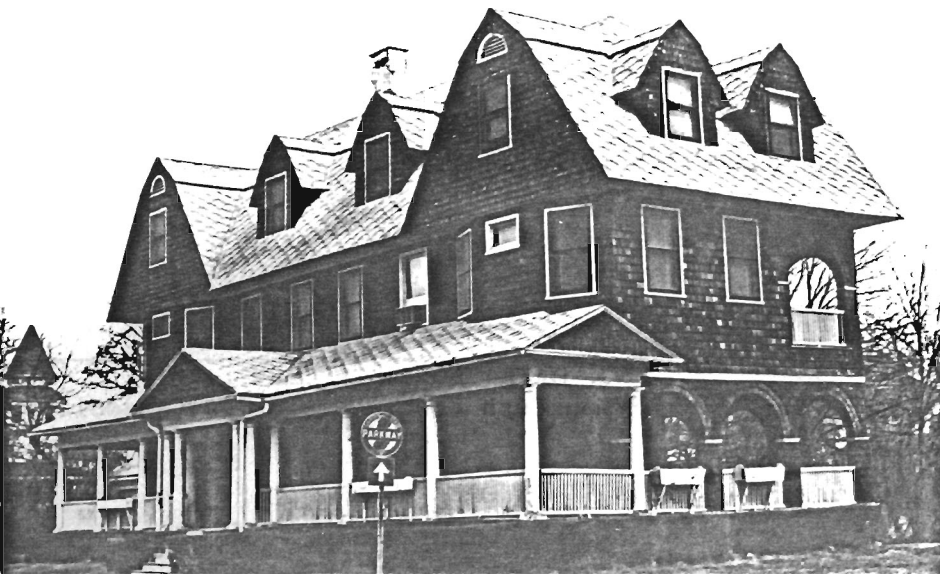
PHOTO Negative File No. 1/28-30

Construction Date:	c. 1900	Source of Date:	Ref. 1,2
Architect:		Builder:	
Style:	Shingle Style	Form/Plan Type:	Rectangle with porch on three sides
Number of Stories:	2½		
Foundation:	Brick		
Exterior Wall Fabric:	Natural Wood shingles		
Fenestration:	6 over 5 asymmetrical bays		
Roof/Chimneys:	Hip with intersecting gambrel roofs; interior ridge chimney

Faces west on a corner rectangular lot.

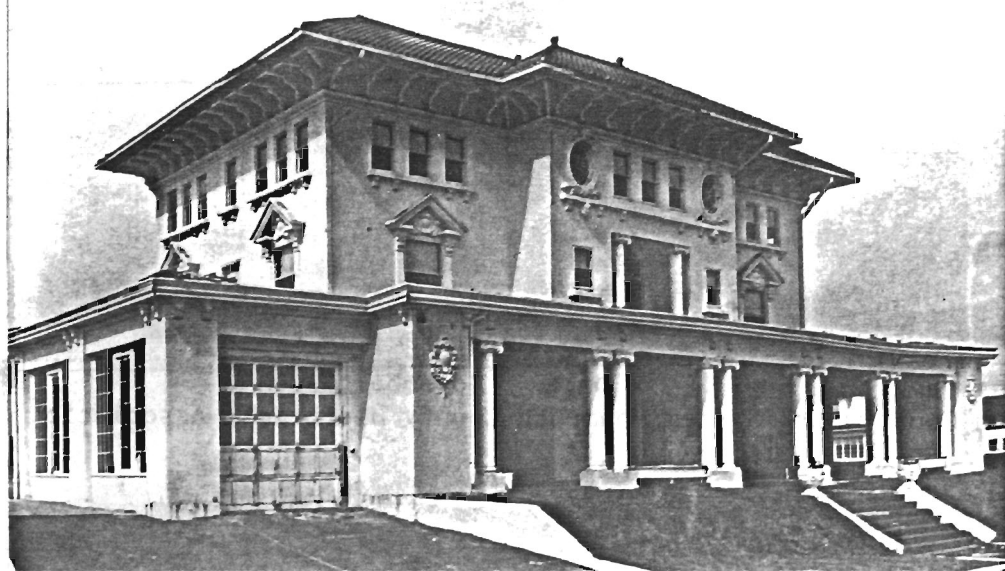
PHOTO Negative File No. 1/25-27

Faces east on corner rectangular lot, opposite beach and Atlantic Ocean.

Repair of roof and gutters needed.

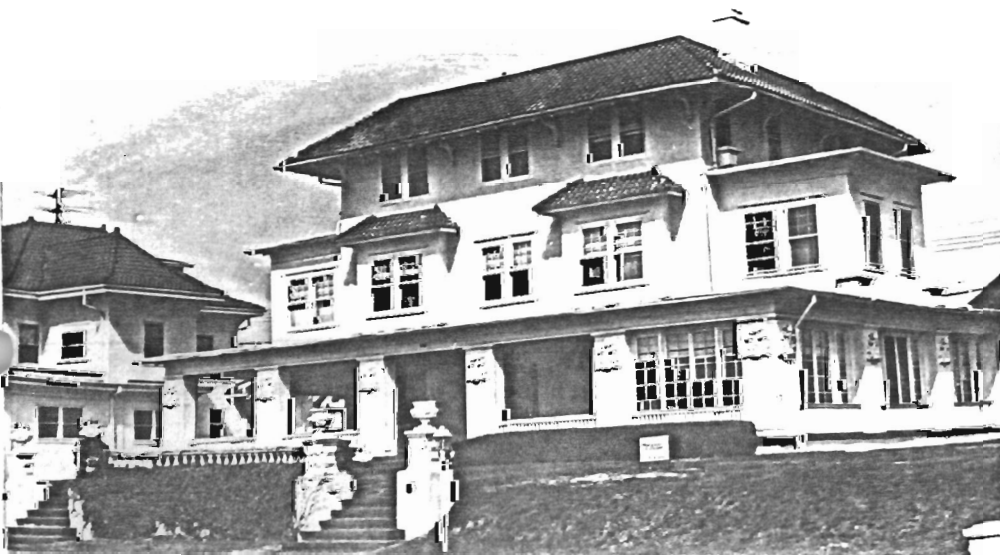
PHOTO Negative File No. 1/19-20 Map (Indicate North)

Mission tile roof with large bracketed eaves.  
Paired 9/1 sash windows.  
Porch on three sides, enclosed on E. end.  
Porch piers embellished with cartouches.

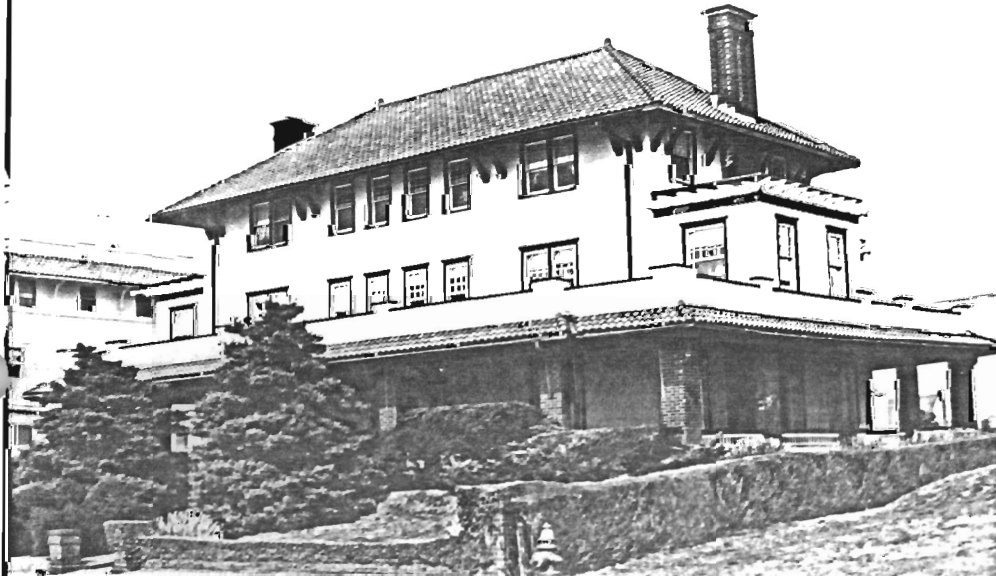
PHOTO Negative File No. 1/21-22 Map (Indicate North)

Mission tile roof with large eaves and paired brackets. Exposed rafter ends on wings. Expansive porch on three sides with parapet, brick piers, and turned post balustrade. Double door with sidelights and elliptical transom.

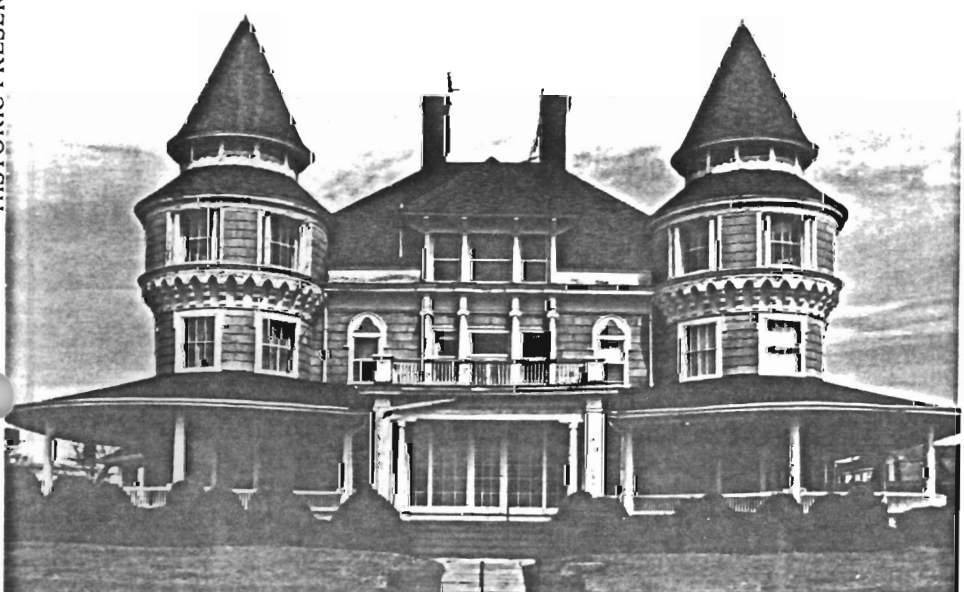
PHOTO Negative File No. 1/23,24

Construction Date:	c. 1900	Source of Date:	Ref. 1 & 2
Architect:		Builder:	
Style:	Victorian Eclectic	Form/Plan Type:	Rectangle with two turrets; porch on 3 sides.
Number of Stories:	2½		
Foundation:	Not visible		
Exterior Wall Fabric:	Asbestos shingles		
Fenestration:	3 bays plus turret on each end		
Roof/Chimneys:	High hip plus conical-roofed turrets; twin interior chimneys		
Additional Architectural Description:	<p>Expansive wraparound porch with porte-cochere on NW corner. Twin turrets with two-tiered conical roofs, colonnettes and wood corbeling. Ionic colonnettes on center tripartite bay. Asbestos shingles are a later addition; original wall fabric was probably wood shingles.</p>

Roof, gutters, and trim need repair.
