Lamington River - FIBI078

SUMMARY OF RESULTS

FIBI078 - Lamington River

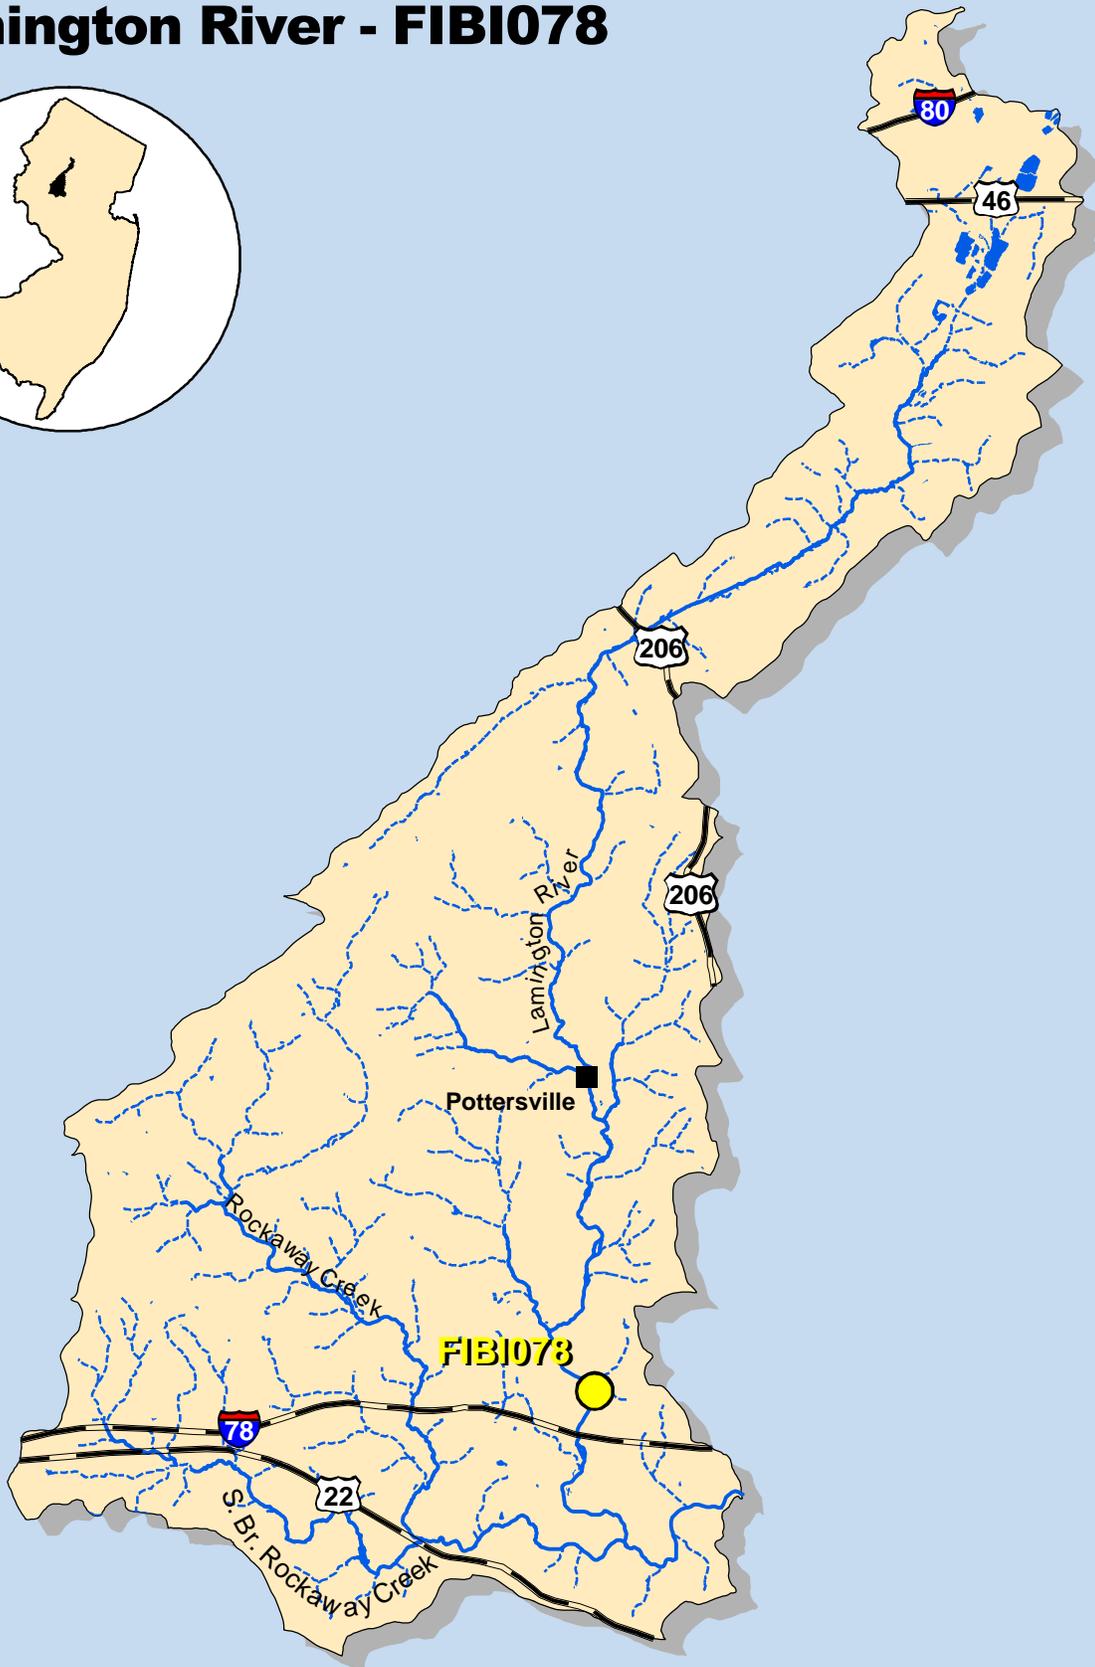
FIBIO78
LAMINGTON RIVER
RATTLESNAKE BRIDGE ROAD
READINGTON TOWNSHIP, SOMERSET COUNTY

Rattlesnake Bridge Road

START

FINISH

SEGMENT SAMPLED

DIRECTION OF FLOW
