Six Mile Run - FIBI022

SUMMARY OF RESULTS – FIBI022

FIBI022
SIX MILE RUN
SOUTH MIDDLEBUSH ROAD
FRANKLIN TWP., SOMERSET COUNTY

FIBI022-Six Mile Run @ S Middlebush Road
Date Sampled - 6/22/2006

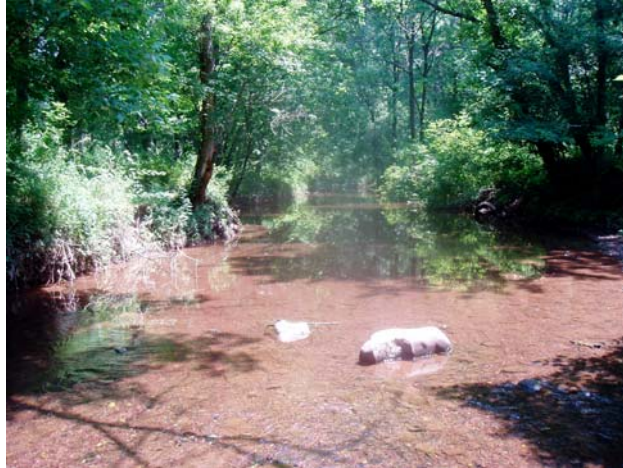
1. Stream Name:	Six Mile Run
2. Sampling Date:	6/22/2006
3. Sampling Location:	South Middlebush Road
4. Municipality:	Franklin Twp.
5. County:	Somerset
6. Watershed Management Area:	10

7. Contributing Drainage Area (Sq. Mi.):	11.1
8. Electrofishing Gear:	2 Backpacks
9. FIBI Score and Rating:	Round 1* Fair (36); Round 2 Fair (34)
10. Habitat Score and Rating:	Round 1 Sub-Optimal (145); Round 2 Sub-Optimal (130)

16. Average Open Forest Canopy:	7%
17. Discharge:	8.8 cfs
18. Substrate:	30% Gravel/Sand, 10% Cobble, 40% Silt, 20% Bedrock
19. Habitat:	25% Riffle, 65% Run, 10% Pool

26. Number of Fish With Anomalies:	3
27. Other Observations:	Heavy fine sediment deposition

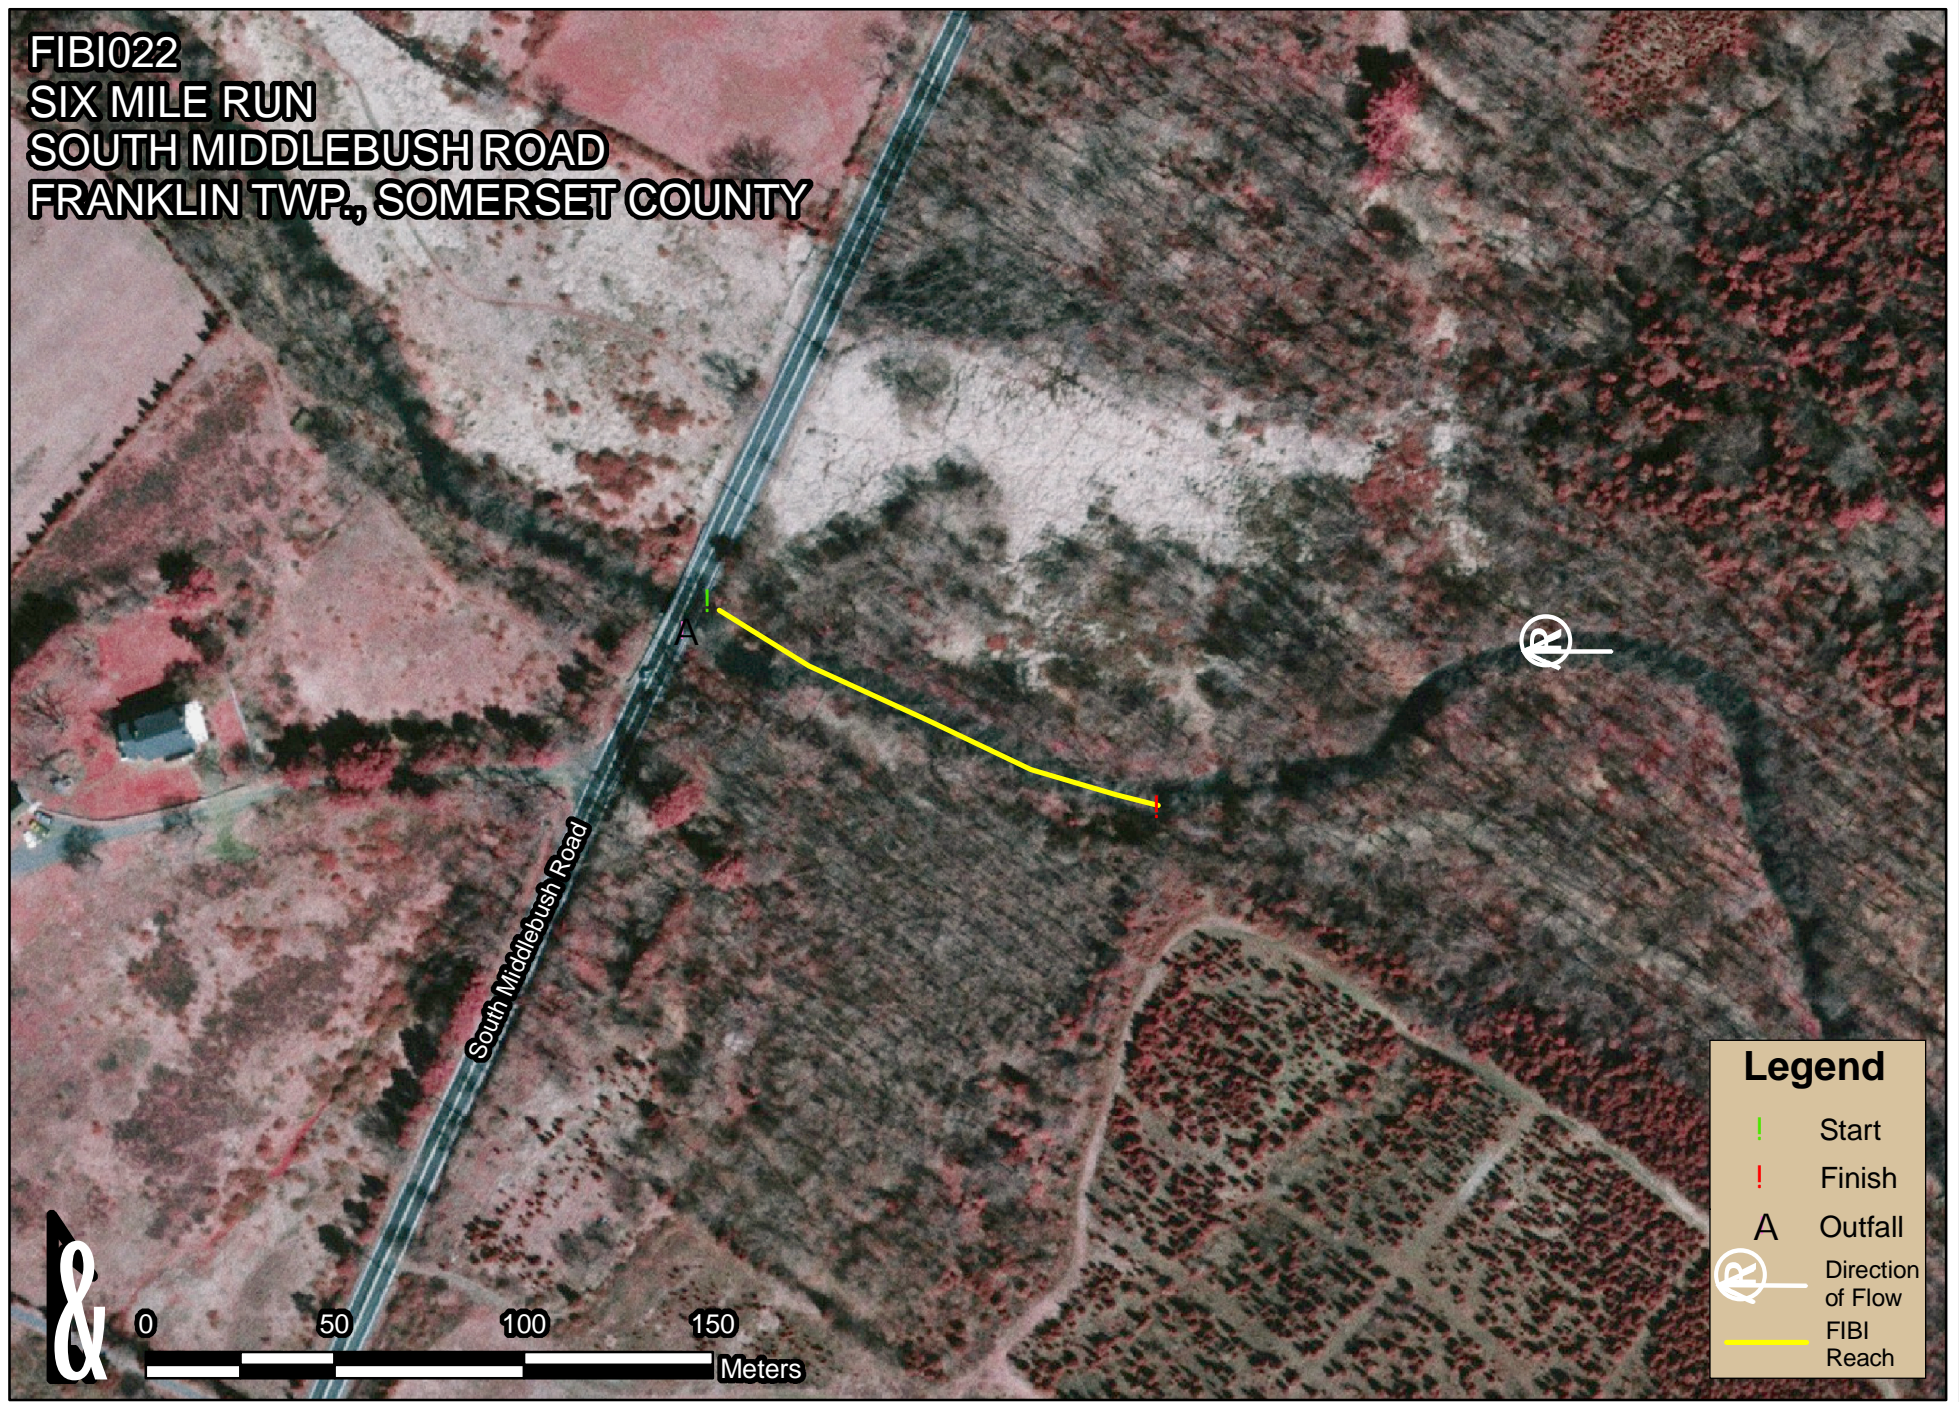
Legend	
!	Start
!	Finish
A	Outfall
(R)	Direction of Flow
—	FIBI Reach
