# Harihokake Creek - FIBI034

## SUMMARY OF RESULTS – FIBI034

**FIBI034  
HARIHOKAKE CREEK  
MILFORD-FRENCHTOWN ROAD (CR 619)  
ALEZANDRIA TWP., HUNTERDON COUNTY**

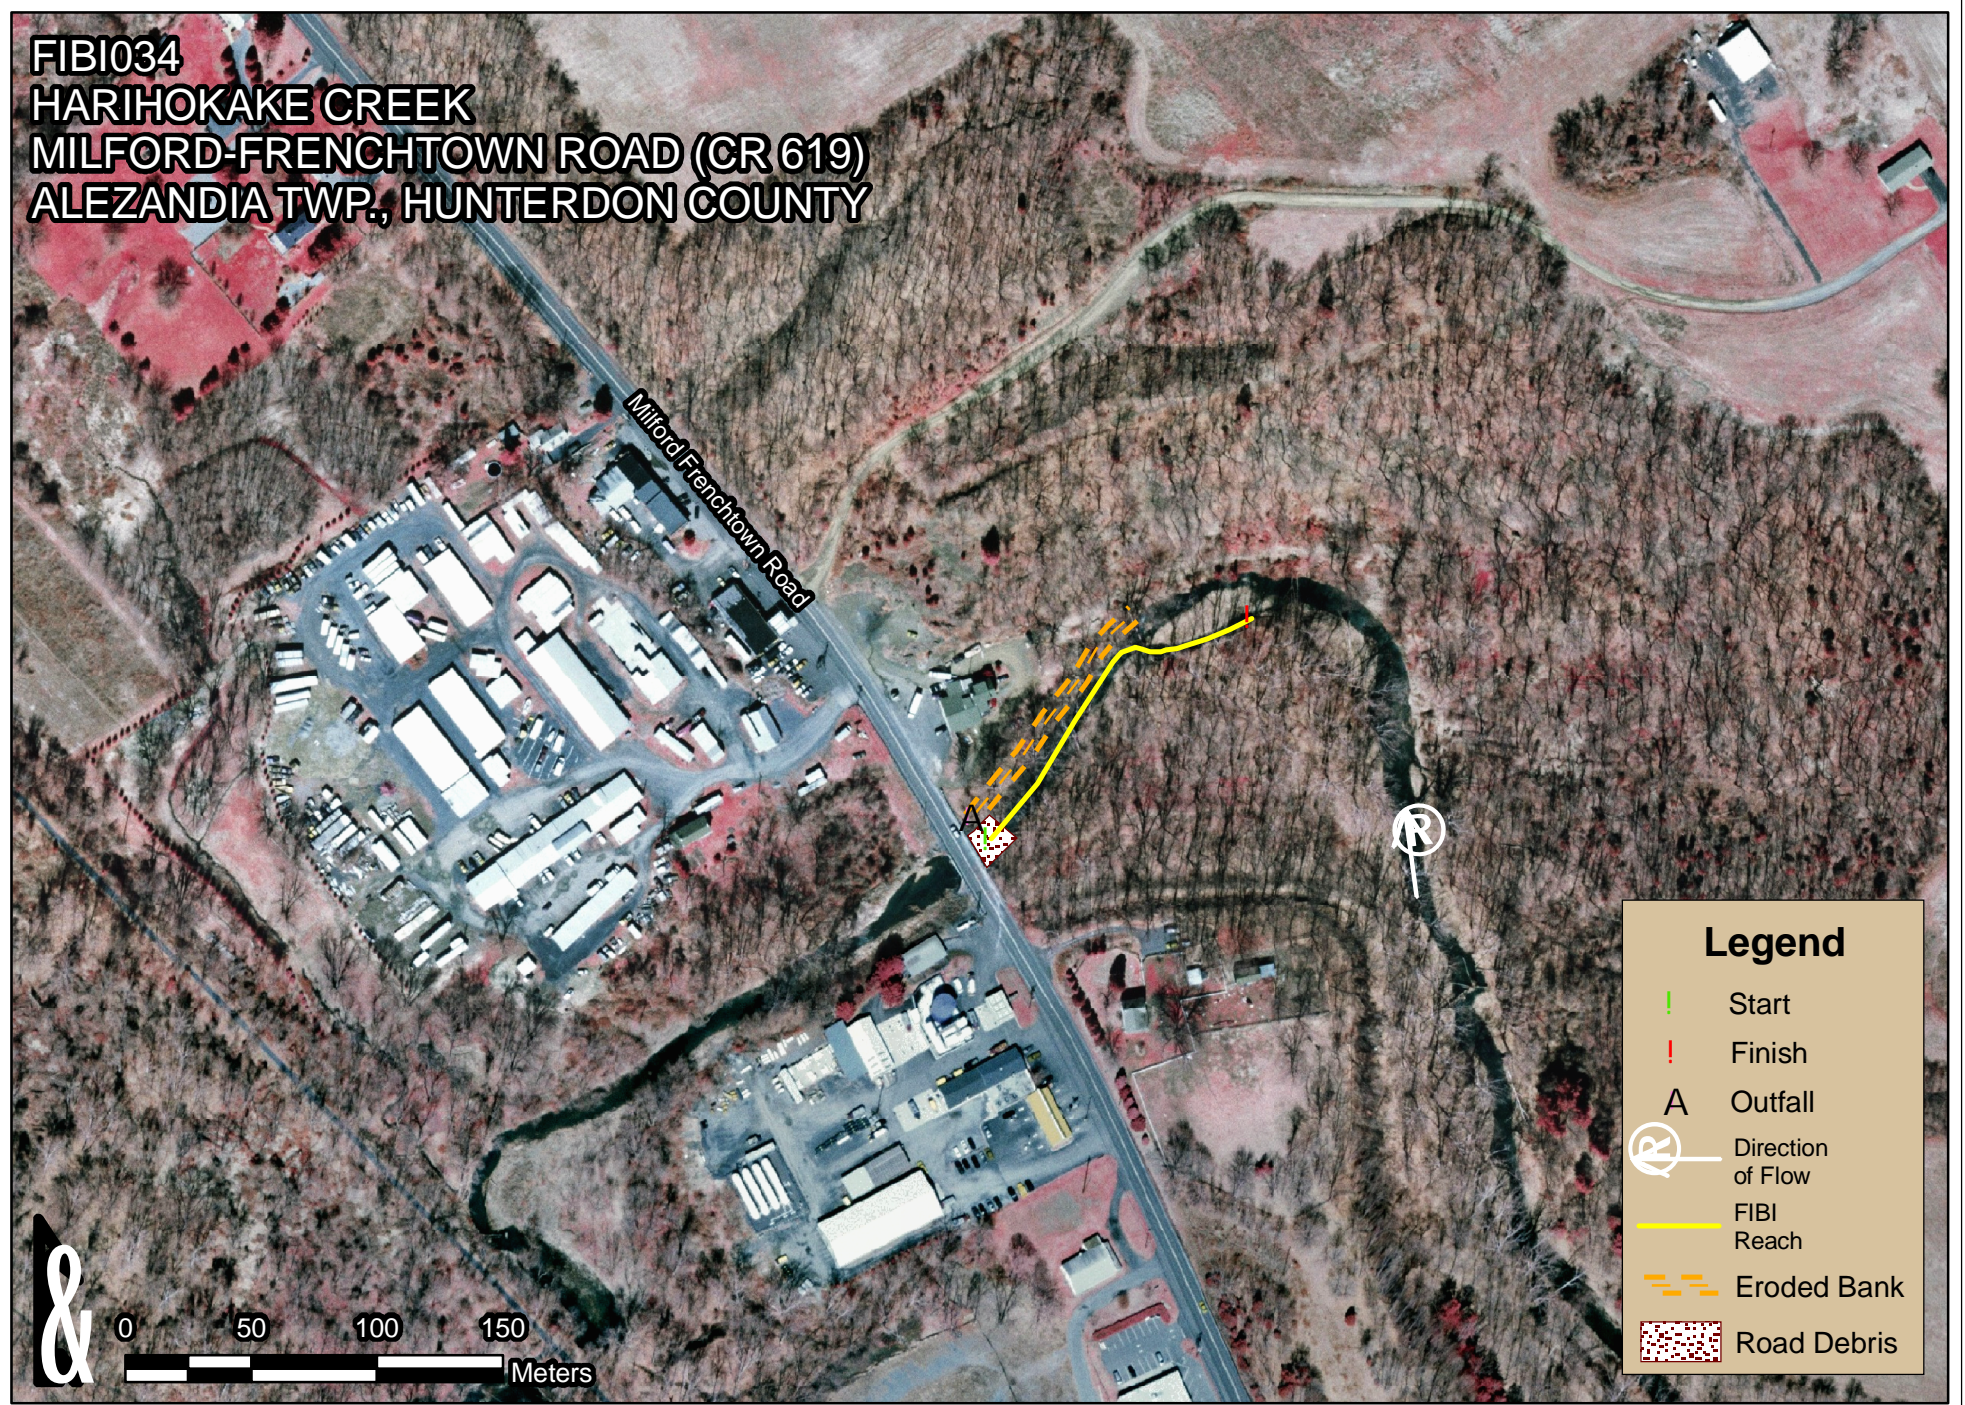
26. Number of Fish With Anomalies:	3
27. Other Observations:	Observed changes to stream and surrounding habitat as a result of severe flooding.
