Pohatcong Creek - FIBI067

SUMMARY OF RESULTS

FIBI067 - Pohatcong Creek

HABITAT ASSESSMENT FOR HIGH GRADIENT STREAMS Pohatcong Creek (FIB1067) – 8/19/03

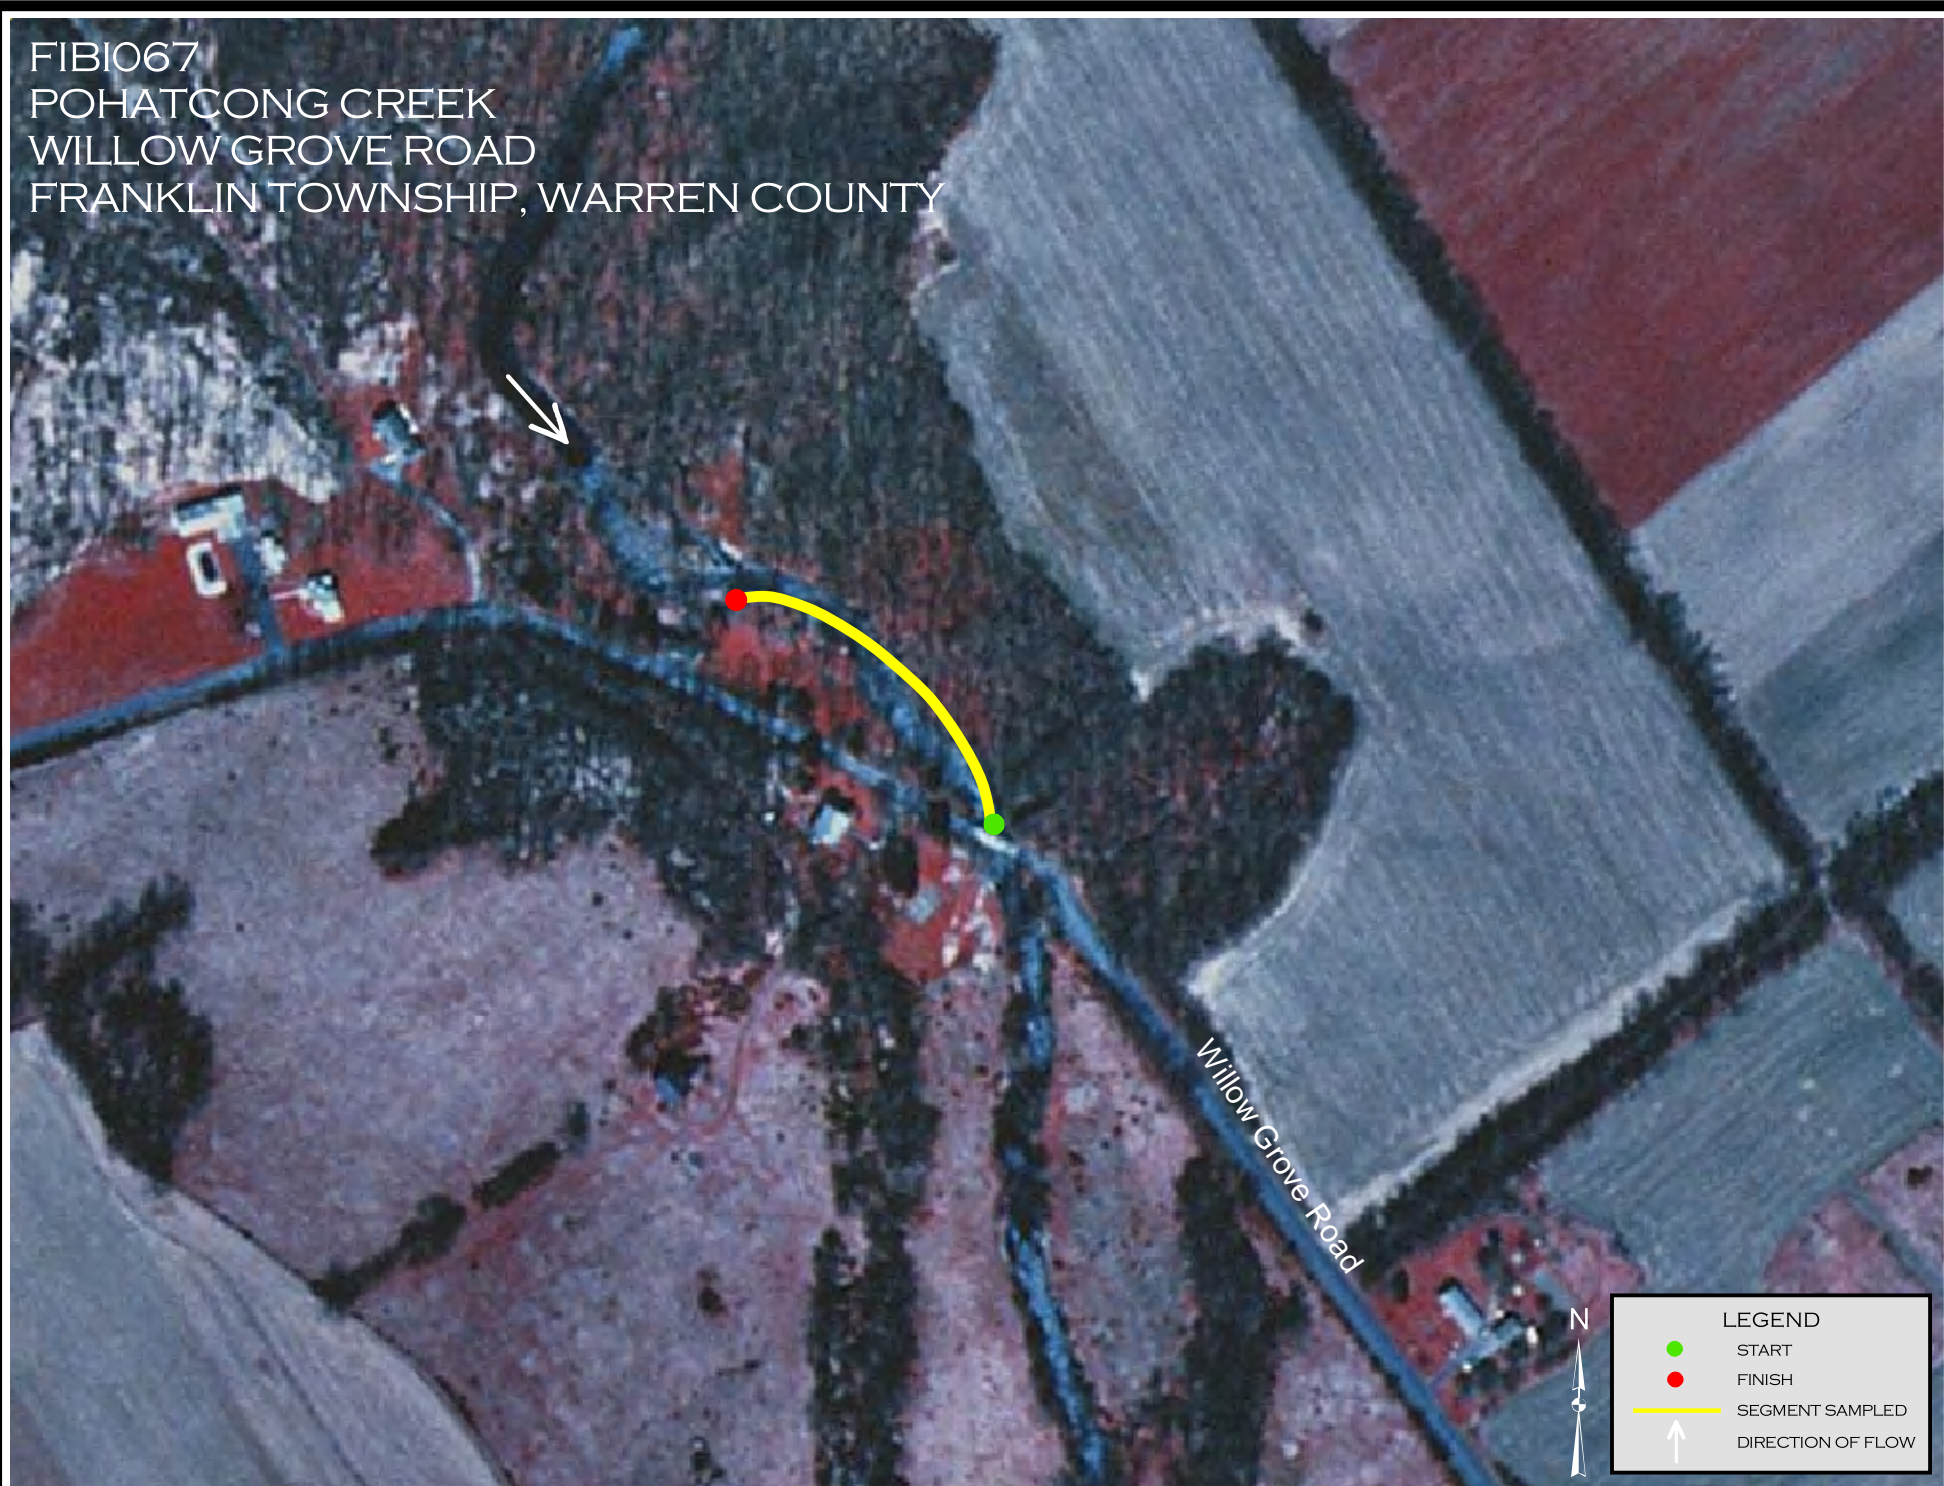
FIBIO67
POHATCONG CREEK
WILLOW GROVE ROAD
FRANKLIN TOWNSHIP, WARREN COUNTY

- START
- FINISH
- SEGMENT SAMPLED
- ↑ DIRECTION OF FLOW
