# NJ FACE INVESTIGATION REPORT

FACE 01-NJ-118-01

## **15-Year-Old Youth Crushed While Cleaning a Dough Mixing Machine**

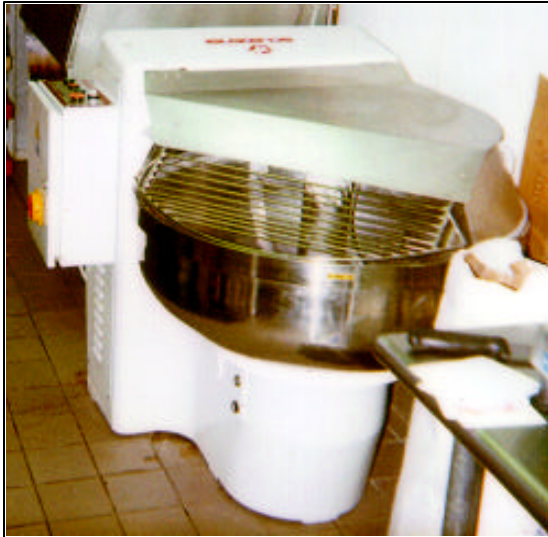
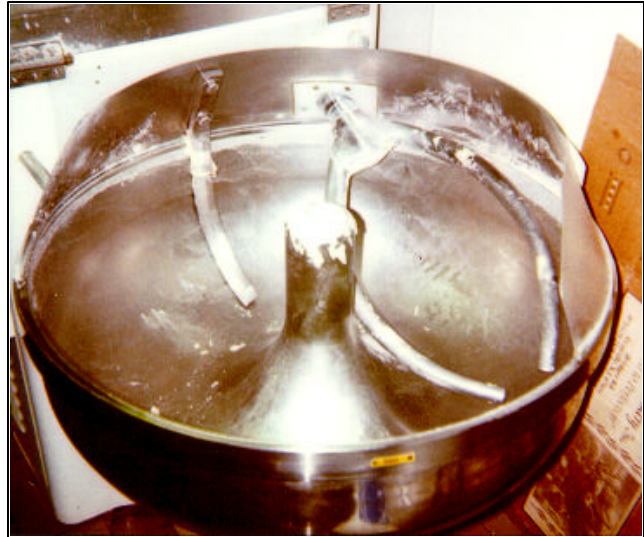
**Photo 1** **Photo 2**  
**Photos of dough mixing machine, cover lowered (1) and raised (2)**

On October 25, 2001, FACE staff accompanied federal OSHA investigators in an examination of the fork mixer. OSHA found that the mixer cover was equipped with a safety interlock activated by a pin pressed by the hinge of the cover. In normal operation, this interlock would activate when the cover was lifted, shutting off the machine. The cover would need to be closed before the machine could be reactivated. On this mixer, the weight of the open cover flexed the hinge enough to disengage the interlock, allowing the machine to activate with the cover open. In this incident, the youth first opened the cover, which disengaged the interlock. He then started the machine and was crushed while cleaning it.

**Discussion:** An inspection of the fork mixer by OSHA found that the safety interlock on the cover had failed, allowing the machine to operate with the cover open. The restaurant owner and staff were unaware of this fault. To prevent future incidents, NJFACE recommends that equipment be maintained in safe operating condition. Machine owners should carefully read the machine's manual for proper instruction for operation, safety devices, and routine maintenance. If the manual is not available, then the machine manufacturer or their distributor should be contacted to get a copy. Interlocks and other safety devices should be tested on a periodic basis.

**Recommendation #1: Employers should ensure that all equipment, including manufacturer's safety devices, is maintained in safe operating condition.**

**Recommendation #2: All machines should be de-energized before cleaning or performing other maintenance.**

**Discussion:** The cover on this mixer was an important machine guard necessary for the safe operation of the machine. Cleaning the machine required lifting the cover, potentially exposing the worker to the mixing fork inside. To prevent future incidents, NJ FACE recommends disconnecting the power to all machines before cleaning and servicing them. With a plug-in machine such as this, removing the plug is a simple and effective way to de-energize the device. Machines permanently wired into the electrical system must be de-energized with a formal lock-out, tag out system as required by OSHA regulations.
