# Customer Behavior Relative to Gap Between Platform and Train

FINAL REPORT

July 2009

Janice R. Daniel, Ph.D., Associate Professor  
Department of Civil and Environmental Engineering  
New Jersey Institute of Technology

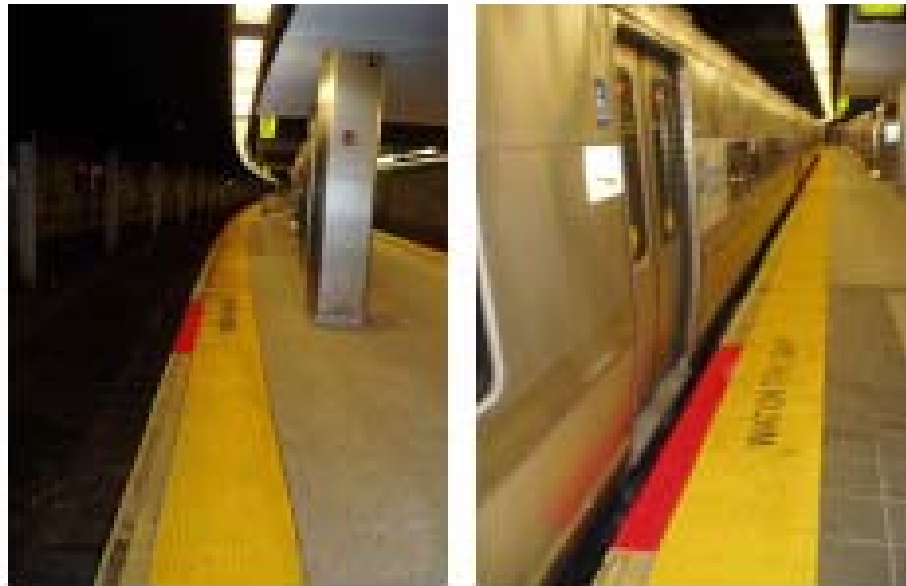
**Figure 2. LIRR Flatbush Ave. Station with Red Lines Underscoring Wider Gap**

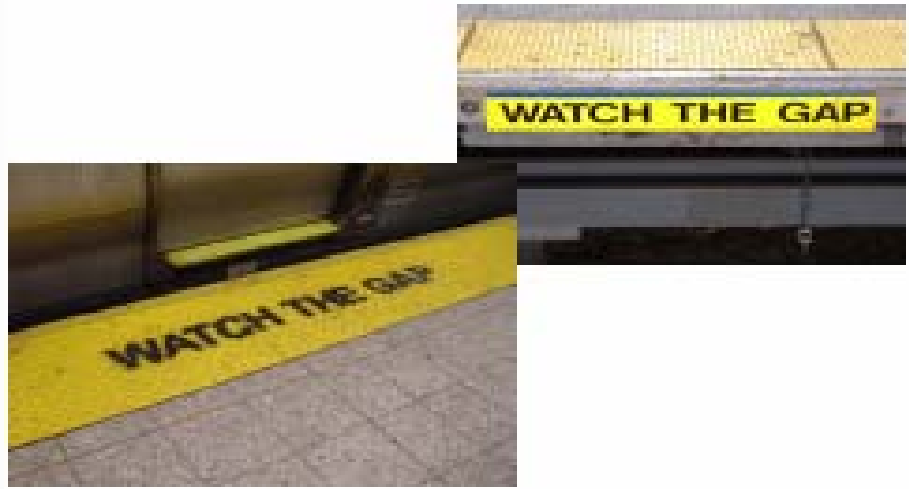
**Figure 3. LIRR stencils “Watch The Gap” to Yellow Lines**

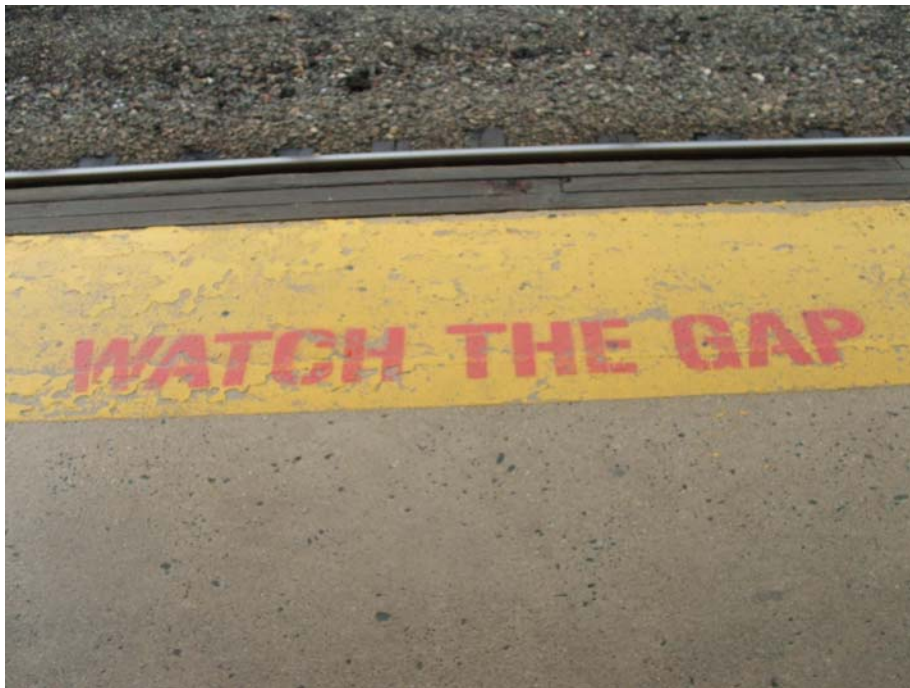
**Figure 4. NJ TRANSIT Rail “Watch The Gap” stenciled to Yellow Lines**

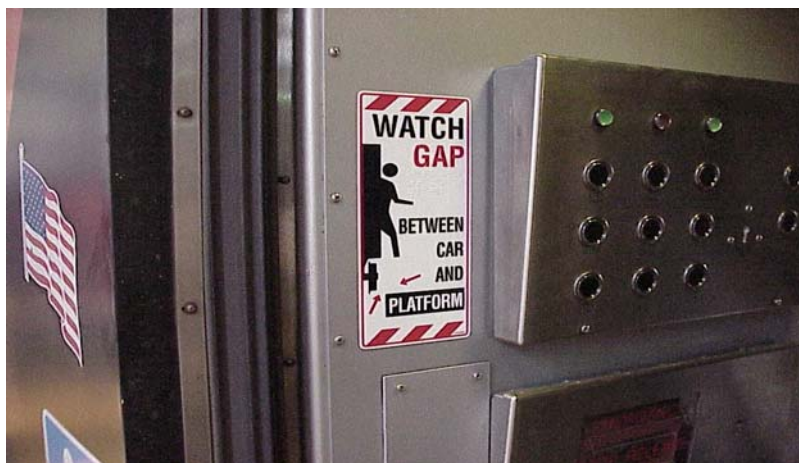
Figure 11. NJ TRANSIT Rail Equipment Gap Signage

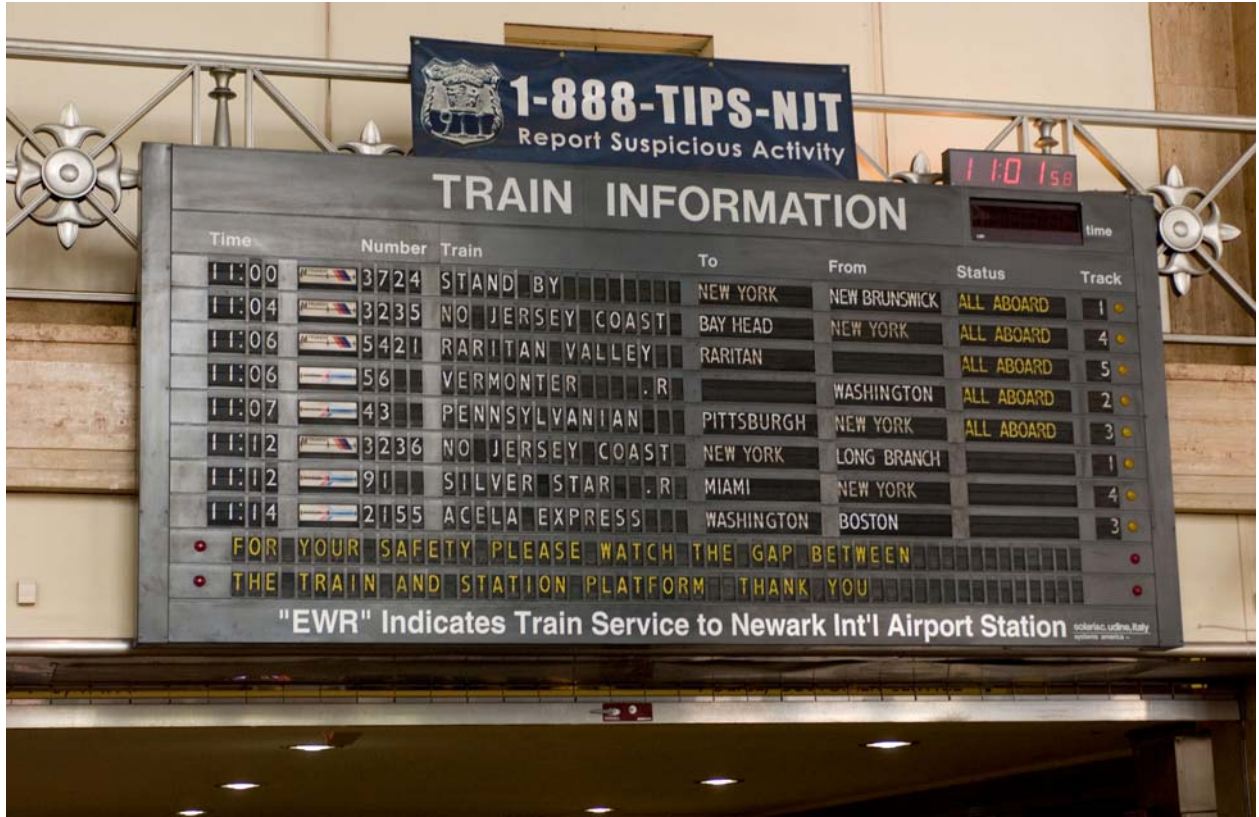
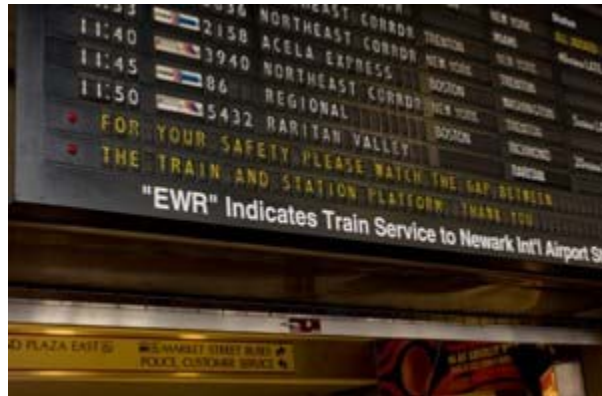
Figure 13. NJ TRANSIT Rail Train Information System – Newark Penn Station

Increasing public awareness through signage and announcements is yet another method employed to mitigate risk at the platform-train interface. Prominently displayed signage to catch the attention of passengers is a way to assist them in focusing on their own boarding and alighting behavior. Figures 8 and 9 show photos of LIRR's signage. Figures 10 and 11 show NJ TRANSIT Rail's signage. Figure 12 demonstrates NJ TRANSIT Rail's electronic safety message. Figure 13 shows the NJ TRANSIT Rail's train information system at Newark Penn Station.

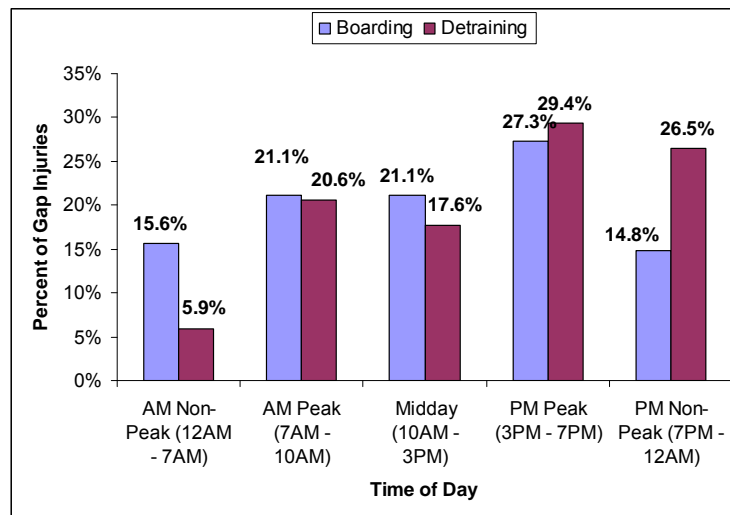
Little difference exists in the percent of gap injuries by boarding or detraining during the AM, Midday and PM peak periods, as shown in Figure 28. Differences exist during both the AM and PM non-peak periods. During the AM non-peak there is a much higher percentage of gap injuries for boarding passengers (16 percent) than for detraining passengers (9 percent). During the PM non-peak, there is much higher percentage of gap injuries for detraining passengers (27 percent) than for boarding passengers (15 percent). It would be incorrect to conclude that the higher percent of gap injuries for boarding passengers in the AM and detraining passengers in the PM was due to a higher number of boarding passengers in the AM and detraining passengers in the PM. Each passenger must board and detrain at least once, so the numbers of boardings and detrainings would be roughly equal within the AM period, and the same for other periods. However, the number of boardings and detrainings would be predominantly at different types of stations, i.e., board at suburban stations in the AM while detraining at Newark or Penn Station in the AM, and the reverse in the PM peak.

**Figure 28. Boarding and Detraining Gap Injuries by Time of Day**
