TUB GIRDER (OPEN BOX) DETAILS
(SHEET 2 OF 3)
INTERIOR CROSSFRAME

PLATE
3.9-9

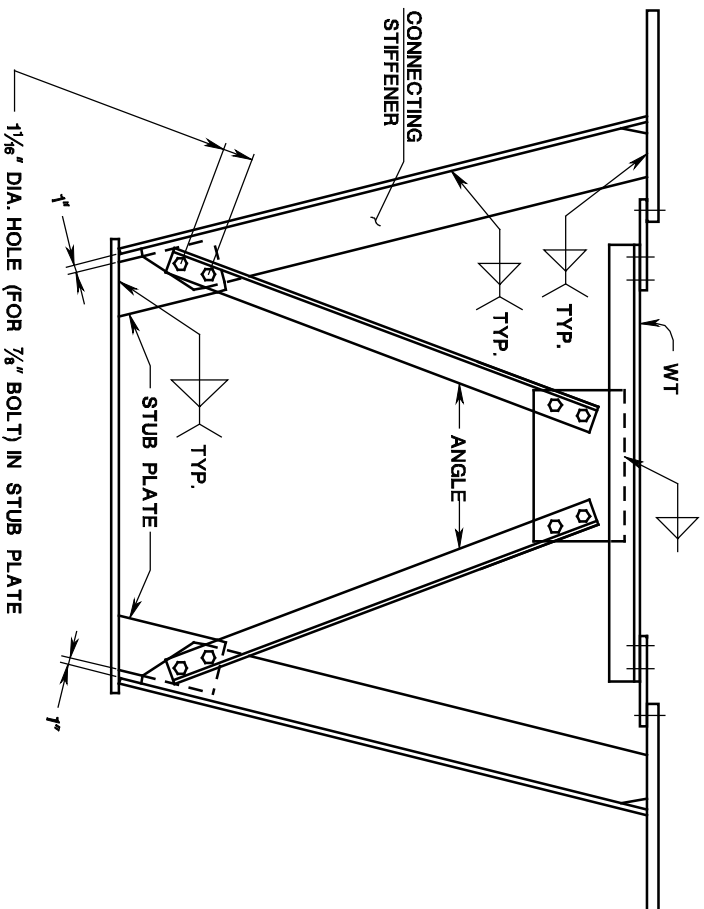
BOTTOM FLANGE (COMPRESSION OR TENSION)
INTERIOR CROSSFRAME

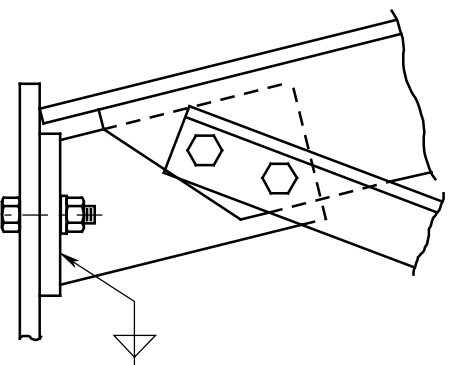
ALTERNATE DETAIL AT TENSION FLANGES
