## Summary of Findings

# Findings of the Interagency Waterway Infrastructure Improvement Task Force

FEMA-1530 DR NJ

October 2004

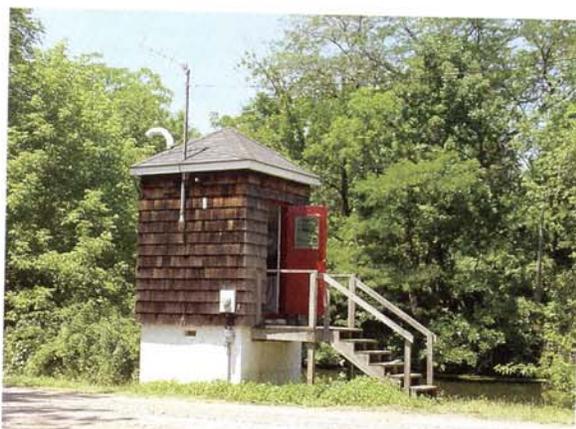
**Figure 2.** Typical "real-time" surface-water gaging station equipped with a data-collection platform and satellite antenna.

The stream stage (the level of the stream typically measured in feet above a datum point) or tide level at each station in the network is automatically measured at 6- or 15-minute intervals, and the value is stored by a data-collection platform (DCP) located on site (fig. 2, fig. 3, and fig. 4).
