United States Department of the Interior
National Park ServiceNational Register of Historic Places
Registration Form

1. Name of Propertyhistoric name Fernbrook Historic Districtother names/site number John Newbold House, New Warlabby Stock Farm**2. Location**street & number 142-150 Bordentown-Georgetown Road☐ not for publicationcity or town Chesterfield Township☐ vicinitystate New Jerseycode NJCounty Burlingtonzip code 08505**3. State/Federal Agency Certification**

Fernbrook Historic District

New Jersey and National Registers Nomination
Chesterfield Township,
Burlington County, New Jersey

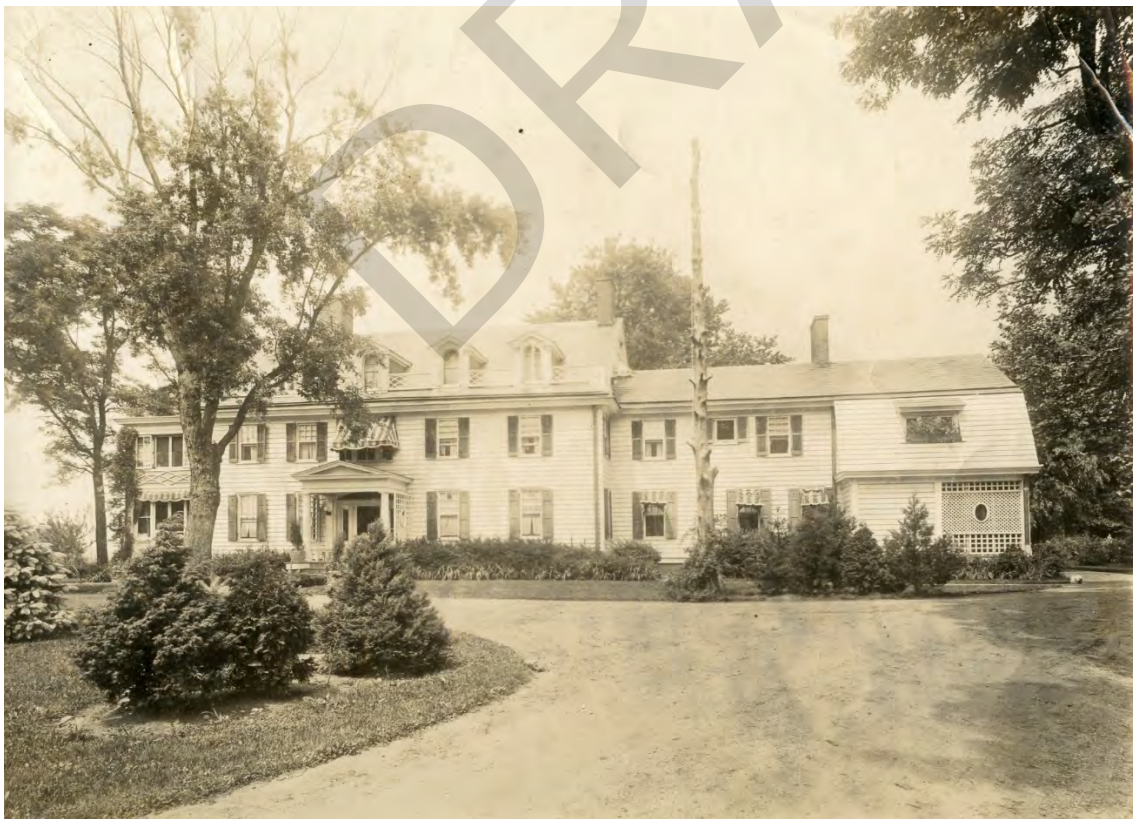
Historic Photo 29: The John Newbold House after 1918 with the western-most section two-stories in height.

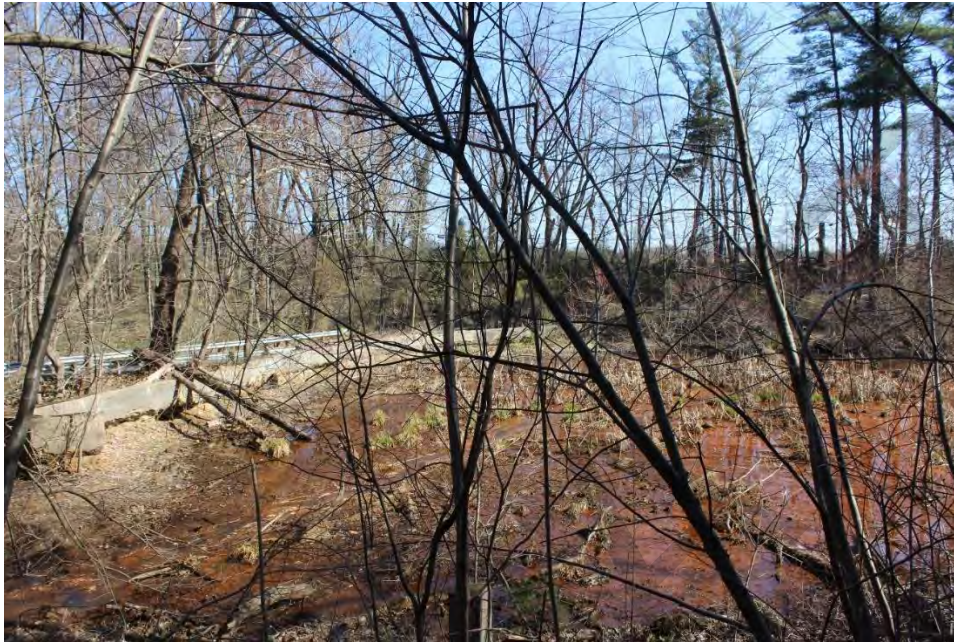
Photo 3: Kuser Dam stands along White Pine Road. It has been breached so it no longer holds water.

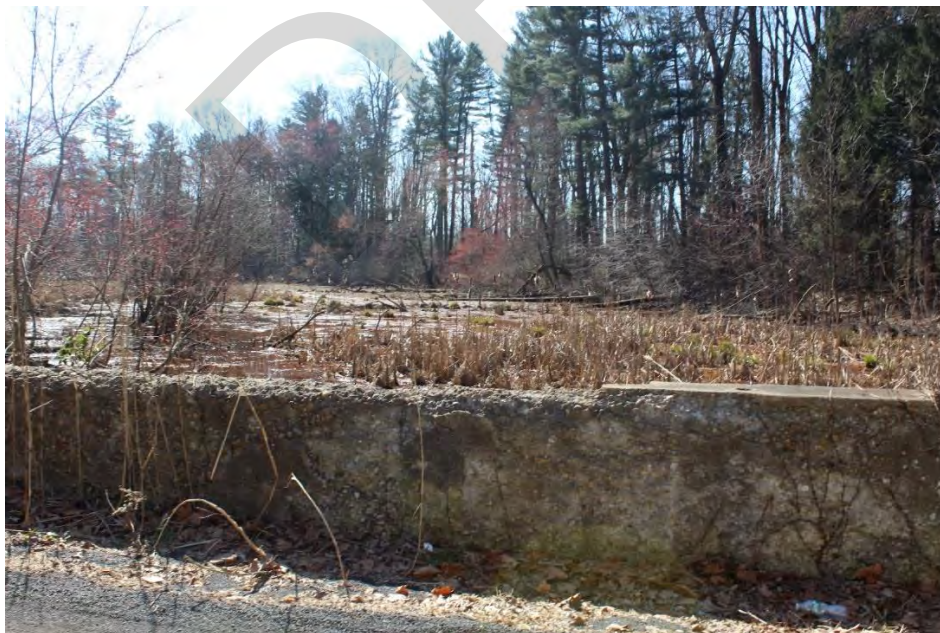
Photo 4: Kuser Dam and Kuser Pond looking south from White Pine Road

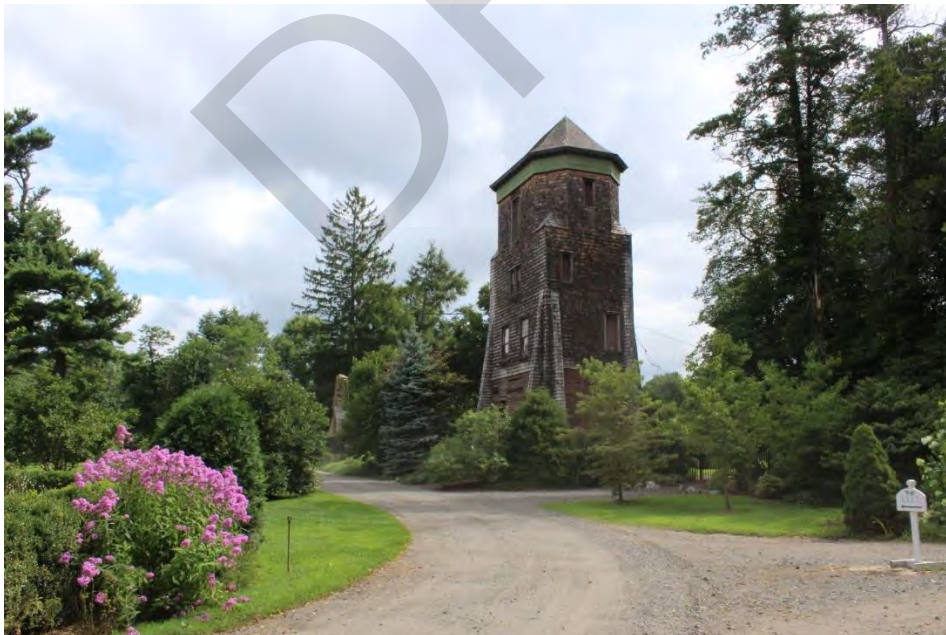
Photo 12: The Drive loops past the tank house

The Tankhouse is a prominent feature of the estate (Photos 6, 12, 43). It retains most of its original fabric with few changes. Its lower level is rectangular in plan, standing on a brick foundation. Sloped and tri-faceted buttresses grace the corners, narrowing through the second floor and disappearing at the third. They are capped by a hipped roof at the fourth floor where the tower becomes an octagon. This is the location of the water tanks. The entry level of the tower is sheathed with clapboard, except for the buttresses. The buttresses, their roofs and the upper levels, are sheathed with cedar shakes. The hipped roof is also cedar shakes; it is supported by a wide clapboard frieze below exposed rafter tails. The cedar shingle sheathing and brick foundation are design motifs of the estate (Photo 44).

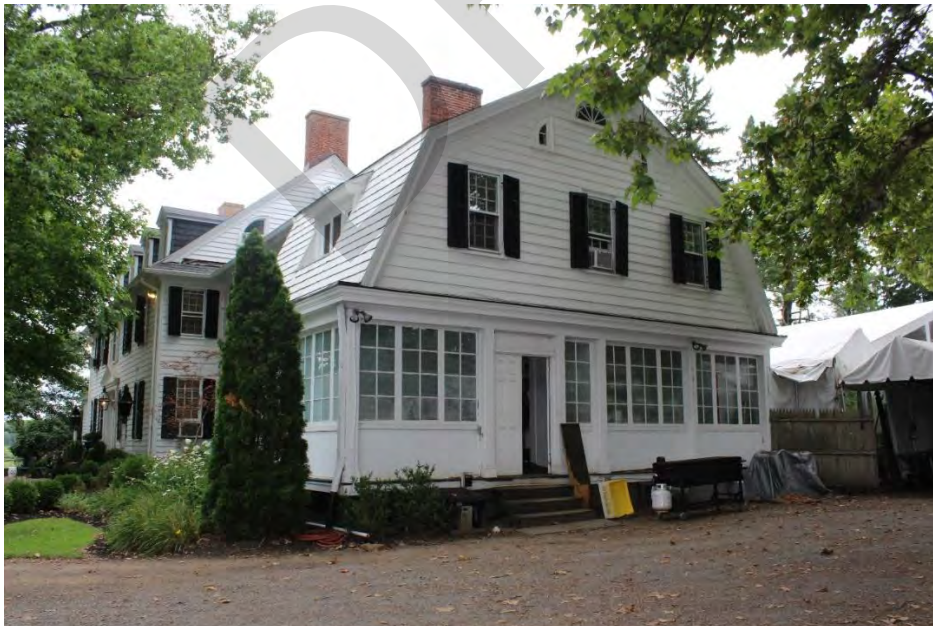
Photo 18: The east elevation of the kitchen wing

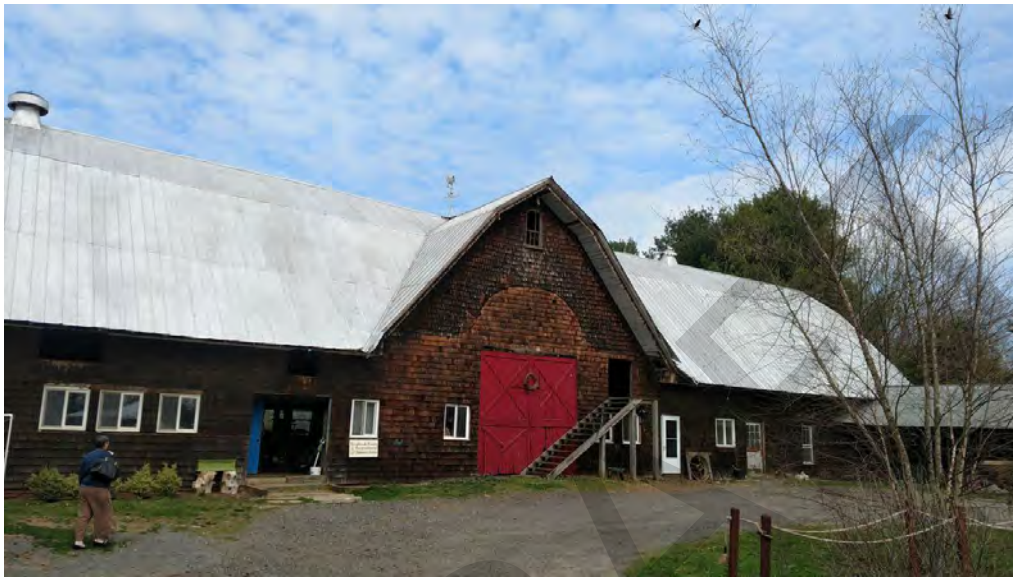
Photo 23: East façade of the dairy barn, likely built by Kuser but may have been constructed by Morgan ca. 1881. The wagon house intersects it.

The imposing dairy barn has a dominant standing seam metal gambrel roof with central cross gambrel with deep eaves. It is shingle-clad and stands on a brick foundation. The east façade, within the barnyard, and the rear, west elevation match (Photos 23, 24). An arched six-over-six double hung sash originally graced the upper gambrel end; the upper sash is no longer extant and the lower is missing its glass. This stands above the original entrances. Adorned by a decorative shingle arch stand a pair of oversized original tongue and groove doors with cross bucks. On the east facade, these doors are used infrequently; modern portable wood exterior stairs are in front them. They provide access to the open upper story, now used for old equipment and furniture storage but originally used for hay and grain storage. Flanking this central gambrel bay are single story wings punched with a mix of man-doors and windows topped by the slope of the gambrel roof. The windows are mostly modern replacements including vinyl casements on the south and fixed-lights on the north. The doors are modern replacements including some garage doors and a plywood door. A historic nine-light tongue and groove door remains at the northern end of the east façade.

It is known that Morgan raised cattle, so he had to have had a barn on the property. It is possible that he built the barn that is extant. It is in the Shingle style and a construction date in the 1880s would be appropriate. However, Kuser seems to have reworked the estate completely and his architectural signature was shingle-clad buildings over brick foundations. Because of this, it seems more likely that the barn dates from the Kuser era.

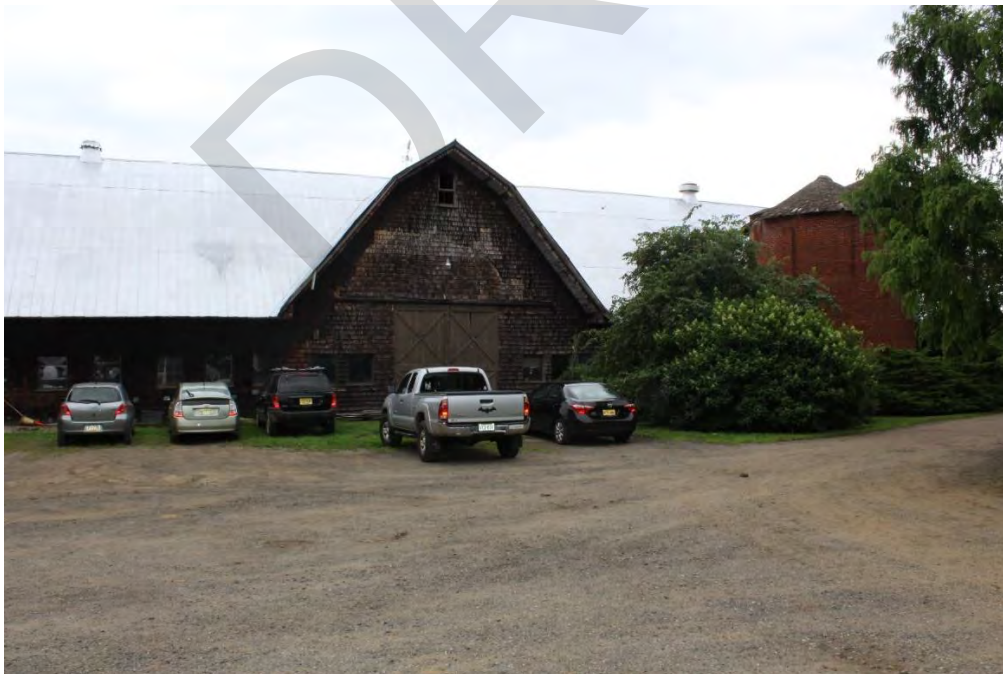
Photo 24: West elevation of the barn

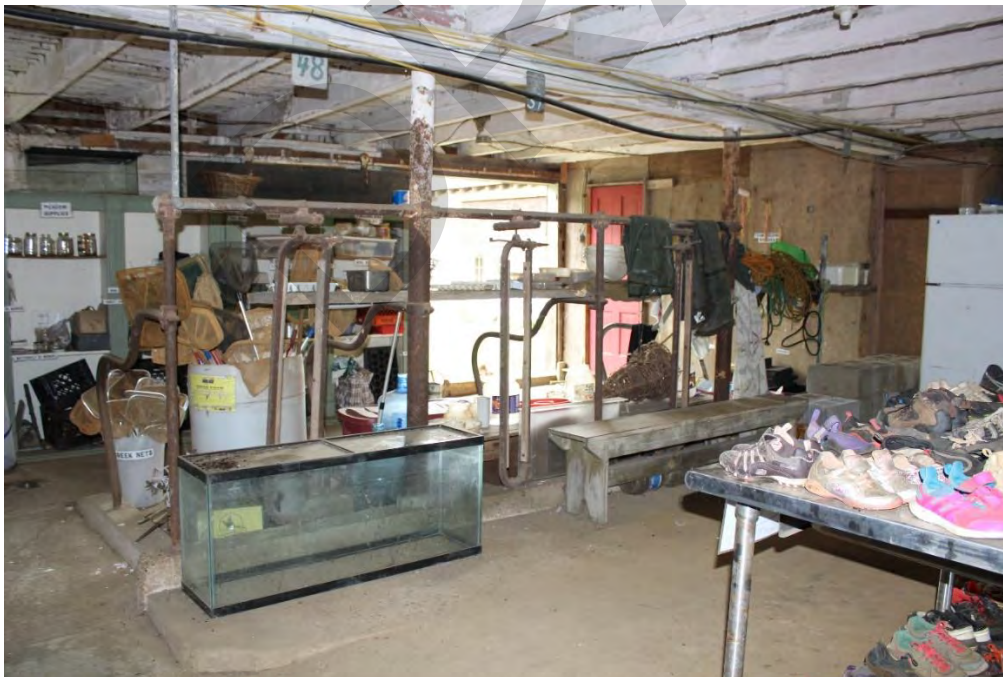
Photo 26: The interior of the barn retains its sloped and curbed concrete floor and cow stanchions, remnant of the dairy operation that began in the 1940s. The barn held as many as 100 cows at times.

Now the environmental center with classroom space, the interior of the barn has been altered, modernized and broken up into smaller rooms. However, evidence of its use for dairy cows in the mid-20th century remain in the center bay including sloped and curbed concrete floor and cow stanchions. Round, steel columns support the exposed wood structure (Photo 26). The large open second floor hayloft with exposed framing and hay trolley track is original and remains completely intact (Photo 27).

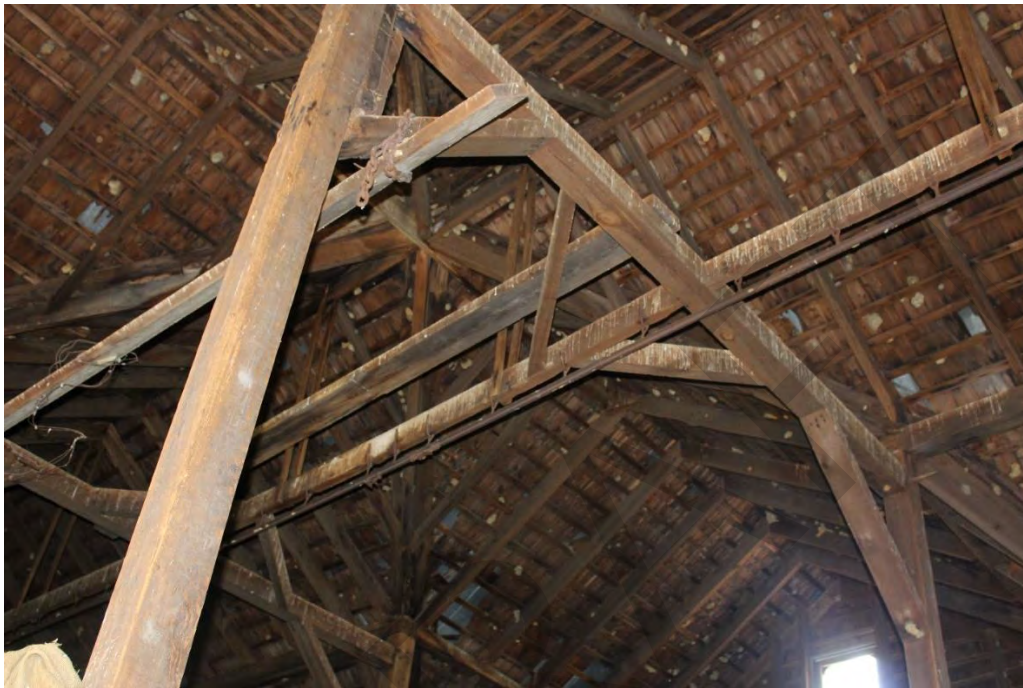
Photo 27: The open grain storage of the second floor retains its original hay trolley

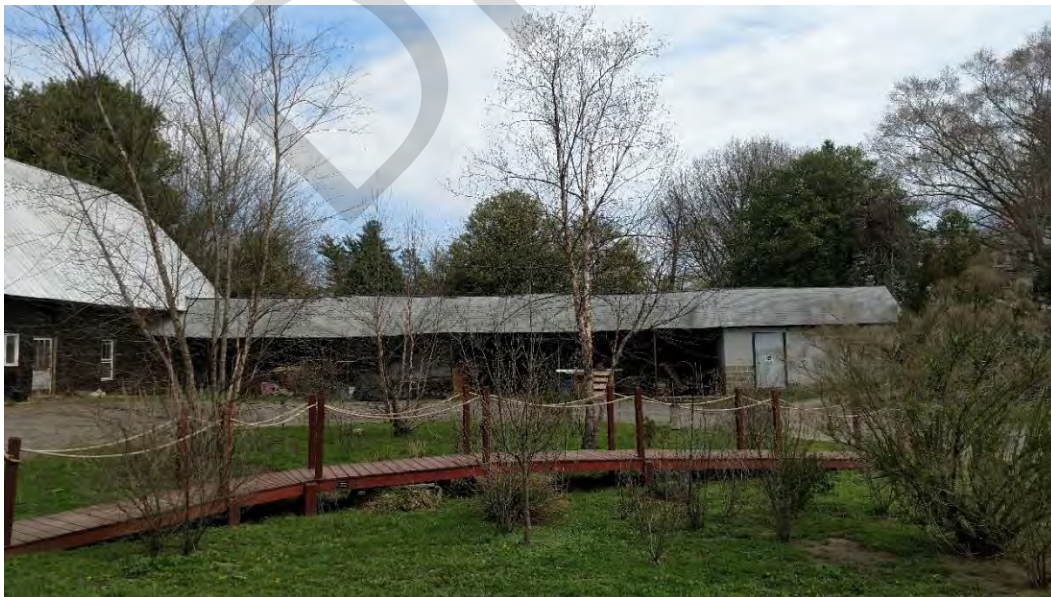
Photo 28: The wagon shed anchors the northeastern side of the barnyard. It was built contemporaneously with the barn.

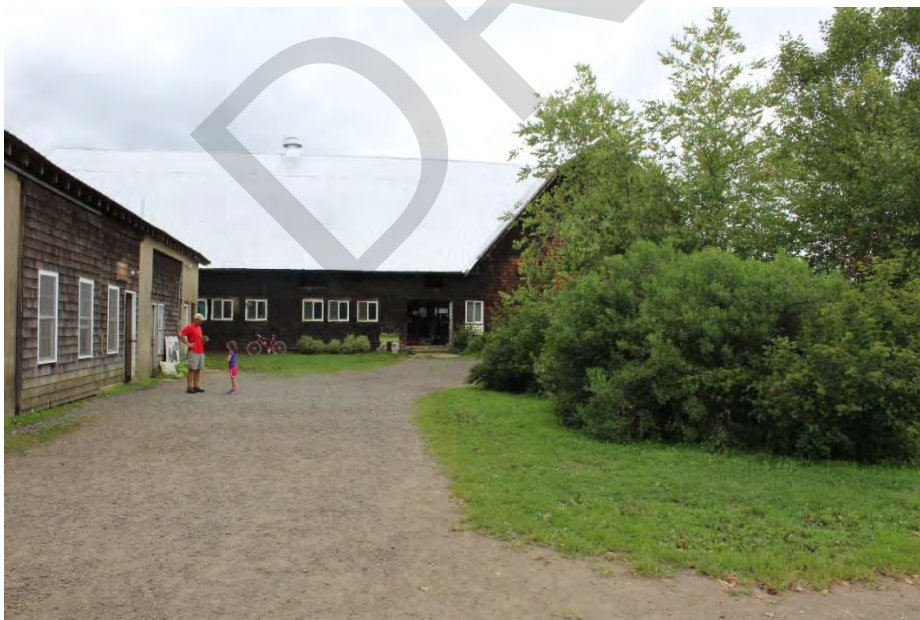
Photo 30: The machine shop dates to ca. 1943. It replaced a building that stood in the same location that was probably attached to the barn like the wagon house is.

The southern side of the barnyard is enclosed by a long, utilitarian, one-and-a-half-story concrete block and shingle-clad building topped by a metal gable roof with exposed rafter tails (Photo 30). Built in 1943, this building replaced an earlier frame building that matched the wagon shed. It was the same length as the wagon shed and was connected to it by a shingle-clad wall. This enclosed the barn yard for farm animals. The existing building was constructed when Fernbrook became a dairy farm; the original wall was removed at this time.

During Walter Kuser's tenure, the south wing of the barn and the barnyard wall were demolished. The existing concrete block Machine Shop was constructed at this time. He also enclosed the eastern end of the wagon shed and converted it to a garage. Walter also added onto the first floor of the west of the Newbold House, making a larger room in Arts and Crafts style with exposed beams, camed windows and rustic fireplace.

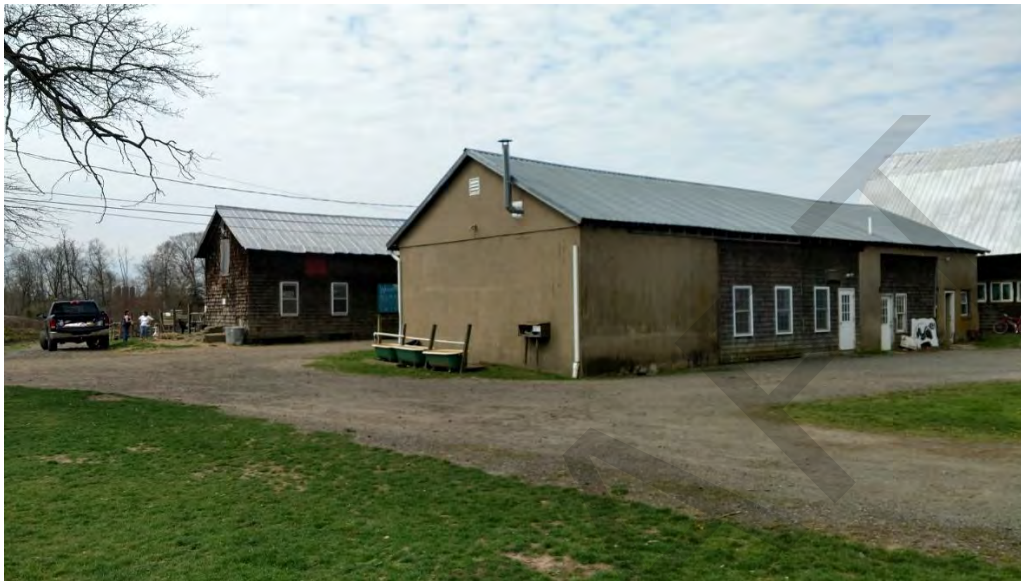
Photo 35: The chicken house stands to the south of the machine shop

Behind the southern anchor of the barnyard, separated by a dirt road, stands a small vernacular chicken house that continues to shelter several animals, currently goats (Photo 35). It is a frame, three-bay, 1 ½ story building with shingle cladding standing on a brick foundation and topped by a corrugated metal gable roof. Like many other buildings on the property, it has a brick foundation and is clad with wood shingles. This seems to be a Kuser era design motif which could support a later date of construction for the barn which has these same details. But the chicken house also could have been built by Morgan ca. 1881.

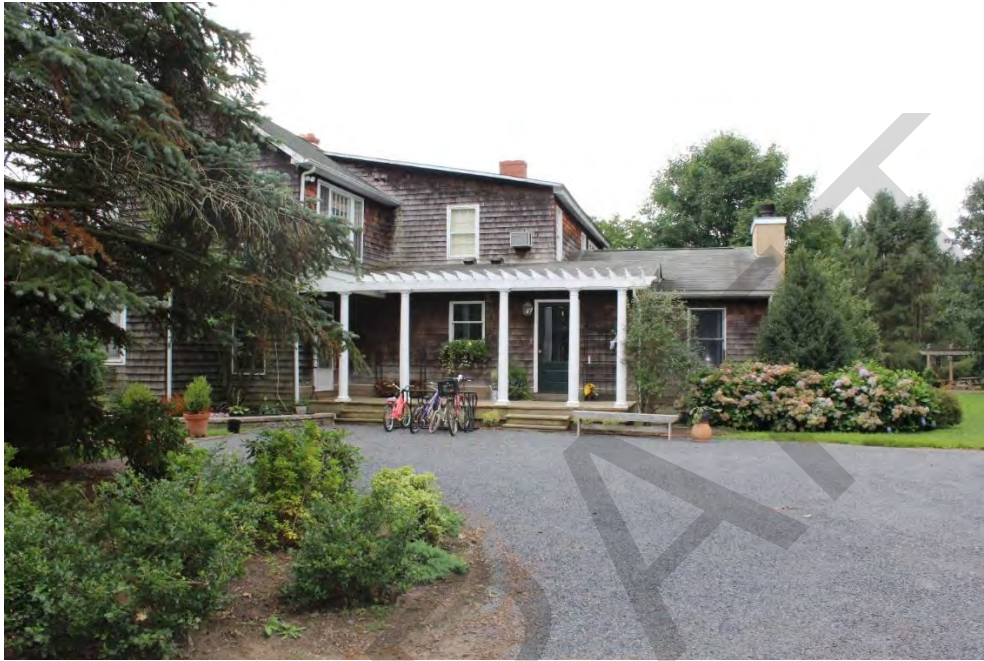
Photo 37: The north and west elevation of the farmhouse. The original building dates to the 19th century and has several 20th century additions

Southwest of the agricultural complex stands a rambling, vernacular farmhouse well hidden by trees and landscaping. It is 2 ½ stories with cedar shake siding, a brick foundation, an asphalt shingle roof and a number of intersecting gables, wing additions, porches and shed dormers. The windows are a mix of hung sash including six-over-six, one-over-one and diamond panes over one. Some date to 19th century and the beginning of the 20th centuries but most appear to be modern replacements. The doors all appear to be new. A columned trellis graces the primary entrance at the east corner of the house.

The original section appears to be a three-bay, front gable, oriented east west. With its shingles, brick foundation and proximity to the agricultural complex, it may have been built by the Kuser family for one of the farmers or gardeners. Architecturally, though, it appears more Victorian so it may have been built by Morgan ca. 1881. According to the Kusers, it is said to have been built in the mid-19th century, meaning constructed by the Satterthwaites. While architecturally this is possible, it isn't clear why this would have happened then as it was a single-family farm, albeit a tenant farm, until Morgan introduced the gentleman farm model. Regardless, at some point in the early 20th century, likely after 1914, a shed roof addition was added, surrounding the original to the south and west. The single-light sash topped by the diamond-paned sash and bay window are indicative of this period. Ca. 1974, another gable section was added to the north; several one-story additions on the south, west and north elevations followed including a mother-in-law suite that was added when the Newbold House was converted to an inn in the early 2000s (Photos 37, 38).

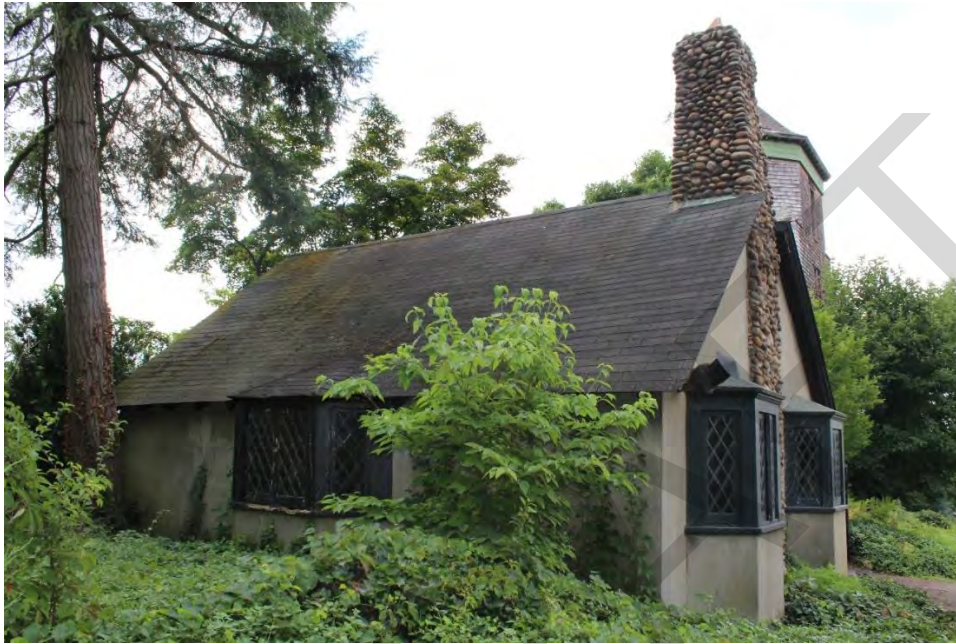
Photo 47: The playhouse was built as an icehouse. Kuser converted it to a playhouse

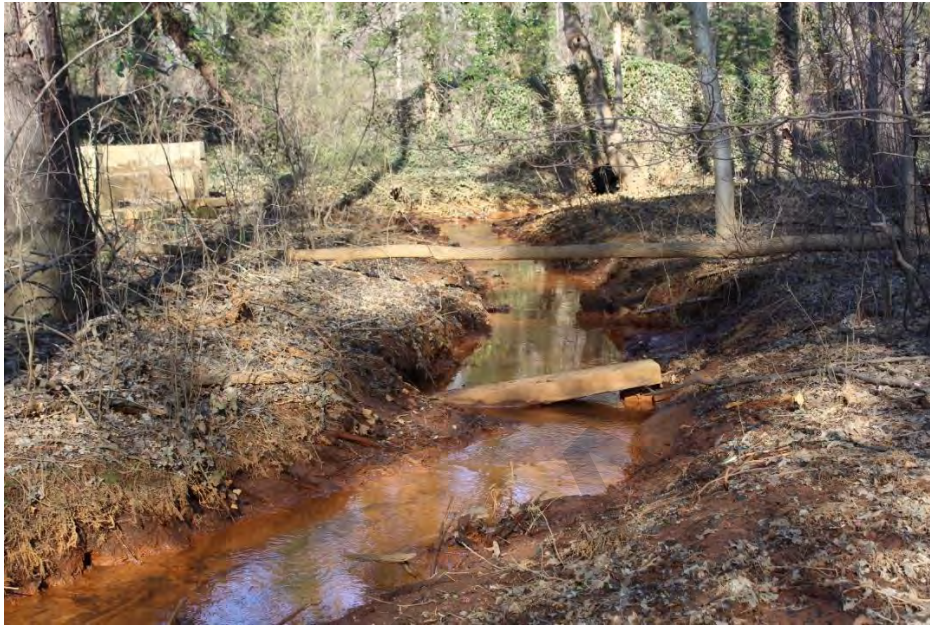
Photo 59: The bluestone slab was rustic bridge that crossed Fern Brook. It is assumed these features were all added when Fern Brook was dammed which was complete by 1912.

As seen in Historic Photo 1, this large bluestone slab was once a rustic bridge that crossed Fern Brook. It stood on rough stone piers, parts of which remain on the west bank (Photo 59).

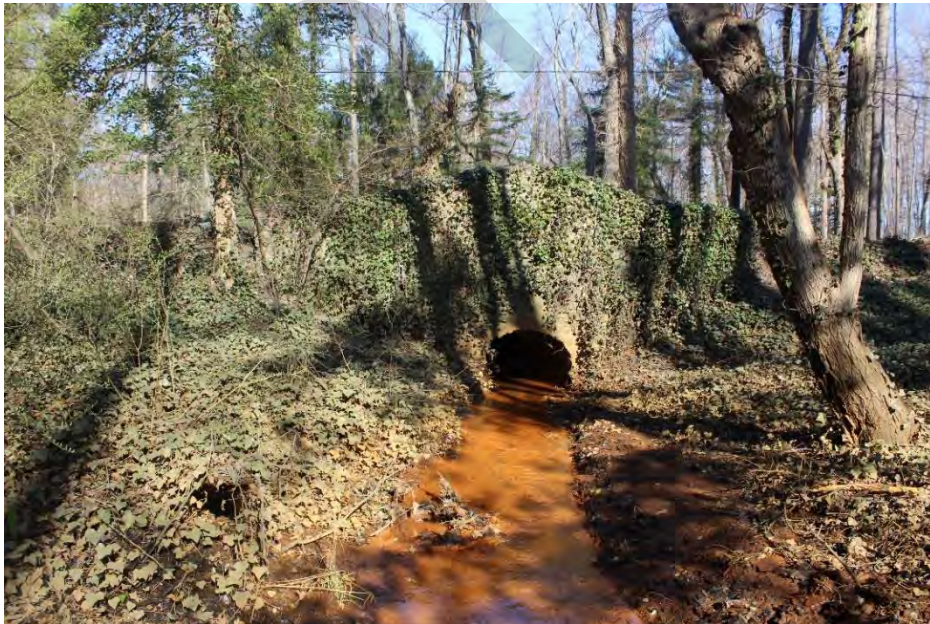
Photo 60: This stone culvert allows Fern Brook to cross under the north driveway. Looking north.

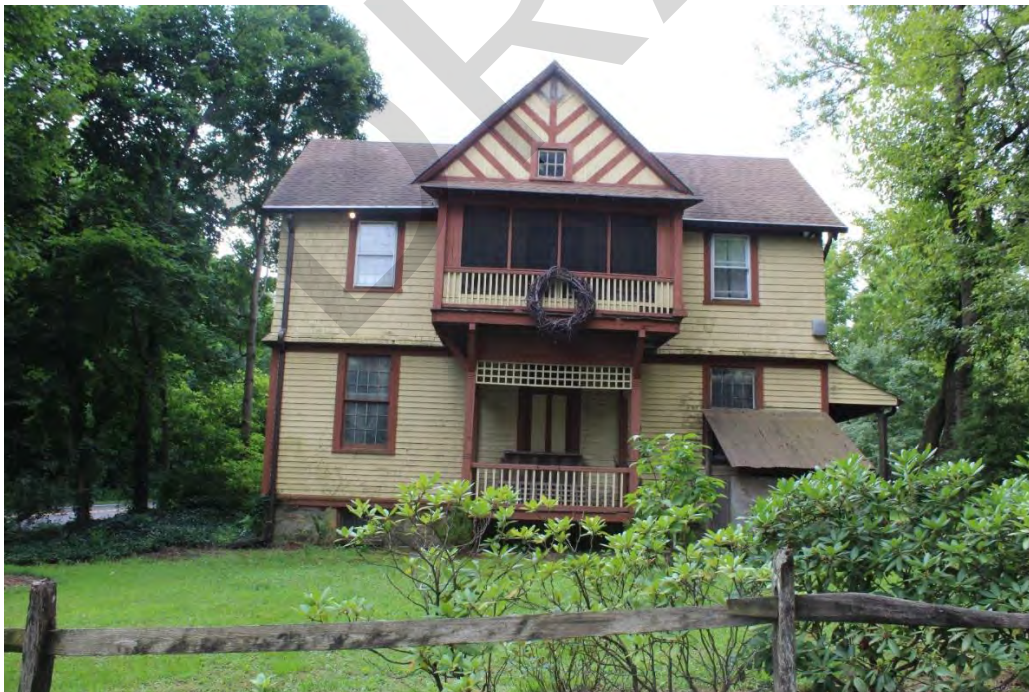
Photo 64: The west façade of the Stick Style Gatehouse. This was likely built by Morgan ca. 1881

At the northern end, closest to the estate drive, is a Stick Style house with a capital T-shaped floor plan with a north south gable section in front and an east west section to the rear. Wood-framed on a stone foundation, the 2 ½ story, three bay, two-bay deep front section is clad with shingles on the upper floor and clapboard below. The gable roof is asphalt-sheathed with exposed rafter tails. The north façade is dominated by a projecting pedimented two-story central bay. Topped by a vertical board pediment with diagonal trim extending from a center six-light sash, the second story is a screened in porch with square balusters. Below, supported by corner bracing, stands an open porch with lattice work connecting reeded square columns. This covers the center entrance which has a two vertical panel door. The windows are twelve-over-twelve; one of the upper windows has been replaced with a one-over-one sash (Photo 64).

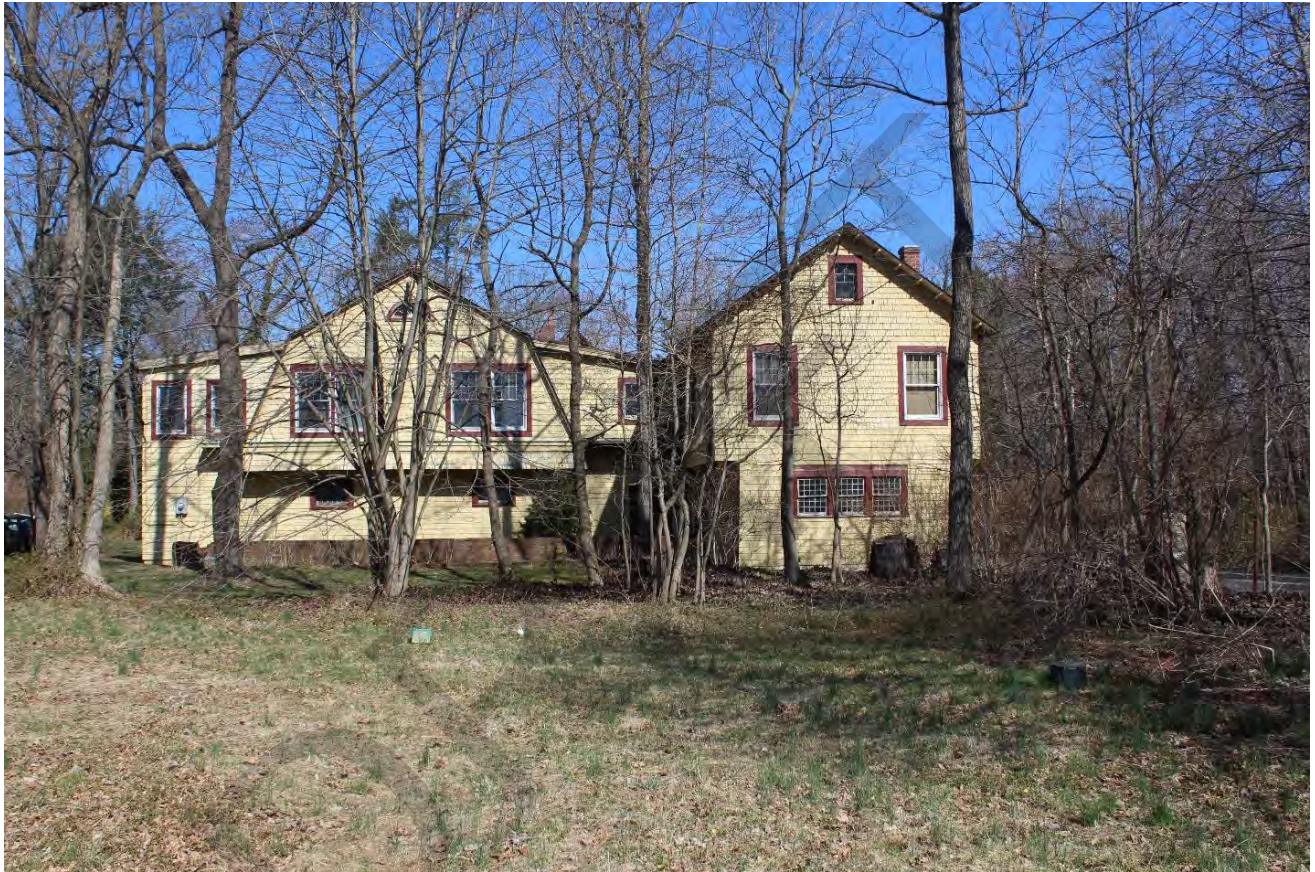
Photo 67: The south elevations of two of the buildings within the Gatehouse Complex.

At the southern end, stands a three-building complex. Two buildings run north-south along the Bordentown-Georgetown Road; they are connected to a third building which runs to the west, giving the complex an L-shaped plan forming a corner enclosure to the driveway. At the southeast corner is the residential component (**Resource 25**). It is a two-story, four-bay, wood-framed house on a brick foundation. Clad in shingles with plain square trim, it is covered by an asphalt gable roof with deep eaves and exposed rafter tails. On both the east and west elevations, the upper story projects beyond the plane of the lower. The east elevation faces the road with four, six-over-one windows and a chimney that runs on the exterior of the first floor but through the interior of the projecting second story. The first-floor windows include four, fifteen-over-fifteen double hung sash; the southern two are paired (Photo 65). Three, six-over-one double hung sash grace the second story of the west elevation over a pair of one-over-one sash at the first. The south gable end consists of one, four-over-one double hung sash in the upper gable end above two, six-over-one double hung sash at the second floor with three, fifteen-over-fifteen double hung sash grouped together at the first floor (Photo 67).
