MUNICIPALITY Matawan

SURVEY Monmouth County

#1329-1 Main St. District
Continuation Sheet

NEW JERSEY DEPARTMENT OF ENVIRONMENTAL PROTECTION
OFFICE OF HISTORIC PRESERVATION
INDIVIDUAL STRUCTURE SURVEY FORM
HISTORIC SITES INVENTORY NO. 1329-1-1

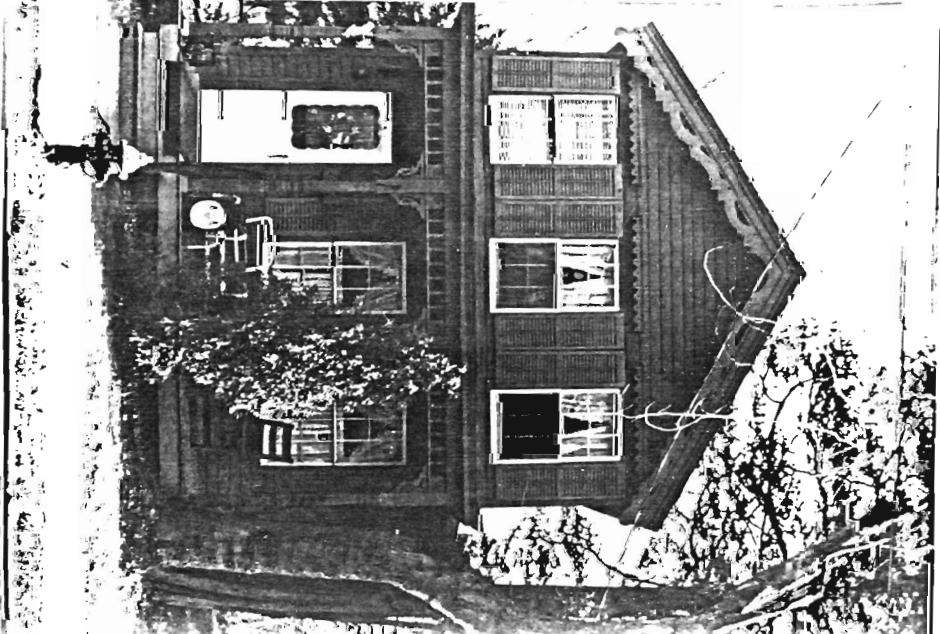
PHOTO Negative File No. 1-30

Construction Date:	c. 1860-1873	Source of Date:	Ref. 1, 2
Architect:		Builder:	
Style:	3 bay with Victorian millwork	Form/Plan Type:	Rectangle, rear lean-to, projecting bay south side
Number of Stories:	2		
Foundation:	Brick		
Exterior Wall Fabric:	Clapboard		
Fenestration:	3 bay symmetrical		
Roof/Chimneys:	Gable; 2 ridge chimneys

A three-bay cottage with undulating vergeboard in the eaves, and windowhoods. 6/6 sash windows. Simple molded door frame, with corner blocks; paneled transom may have formerly been glass. Three-bay porch with turned posts, brackets, and spindle ornamental below cross beam.

ORIGINAL USE: Residence
PHYSICAL CONDITION: Excellent ☐ Good ☒ Fair ☐ Poor ☐
REGISTER ELIGIBILITY: Yes ☐ Possible ☐ No ☐ Part of District ☒
THREATS TO SITE: Roads ☐ Development ☐ Zoning ☐ Deterioration ☐
No Threat ☒ Other ☐

Appears to be some deterioration of foundation

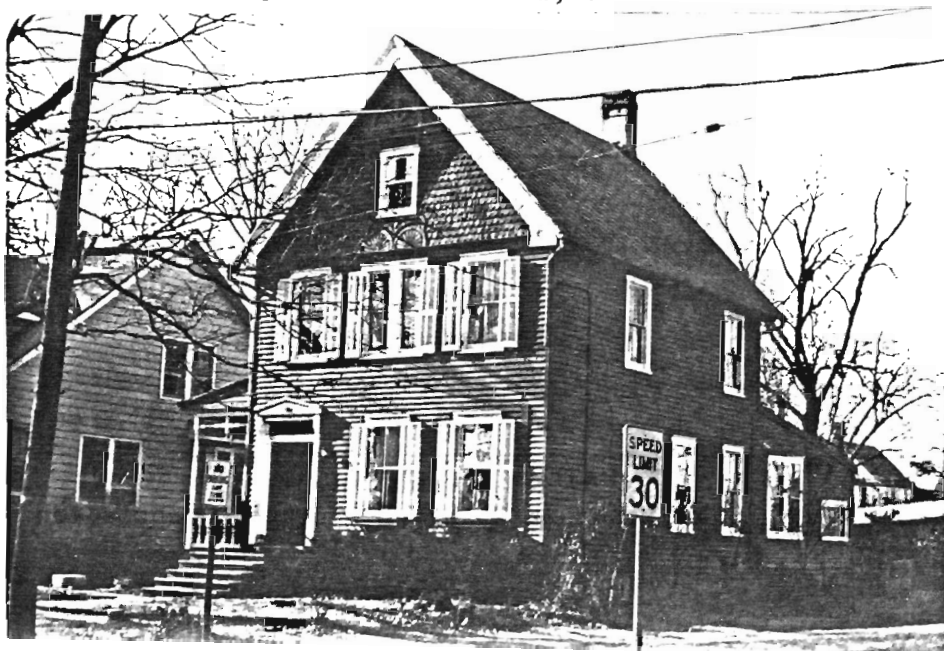
PHOTO Negative File No. 1-31, 32

Construction Date:	c. 1889-1891	Source of Date:	Ref. 1, 2
Architect:		Builder:	
Style:	3 bay with Eastlake elements	Form/Plan Type:	Rectangle, with rear ell
Number of Stories:	2½		
Foundation:	Brick		
Exterior Wall Fabric:	Clapboard, shingle		
Fenestration:	3 bay symmetrical		
Roof/Chimneys:	Gable; ridge chimney, rear end wall		
Additional Architectural Description:

Faces southeast, adjacent to vacant lot

ORIGINAL USE: Residence PRESENT USE: Residence
PHYSICAL CONDITION: Excellent ☒ Good ☐ Fair ☐ Poor ☐
REGISTER ELIGIBILITY: Yes ☐ Possible ☐ No ☐ Part of District ☒
THREATS TO SITE: Roads ☐ Development ☐ Zoning ☐ Deterioration ☐
No Threat ☒ Other ☐

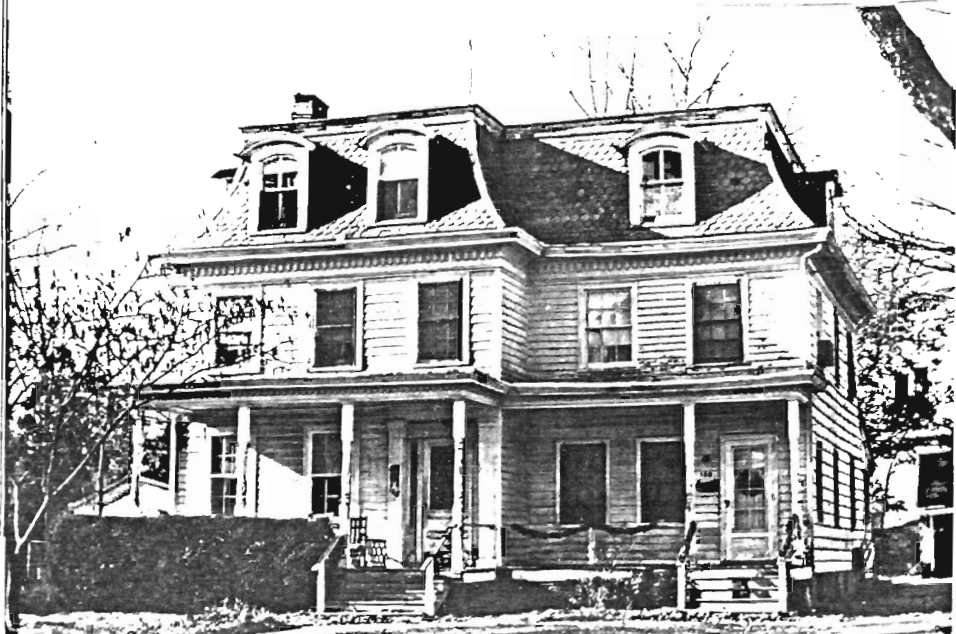
PHOTO Negative File No. 1-29

Number of Stories:	2½		
Foundation:	Brick, with stucco veneer		
Exterior Wall Fabric:	Clapboard		
Fenestration:	5 over 6 bay, asymmetrical		
Roof/Chimneys:	Mansard, with concave profile; internal chimney, south wall, slate roofing		
Additional Architectural Description:

Patterned, multicolored slate roofing has segmental head dormers, a milled cornice and denticulated frieze. 6/6 sash windows with simple milled surrounds. Recessed doorway with Doric order pilasters supporting a broad frieze, and narrow side lights. North door has simple frame. Porch has turned posts and dentils similar to those on cornice.

ORIGINAL USE: Residence
PHYSICAL CONDITION: Excellent ☐ Good ☐ Fair ☒ Poor ☐
REGISTER ELIGIBILITY: Yes ☐ Possible ☐ No ☐ Part of District ☒
THREATS TO SITE: Roads ☐ Development ☐ Zoning ☐ Deterioration ☐
No Threat ☒ Other ☐

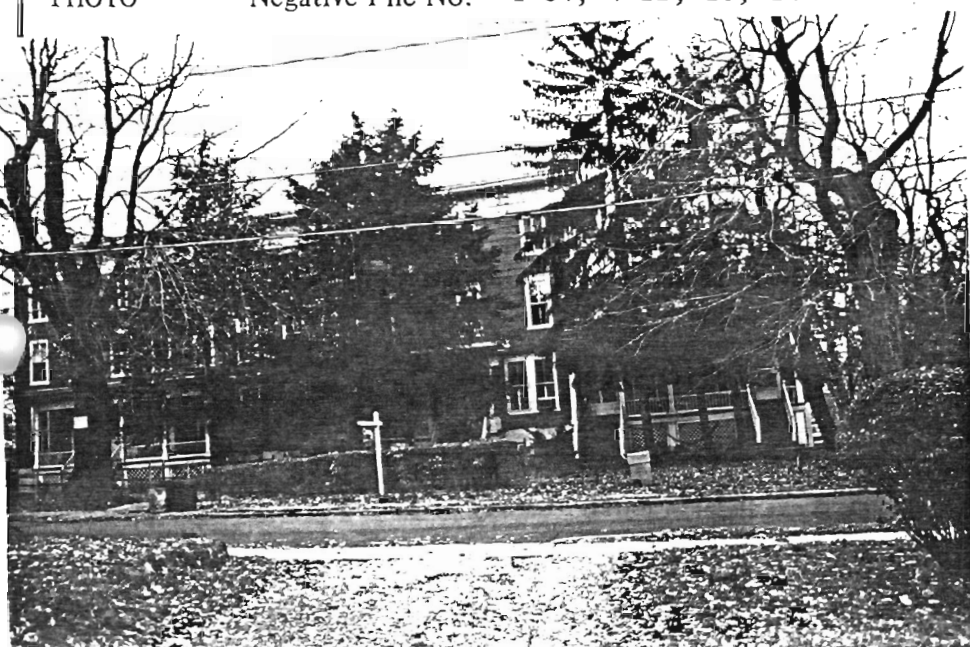
PHOTO Negative File No. 1-34; 4-12, 13, 14

Large city lot, on steep bank above Lake Lefferts. Row of conifers in front of building.

ORIGINAL USE: Private school
PHYSICAL CONDITION: Excellent ☐ Good ☒ Fair ☐ Poor ☐
REGISTER ELIGIBILITY: Yes ☐ Possible ☐ No ☐ Part of District ☒
THREATS TO SITE: Roads ☐ Development ☐ Zoning ☐ Deterioration ☐
No Threat ☒ Other ☐

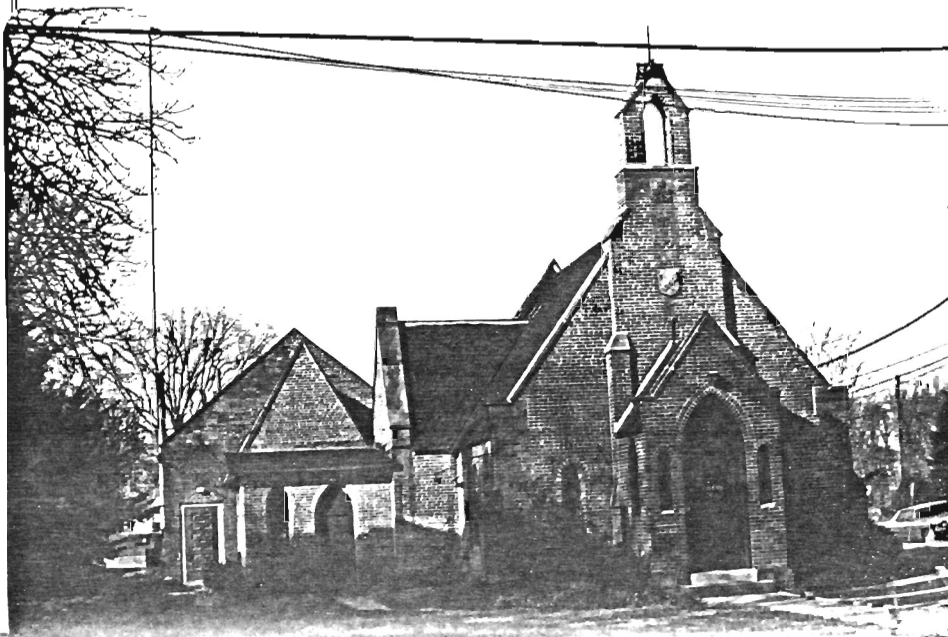
Negative File No. 2-7

Construction Date:	1850-1851	Source of Date:	Ref. 1
Architect:		Builder:	
Style:	Gothic Revival	Form/Plan Type:	L-plan with vestibule main block; rectangle addition
Number of Stories:	1		
Foundation:	Brick, with sandstone sills		
Exterior Wall Fabric:	Brick		
Fenestration:	3 bay symmetrical main block, irregular additions		
Roof/Chimneys:	Cross gable main block; gable addition

Faces SE on corner city lot. A parking lot is adjacent to the building.

The congregation was founded in 1850 and the construction of the church building was sponsored by Colonel John Travers who lived on Cheesequake Creek. The building is one of the best examples of the Gothic Revival style in the county.

ORIGINAL USE: Church PRESENT USE: Restaurant
PHYSICAL CONDITION: Excellent ☒ Good ☐ Fair ☐ Poor ☐
REGISTER ELIGIBILITY: Yes ☐ Possible ☐ No ☐ Part of District ☒
THREATS TO SITE: Roads ☐ Development ☐ Zoning ☐ Deterioration ☐
No Threat ☒ Other ☐

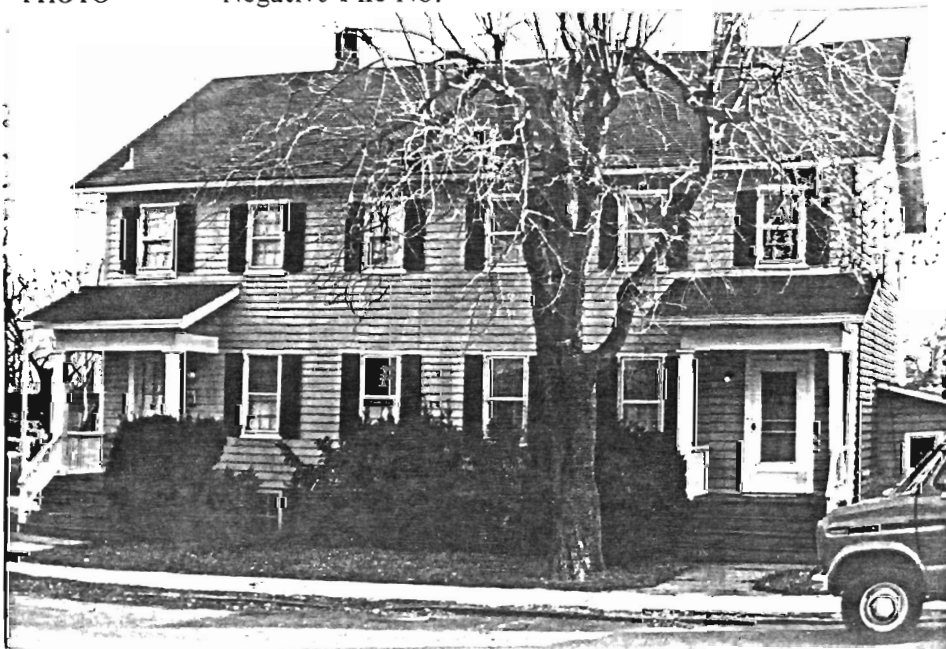
Negative File No. 2-10

A simple 6 bay structure with 9/6 sash windows on the 1st floor and 6/6 sash on the second. Small transom lights and entryway porches are over each doorway, which are approached by steps. Porch roofs and main roof have wide overhanging eaves, the roofs are probably later replacements. The original are likely to have been nearly flush with the end walls.

Faces northwest on city lot.

ORIGINAL USE: Residence
PHYSICAL CONDITION: Excellent ☐ Good ☒ Fair ☐ Poor ☐
REGISTER ELIGIBILITY: Yes ☐ Possible ☐ No ☐ Part of District ☒
THREATS TO SITE: Roads ☐ Development ☐ Zoning ☐ Deterioration ☐
No Threat ☒ Other ☐

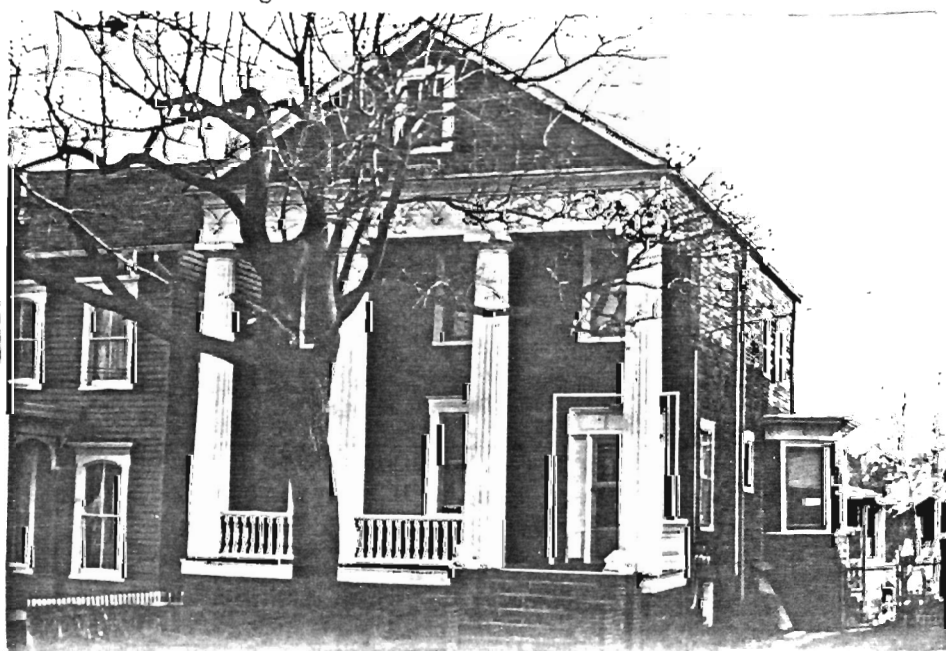
PHOTO Negative File No. 2-12

Greek Revival temple form. Portico is supported by Doric order columns, has a broad frieze with tracery, and a window in the pediment. Original door enframingent has been removed or obscured by the siding. Low balustrade lines porch. Window sash has been replaced; windows have broad surrounds with projecting drip moldings. Projecting bay with bracketed eaves is later addition.

Faces west on city lot, situated close to road.

ORIGINAL USE: Residence
PHYSICAL CONDITION: Excellent ☐ Good ☐ Fair ☒ Poor ☐
REGISTER ELIGIBILITY: Yes ☐ Possible ☐ No ☐ Part of District ☒
THREATS TO SITE: Roads ☐ Development ☐ Zoning ☐ Deterioration ☐
No Threat ☒ Other ☐

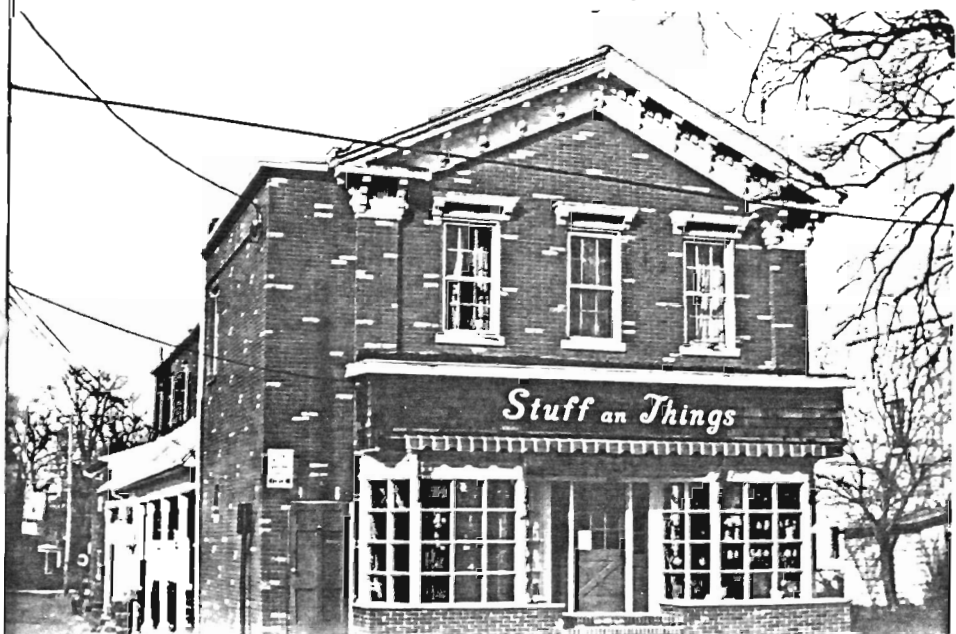
PHOTO Negative File No. 1-4, 5

Construction Date:	1854	Source of Date:	Ref. 1
Architect:		Builder:	
Style:	Italianate	Form/Plan Type:	Rectangle with south side additions and porch
Number of Stories:	2		
Foundation:	Brick		
Exterior Wall Fabric:	Simulated brick over brick		
Fenestration:	3 bay		
Roof/Chimneys:	Gable; chimney at rear

Set close to road on corner lot.

ORIGINAL USE: Commercial
PHYSICAL CONDITION: Excellent ☐ Good ☒ Fair ☐ Poor ☐
REGISTER ELIGIBILITY: Yes ☐ Possible ☐ No ☐ Part of District ☒
THREATS TO SITE: Roads ☒ Development ☐ Zoning ☐ Deterioration ☐
No Threat ☐ Other ☐

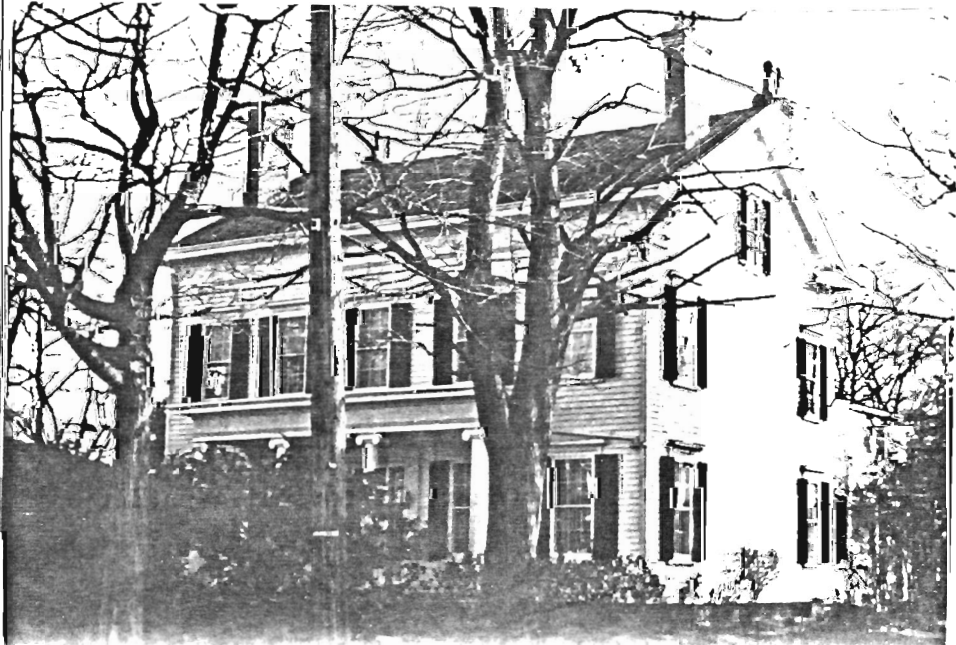
PHOTO Negative File No. 1-2, 3

Construction Date: c. 1850-1860 Source of Date: Stylistic; Ref. 1, 2
Architect: Builder:
Style: Greek Revival Form/Plan Type: Rectangle with rear ell
Number of Stories: 2½
Foundation: Brick
Exterior Wall Fabric: Clapboard
Fenestration: 5 bay, slightly asymmetrical
Roof/Chimneys: Gable; 2 sets twin end chimneys, standing seam tin roofing
Additional Architectural Description:

ORIGINAL USE: Residence PRESENT USE: Residence
PHYSICAL CONDITION: Excellent ☒ Good ☐ Fair ☐ Poor ☐
REGISTER ELIGIBILITY: Yes ☐ Possible ☐ No ☐ Part of District ☒
THREATS TO SITE: Roads ☐ Development ☐ Zoning ☐ Deterioration ☐
No Threat ☒ Other ☐

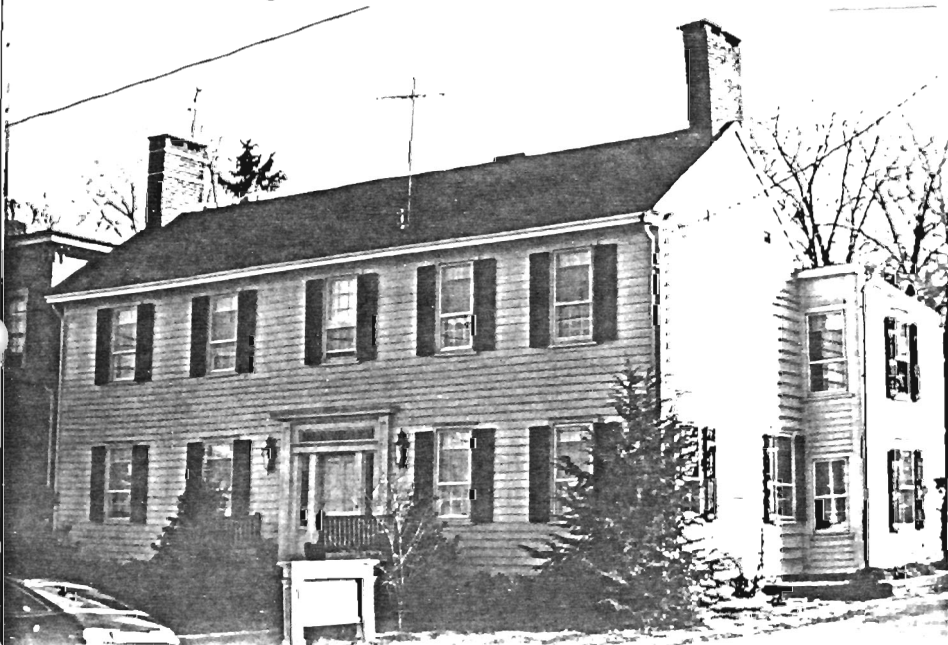
PHOTO Negative File No. 1-6, 7, 8*

Construction Date: 1790-1820 Source of Date: Stylistic
Architect: Builder:
Style: 5 bay with Federal elements Form/Plan Type: Rectangle w/ rear addition
Number of Stories: 2
Foundation: Coursed fieldstone
Exterior Wall Fabric: Clapboard; weatherboard on south wall
Fenestration: 5 bay
Roof/Chimneys: Gable, 2 internal end chimneys
Additional Architectural Description:

Faces NW on corner lot, low shrubs around foundation. Connected barn complex in rear, frame with one and two story sections.

ORIGINAL USE: Residence
PHYSICAL CONDITION: Excellent ☒ Good ☐ Fair ☐ Poor ☐
REGISTER ELIGIBILITY: Yes ☐ Possible ☐ No ☐ Part of District ☒
THREATS TO SITE: Roads ☐ Development ☐ Zoning ☐ Deterioration ☐
No Threat ☒ Other ☐

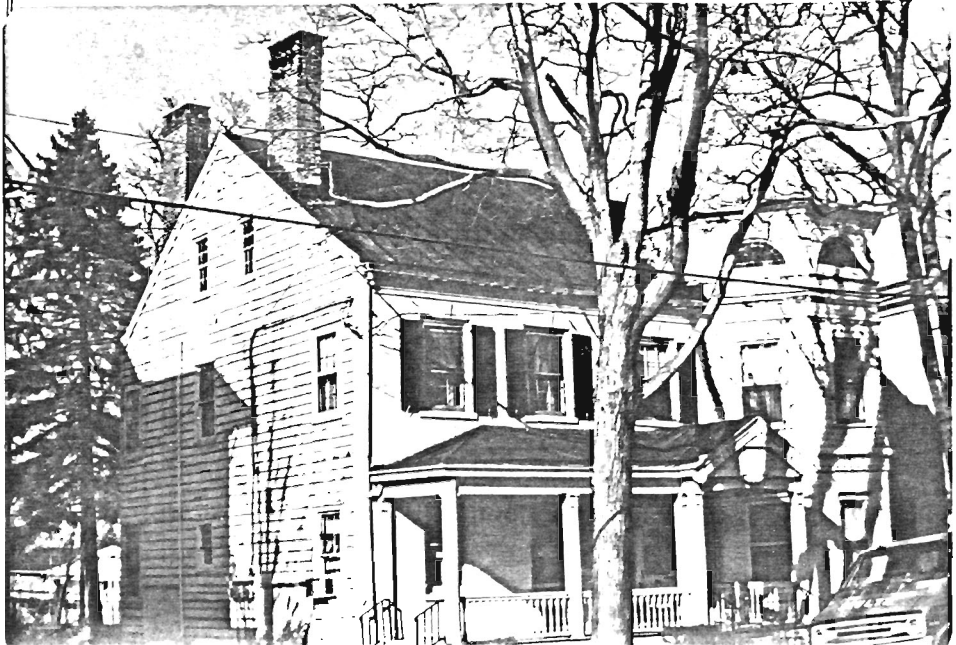
PHOTO Negative File No. 1-16, 17*

Eaves are flush with end walls; modillion cornice. 6/6 sash windows; second floor windows have flat arch with keystone. Late federal doorway enframingent, with Ionic order engaged columns and pilasters. Side and transom lights with elliptical tracery, and a molded cornice with a recessed central section. Two exposed hearth backs on south wall. Queen Anne tower and porch were added c. 1890; they have a variety of shingle types, semicircular third floor windows and 1/1 sash.

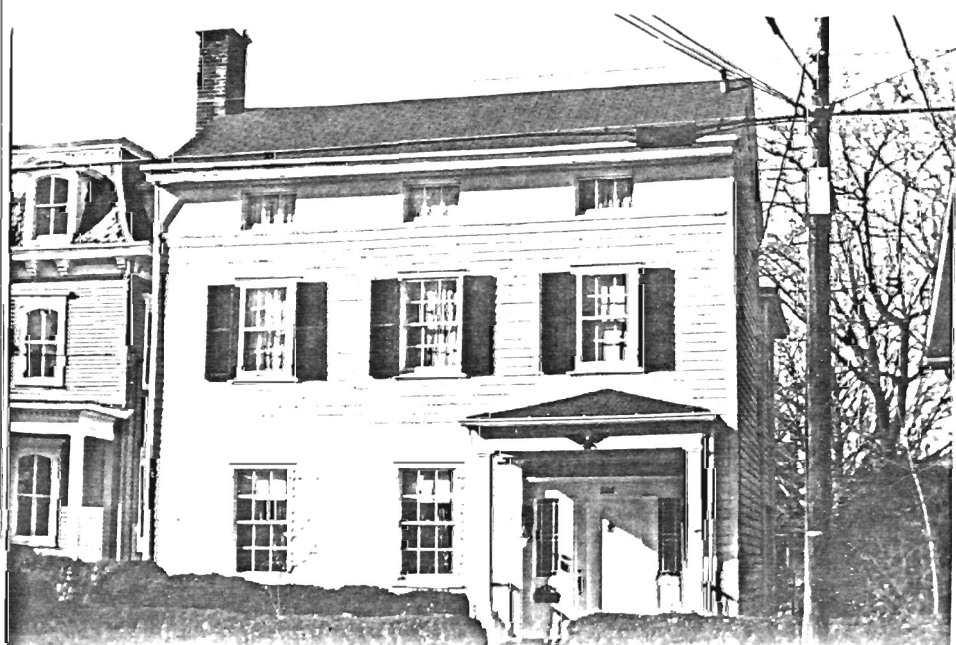
PHOTO Negative File No. 1-19

Faces southeast, set very close to road, rows of low shrubs cover foundation, and mark lot along sidewalk.

Construction Date:	1836	Source of Date:	Ref. 1
Architect:		Builder:	
Style:	Greek Revival	Form/Plan Type:	Rectangle, brick rear ell and rear porch
Number of Stories:	2½		
Foundation:	Brick, with sandstone sills		
Exterior Wall Fabric:	Brick, with Flemish bond		
Fenestration:	5 bay symmetrical		
Roof/Chimneys:	Gable; 2 sets twin end wall chimneys		
Additional Architectural Description:

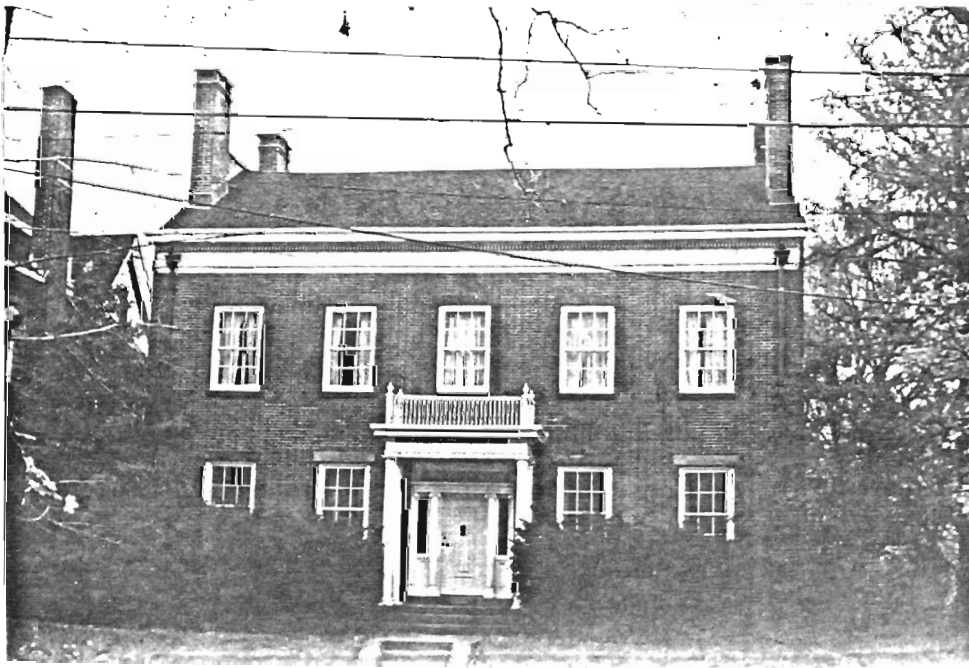
Negative File No. 1-24, 27 ; 4-11*

Faces northwest on city lot, on small bank above road level. Shrubs around base of house, trees along sides of lot.

Construction Date: c. 1780
Architect:
Style: Federal with Colonial Revival alterations
Number of Stories: 2
Foundation: Random and coursed ashlar
Exterior Wall Fabric: Clapboard, brick; walls are brick lined
Fenestration: 5 bay, slightly asymmetrical
Roof/Chimneys: Center gable; internal ridge chimney
Source of Date: Ref. 1, 2
Builder:
Form/Plan Type: Rectangle rear addition, brick solarium south side

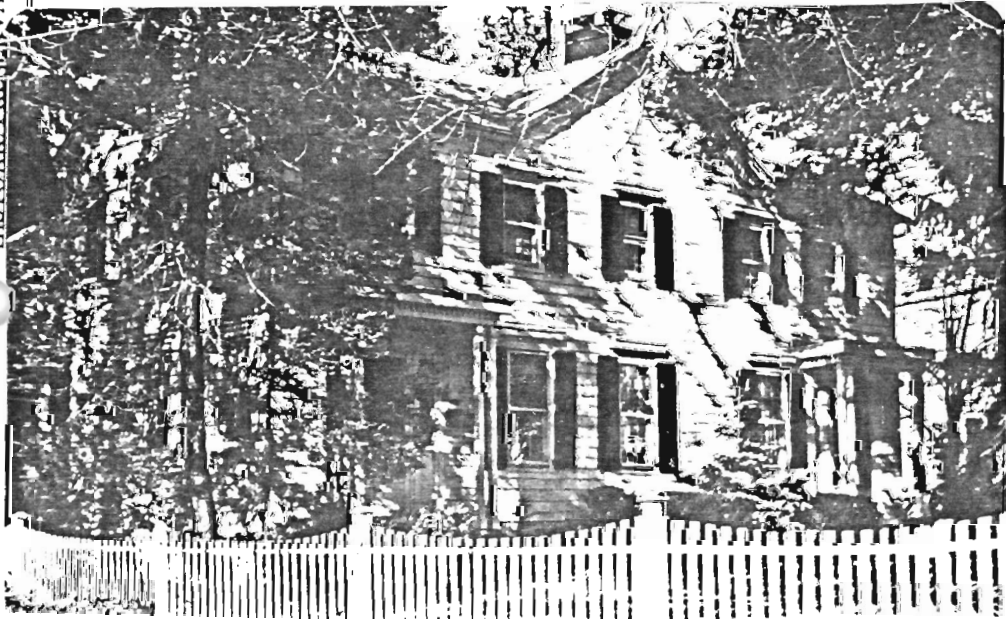
PHOTO Negative File No. 1-22,23; 4-16*

Faces southeast on corner city lot. A picket fence marks the perimeter of the lot which includes a number of mature trees, both in front of and behind the house, as well as considerable shrubbery.

Construction Date: c. 1873-1880 Source of Date: Ref. 1; Stylistic
Architect: Builder:
Style: Second Empire Form/Plan Type: Square with central pavilion projecting bays north and south walls
Number of Stories: 3½
Foundation: Brick
Exterior Wall Fabric: Clapboard
Fenestration: 3 bay symmetrical
Roof/Chimneys: Concave mansard main roof, convex mansard tower, internal chimney south wall
Additional Architectural Description:

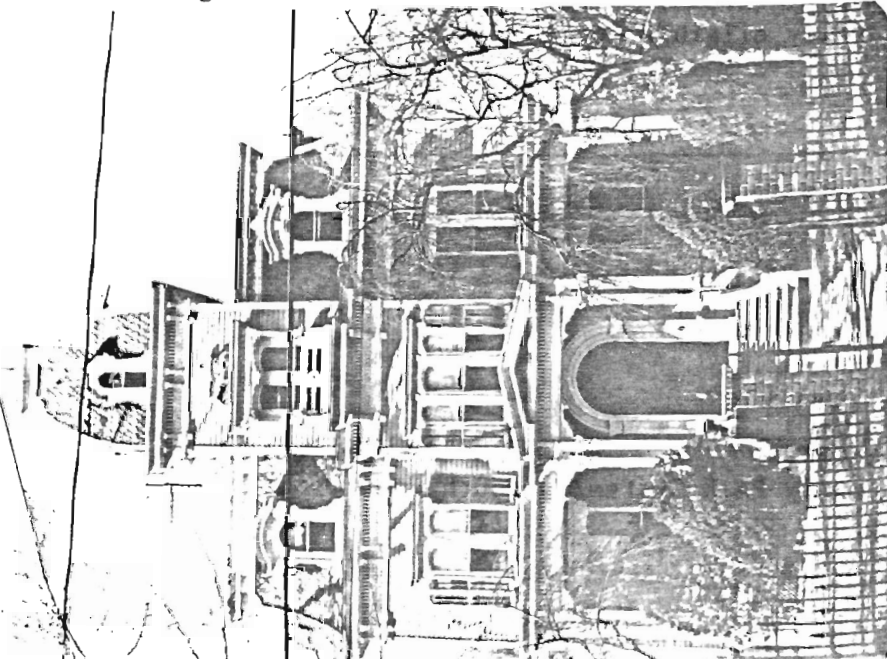
PHOTO Negative File No. 1-25, 26*

Faces southeast on city lot. Lot is marked with a brick and iron fence.

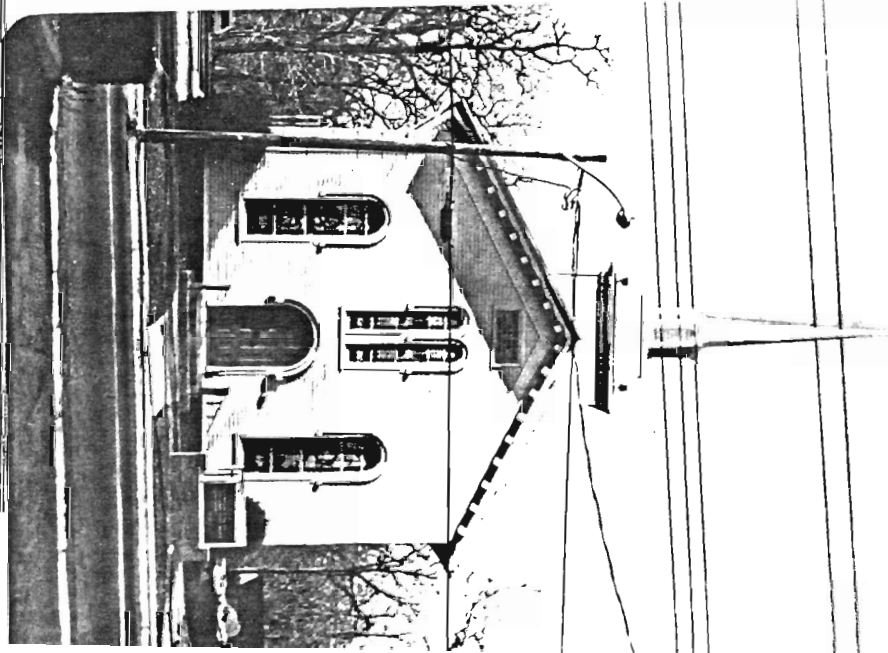
PHOTO Negative File No. 1-28

Construction Date:	1860	Source of Date:	Datestone on front facade
Architect:		Builder:	
Style:	Italianate	Form/Plan Type:	Rectangle, with rear additions
Number of Stories:	1½		
Foundation:	Brick		
Exterior Wall Fabric:	Clapboard		
Fenestration:	3 bay symmetrical		
Roof/Chimneys:	Gable		
Additional Architectural Description:

Simple Italianate Church. Double, round-headed doorway with pronounced drip moldings. Tall, round headed stained glass windows with pronounced drip moldings, paired windows in central bay. Modillion cornice and wide fascia board. Steeple is a replacement, and is considerably smaller than the original.

Faces southeast on city lot, a parking lot is adjacent to the building

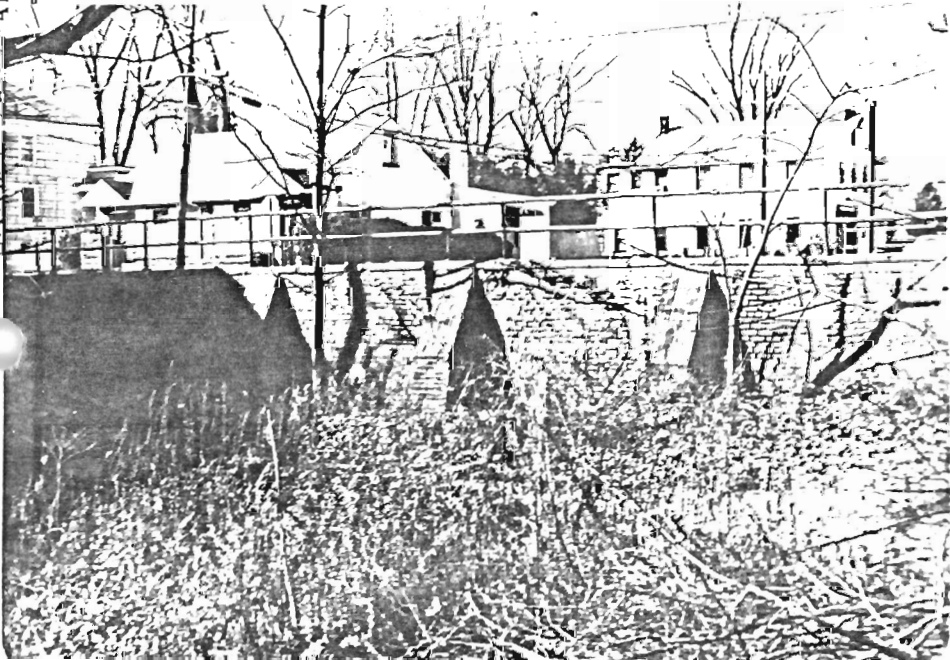
PHOTO Negative File No. 3-6

Brick bridge with buttresses; carries Main Street over Aberdeen Creek.

This bridge spans the deep gully formed by Aberdeen Creek. The bridge replaced as earlier stone bridge which was in place by 1851. The gully separated the commercial/residential section of Matawan to the north from the light industrial/working class residential section to the south side. The area now called Terhune Park was the site of the first brickyard in the town; it is adjacent to the bridge on the east side. A pottery and tile works was established in 1852 by Josiah Van Schoick and Ezra Dunn on the west side of the bridge. Tanneries, sash and blind mills and carpentry shops could also be found in this section of the town. The brick and ceramics industries were an important part of Matawan's economy, during the 19th and early 20th centuries.

ORIGINAL USE: Bridge
PHYSICAL CONDITION: Excellent ☐ Good ☐ Fair ☒ Poor ☐
REGISTER ELIGIBILITY: Yes ☐ Possible ☐ No ☐ Part of District ☒
THREATS TO SITE: Roads ☐ Development ☐ Zoning ☐ Deterioration ☐
No Threat ☐ Other ☐

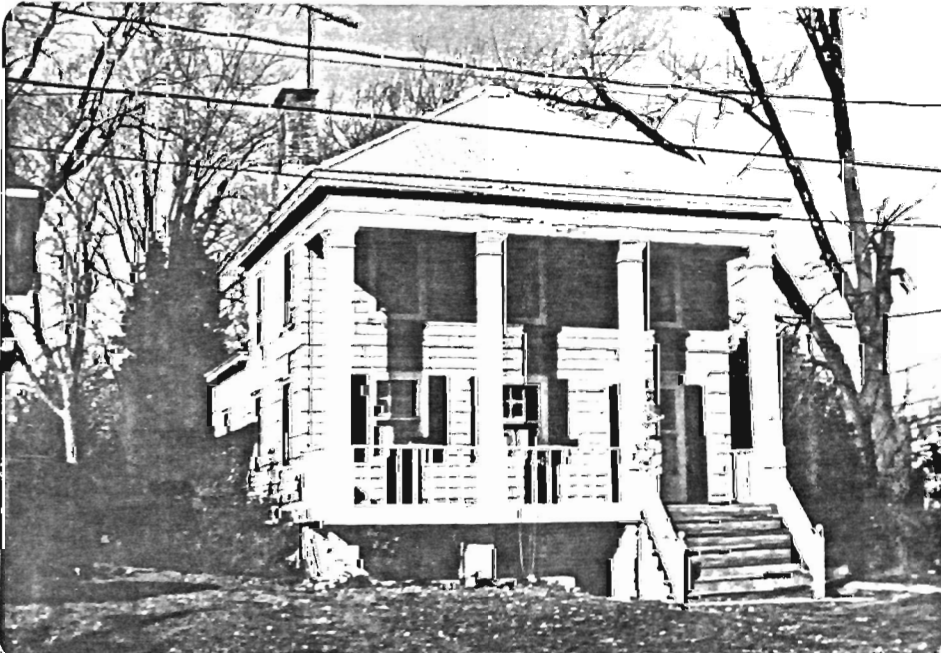
PHOTO Negative File No. 3-4

Construction Date: c. 1830-1851 Source of Date: Stylistic; Ref. 1
Architect: Builder:
Style: Greek Revival Form/Plan Type: Square with rear ell
Number of Stories: 2 plus raised basement
Foundation: Brick
Exterior Wall Fabric: Asbestos shingle over clapboard
Fenestration: 3
Roof/Chimneys: Pyramidal; internal chimney on south wall

Faces southeast on city lot

ORIGINAL USE: Residence
PHYSICAL CONDITION: Excellent ☐ Good ☐ Fair ☒ Poor ☐
REGISTER ELIGIBILITY: Yes ☐ Possible ☐ No ☐ Part of District ☒
THREATS TO SITE: Roads ☐ Development ☐ Zoning ☐ Deterioration ☒
No Threat ☐ Other ☐
COMMENTS:

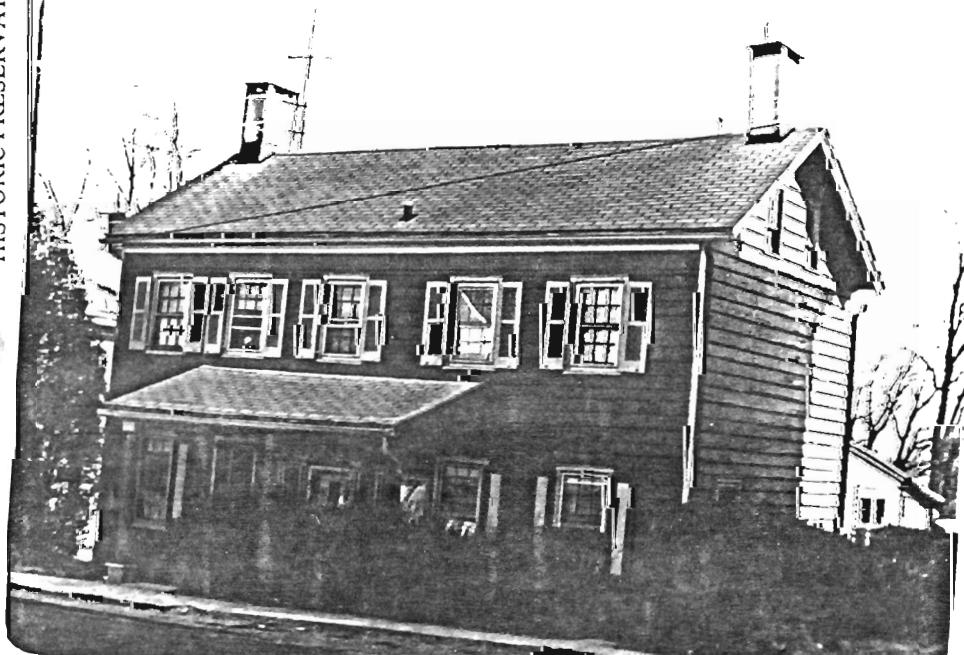
Negative File No. 2-36, 3-2

The main body of this house was built in two major sections; the north three bays are probably the earlier section. The house was expanded to five bays by the early 19th century. First floor windows are 9/6 sash, the second floor are 6/6. Modern door in Federal enframing with four slender, grooved pilasters and side and transom lights. Roof is a replacement, original was probably flush with the end walls. Exposed hearthback on north wall. A second doorway has been added, adjacent to main door.

Faces northwest on city lot, situated close to road and neighboring houses.

ORIGINAL USE: Residence
PHYSICAL CONDITION: Excellent ☐ Good ☐ Fair ☒ Poor ☐
REGISTER ELIGIBILITY: Yes ☐ Possible ☐ No ☐ Part of District ☒
THREATS TO SITE: Roads ☐ Development ☐ Zoning ☐ Deterioration ☐
No Threat ☒ Other ☐
COMMENTS:

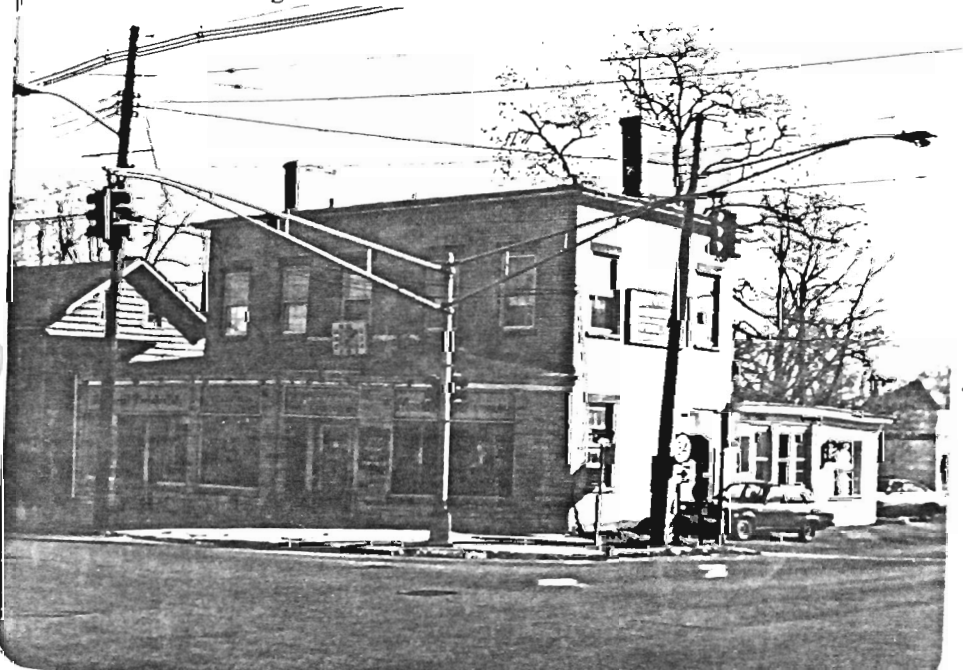
2-35

Sits at northeast corner of major intersection, close to both roads.

ORIGINAL USE: Residence
PHYSICAL CONDITION: Excellent ☐ Good ☐ Fair ☒ Poor ☐
REGISTER ELIGIBILITY: Yes ☐ Possible ☐ No ☐ Part of District ☒
THREATS TO SITE: Roads ☐ Development ☐ Zoning ☐ Deterioration ☐
No Threat ☐ Other ☒

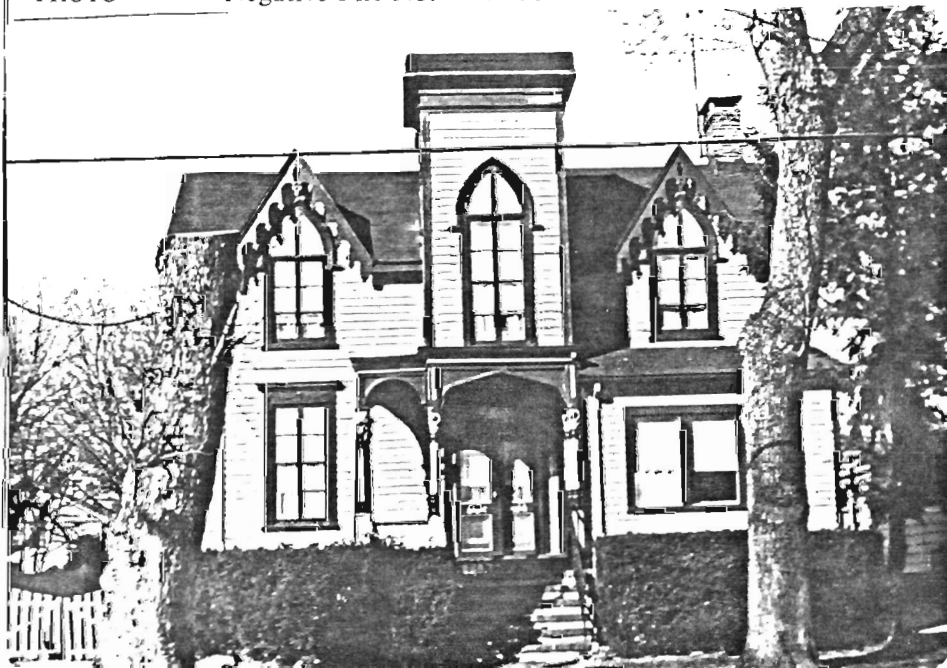
PHOTO Negative File No. 3-33

Construction Date:	c. 1851-1855	Source of Date:	Ref. 1, 2
Architect:		Builder:	
Style:	Carpenter Gothic	Form/Plan Type:	Rectangle with rear ell projecting central tower with shed addition front facade
Number of Stories:	2 plus raised basement		
Foundation:	Brick		
Exterior Wall Fabric:	Clapboard		
Fenestration:	3 bay		
Roof/Chimneys:	Gable with gable dormers; flat roof tower; interal end chimney		
Additional Architectural Description:

The loss of the upper section of the tower, and the addition of the ell on the front facade (added c. 1927-32) have compromised what was a very good example of Carpenter Gothic house. Original characteristics include: 4/4 sash windows, the second floor windows having lancet arch heads which project above the roofline; vergeboard in the eaves; a double doorway with a transom light; and a porch with Tudor and round arches. A second chimney may have formerly been on the south end of the house.

Faces southeast on city lot, a small sheet metal shed is in the rear of the lot.

This is a well maintained, if somewhat altered, example of a Carpenter Gothic residence. It is located near the site of William D. Bailey's sash and blind mill, and the millwork found on this house might have been made there. The house is similiar to the William D. Bailey house (1329-21). This lot, and the other lots north of State Route 34 between Main Street and Franklin Street were subdivided by Thomas I. Bedle beginning in the 1850's. Many modest residences such as this were built in this area.

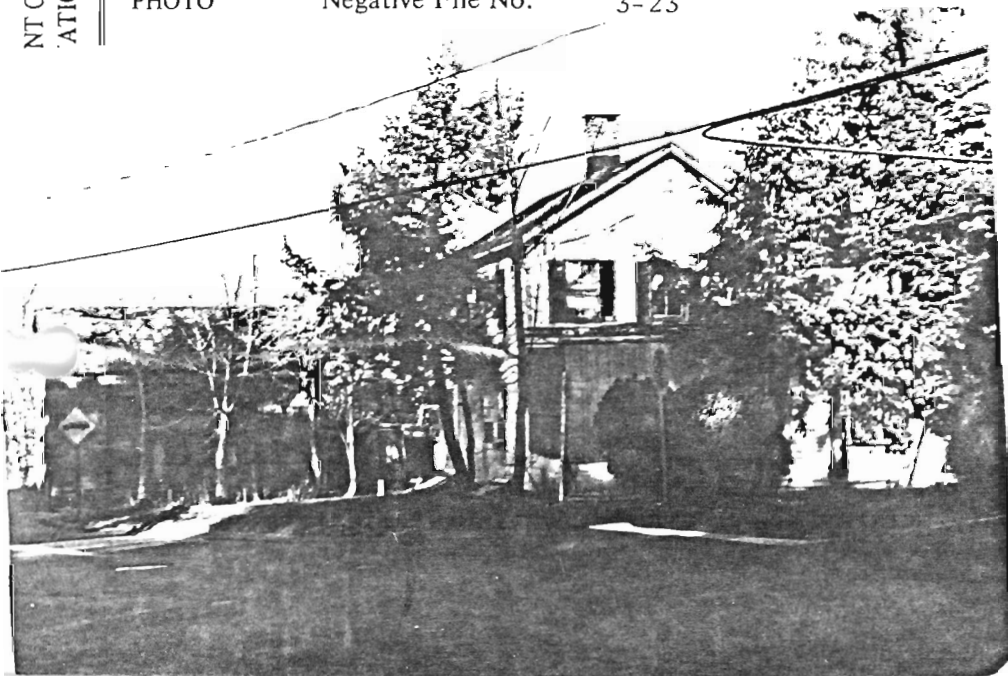
PHOTO Negative File No. 3-23

Faces south on corner lot of three acres. Barn and derelict shed are in the rear of the lot. House is closely circled by conifers.

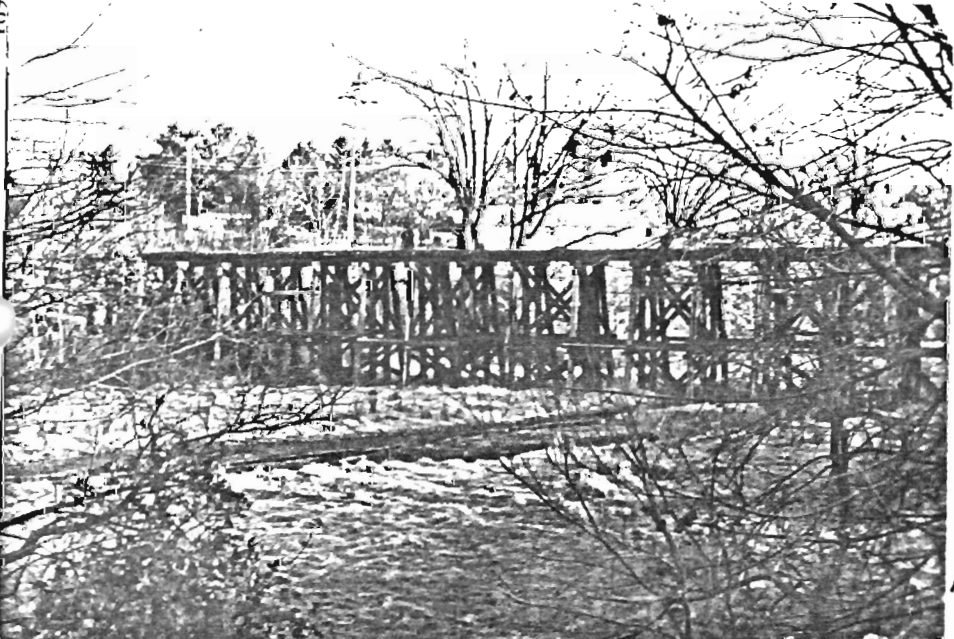
PHOTO Negative File No. 2-4,5,6

400' timber railroad trestle

Crosses Lake Matawan/Gravelly Brook, a low marsh area with steep bluffs on either side.

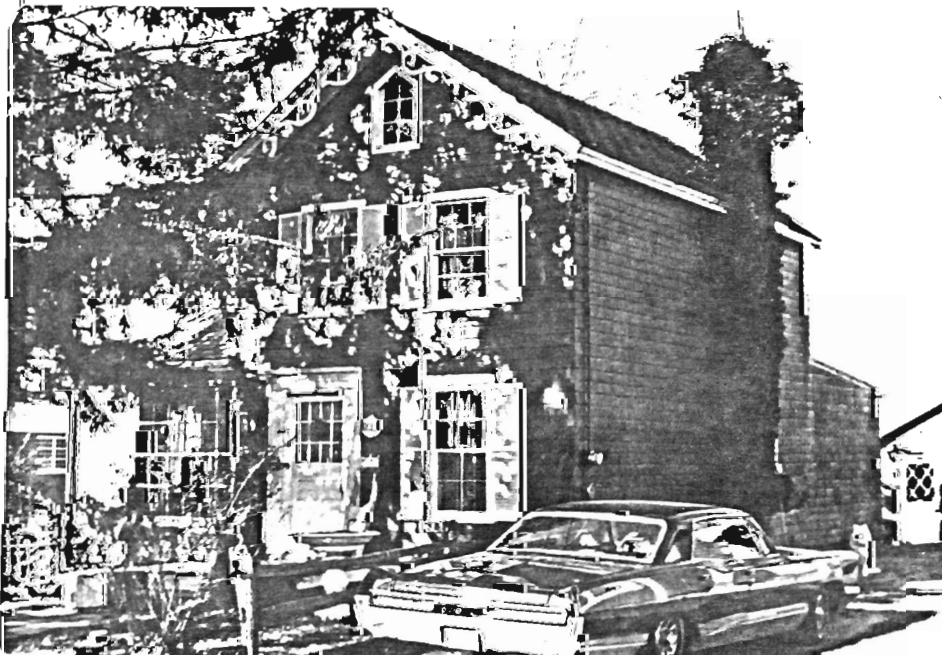
Negative File No. 2-32

Faces southeast on a well maintained city lot with a small garage in rear

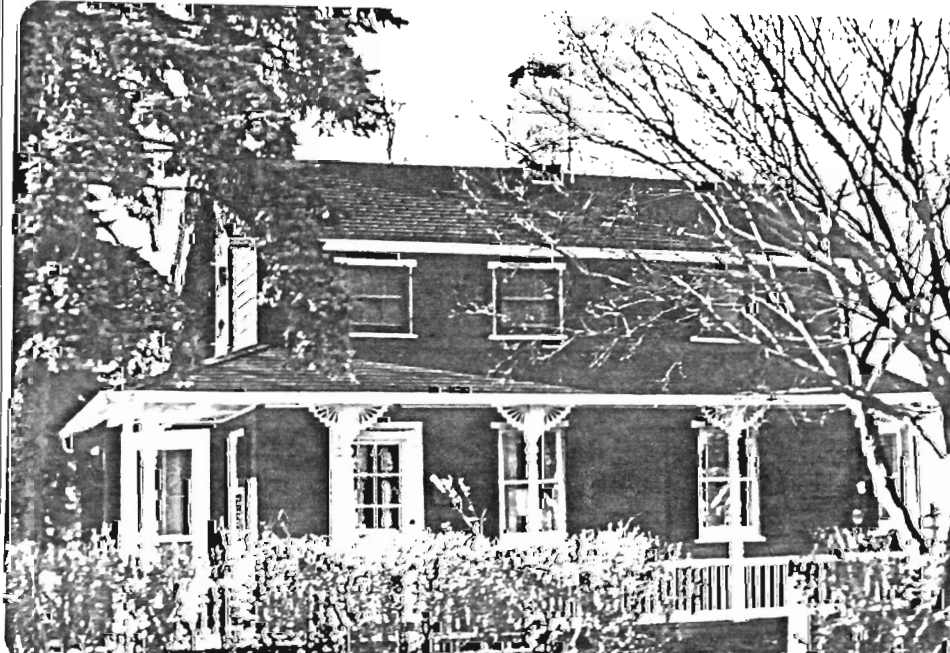
PHOTO Negative File No. 3-17

Faces east on city lot, small frame shed in rear lot.

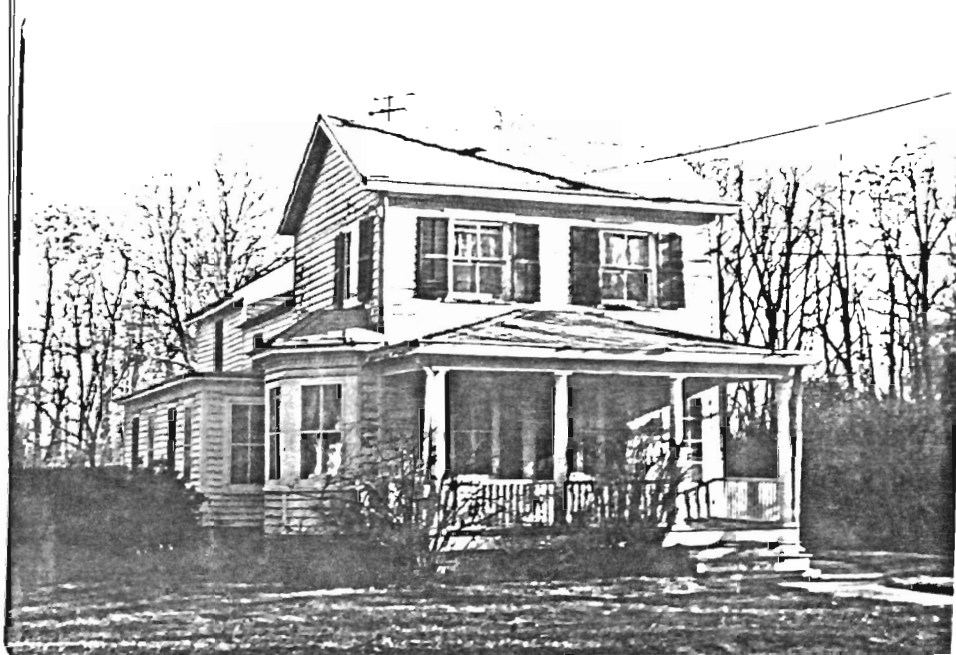
PHOTO Negative File No. 3-18

Faces west on an open irregular lot, wooded in rear of lot.

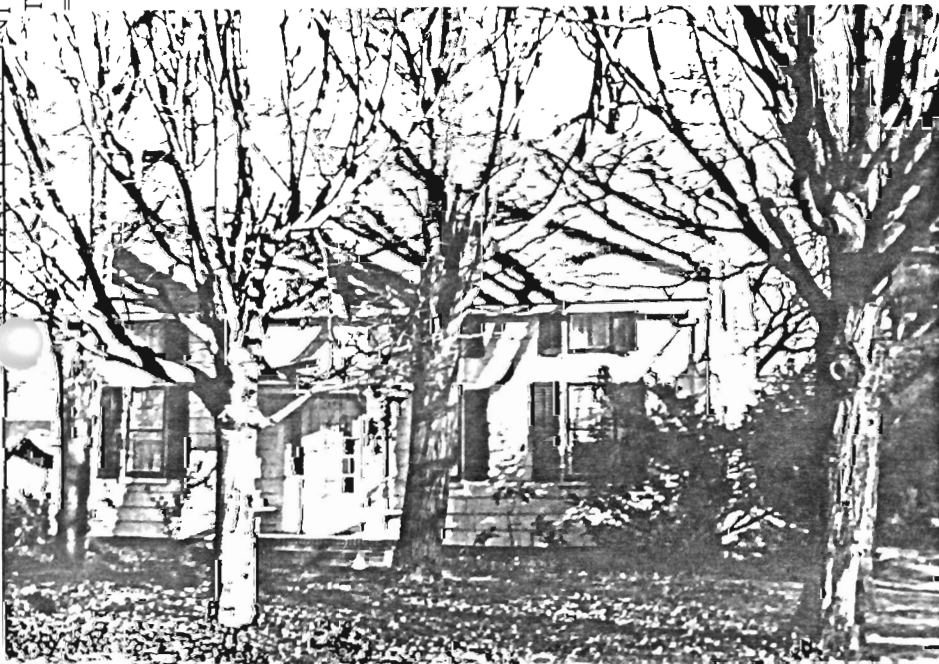
Negative File No. 3-19*

Faces west on long rectangular five acre lot; several mature deciduous trees stand in front of house.

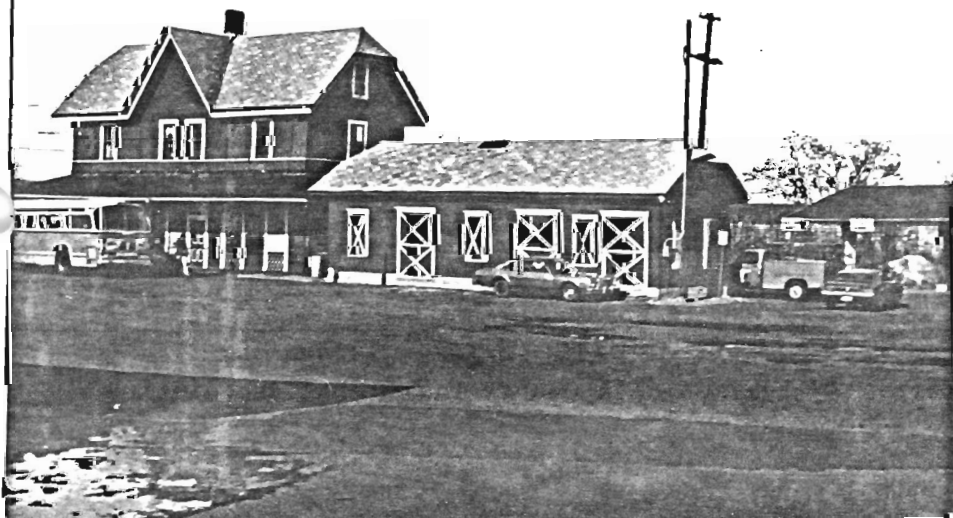
PHOTO Negative File No. 2-19; 4-29*

Large open lot along railway, surrounded by large commuter parking area.

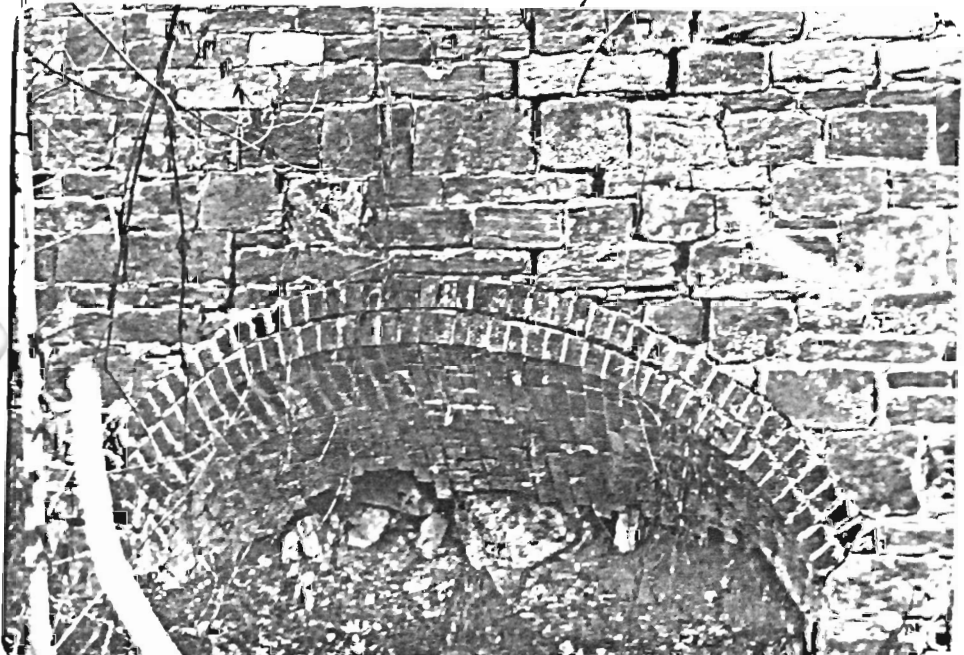
PHOTO Negative File No. 2-29, 30

Construction Date:	c. 1860-1873	Source of Date:	Ref. 1, 2
Architect:		Builder:	
Style:		Form/Plan Type:	
Number of Stories:			
Foundation:			
Exterior Wall Fabric:			
Fenestration:			
Roof/Chimneys:			
Additional Architectural Description:	Lime kiln; random ashlar main section with two row brick restraining arch

Built into steep bluff adjacent to marsh area around Matawan Creek. Area surrounding kiln is now overgrown.
