MUNICIPALITY Matawan

SURVEY Monmouth County

#1329-1 Main St. District
Continuation Sheet

NEW JERSEY DEPARTMENT OF ENVIRONMENTAL PROTECTION
OFFICE OF HISTORIC PRESERVATION
INDIVIDUAL STRUCTURE SURVEY FORM
HISTORIC SITES INVENTORY NO. 1329-1-1

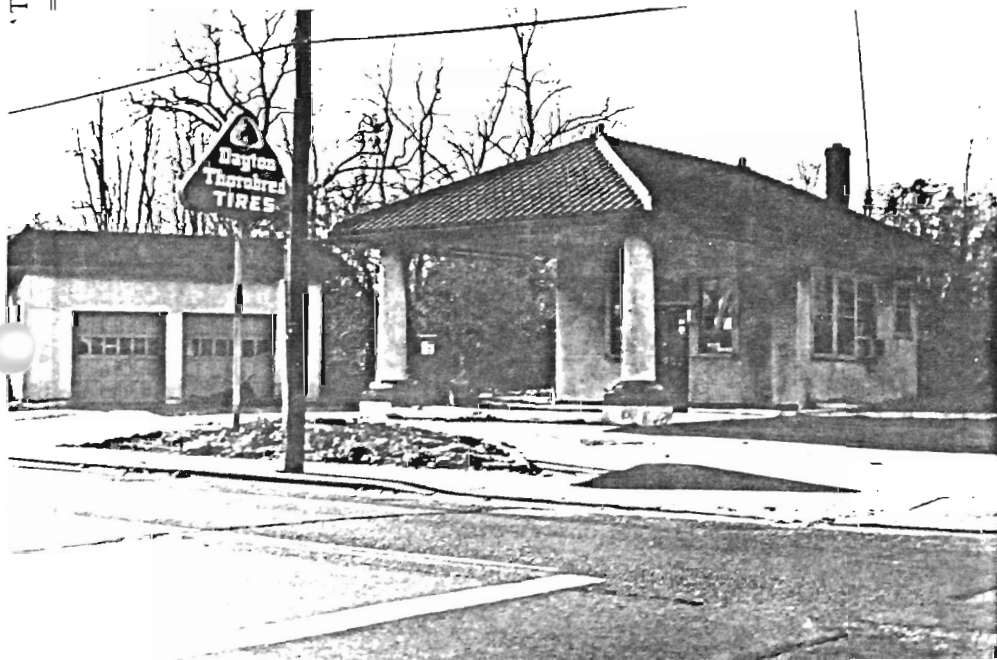
Negative File No. 3-11

Situated on corner lot at busy intersection. A stucco, two-bay garage building with a mission tile mansard roof is also on the lot.

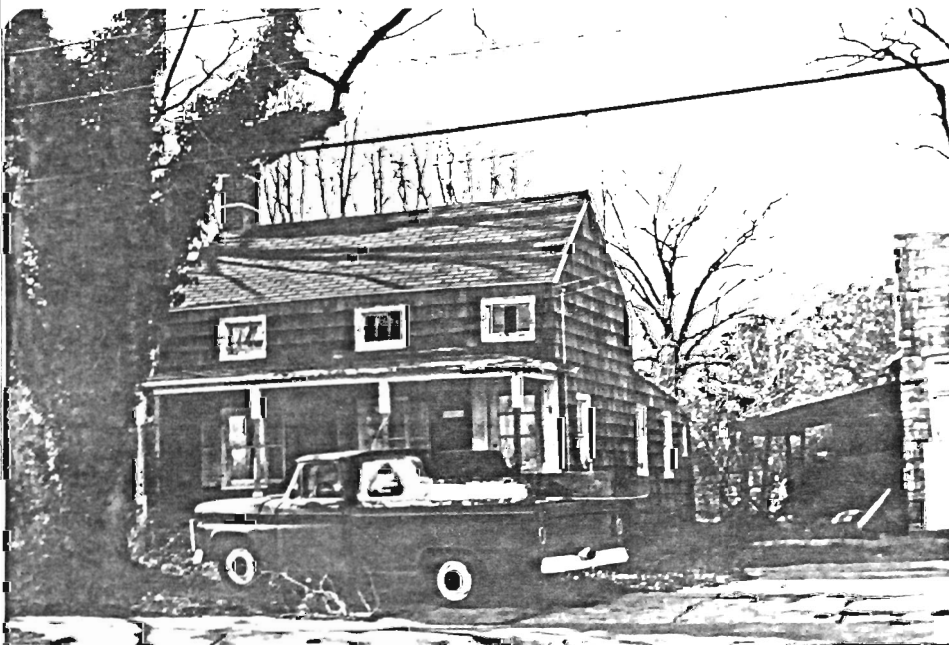
Negative File No. 3-12

Small, irregularly shaped city lot, adjacent to gas station, may be same lot.

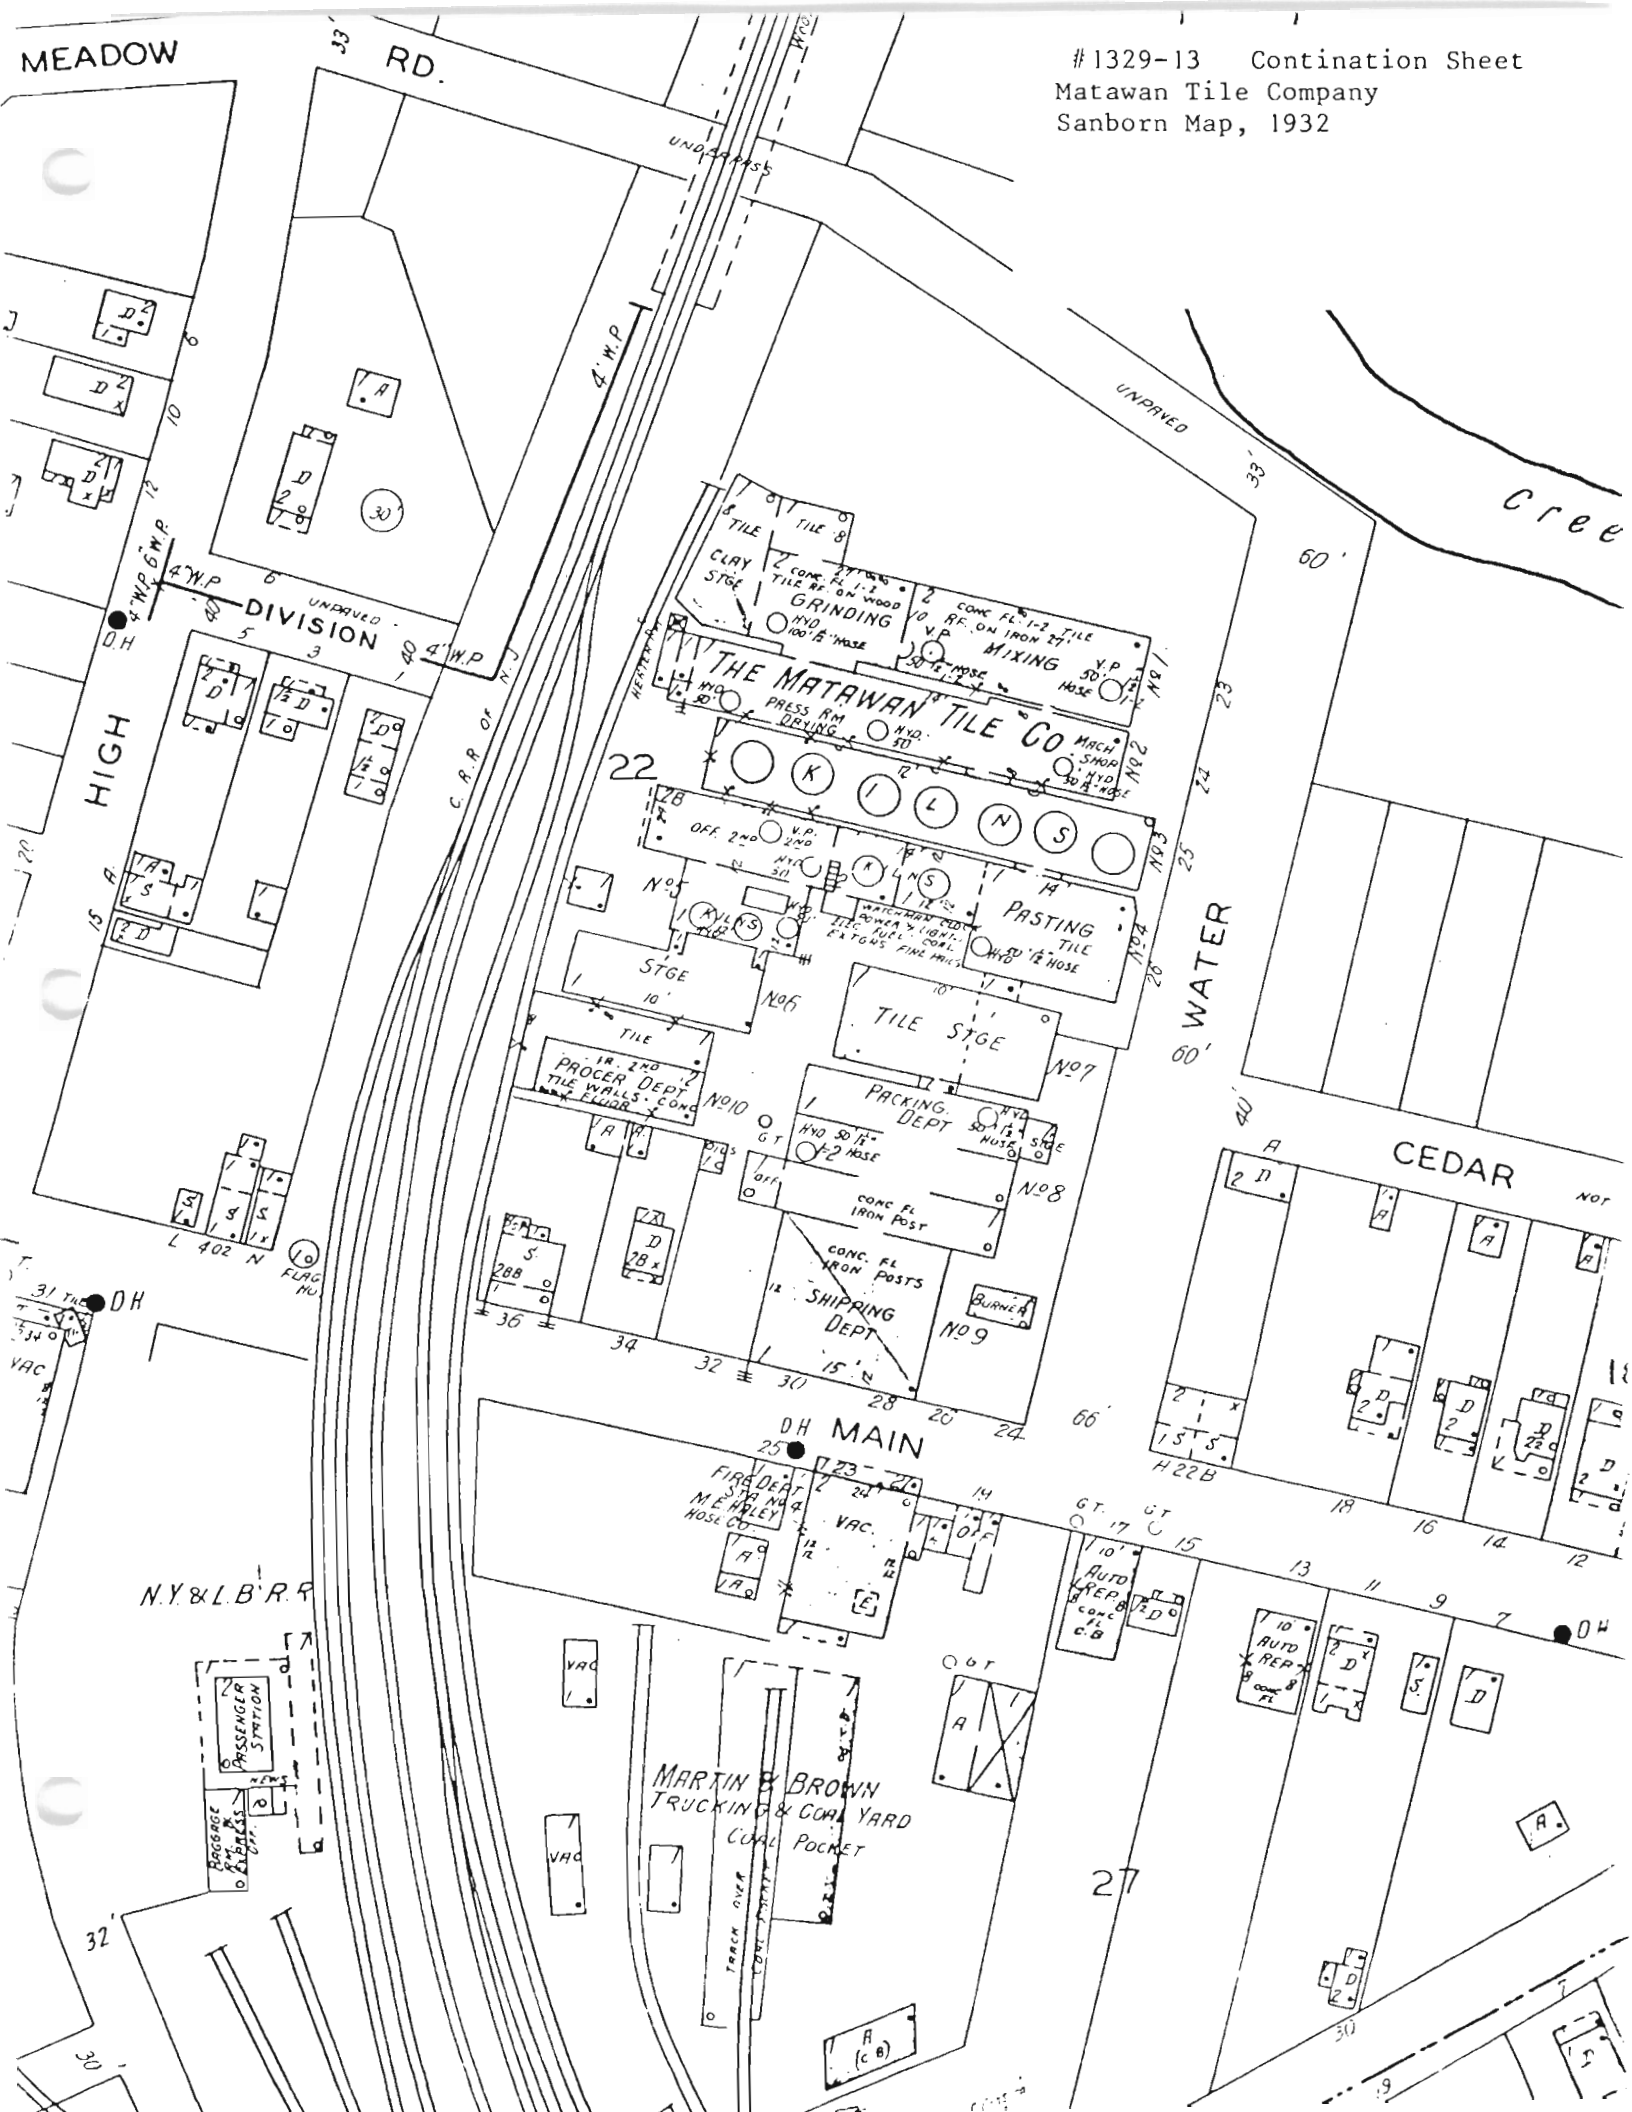
#1329-13 Continuation Sheet
Matawan Tile Company
Sanborn Map, 1932

SIGNIFICANT STRUCTURES			
	A Shipping Building	B Kiln Building	C	D
DATE	c. 1923-1932	c. 1873-1886		
BUILDER/ARCH.				
FORM/PLAN	Square	Rectangle		
STORIES	1	2		
FOUNDATION	Concrete	Brick		
EXTERIOR WALL FABRIC	Brick/tile	Brick		
STRUCTURAL SYSTEM	Steel frame	Load bearing masonry		
ROOF/CHIMNEYS	Monitor	Shallow pitch gable		
ADDITIONAL ARCHITECTURAL DESCRIPTION	<p>A. Retains much of the tile decoration on the exterior, though some of it has been obscured by paint. Doorway on street facade replaced a window.</p> <p>B. Section on far right (in photo) with large windows was added by Matawan Tile Co. between 1914 and 1923. Has tile sign "Office" above door.</p>			
CONDITION COMMENTS:	E <input type="checkbox"/> G <input checked="" type="checkbox"/> F <input type="checkbox"/> P <input type="checkbox"/>	E <input type="checkbox"/> G <input checked="" type="checkbox"/> F <input type="checkbox"/> P <input type="checkbox"/>	E <input type="checkbox"/> G <input type="checkbox"/> F <input type="checkbox"/> P <input type="checkbox"/>	E <input type="checkbox"/> G <input type="checkbox"/> F <input type="checkbox"/> P <input type="checkbox"/>

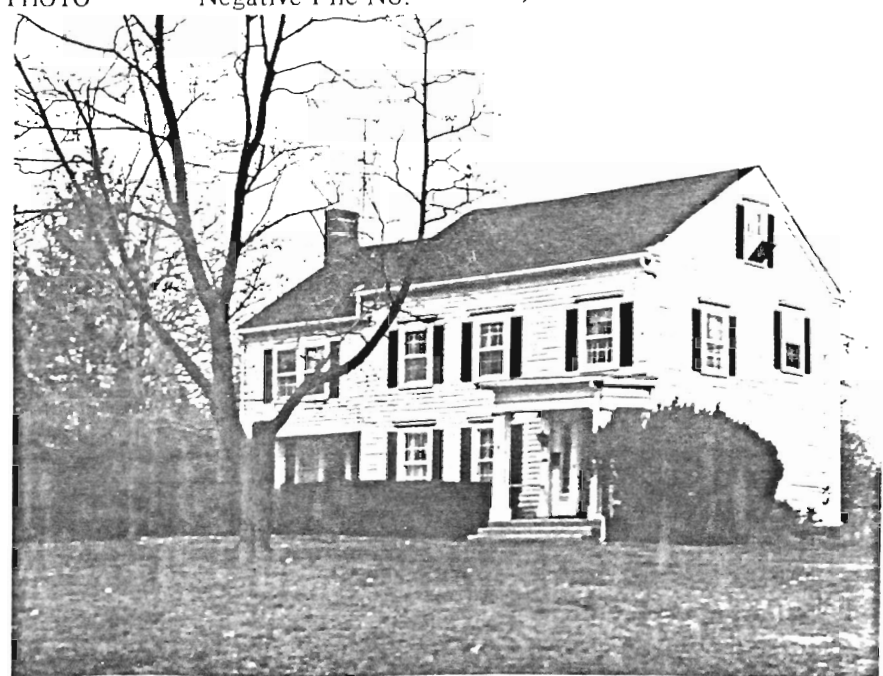
PHOTO Negative File No. 4-30,31

Construction Date:	c. 1736; mid-late 18th c.	Source of Date:	Ref. 1
Architect:		Builder:	
Style:	Georgian with later alterations	Form/Plan Type:	Square with side wing and ell
Number of Stories:	2½		
Foundation:	Fieldstone		
Exterior Wall Fabric:	Clapboard		
Fenestration:	3 bay asymmetrical with 2 bay wing		
Roof/Chimneys:	Gable; external end chimney on wing		
Additional Architectural Description:

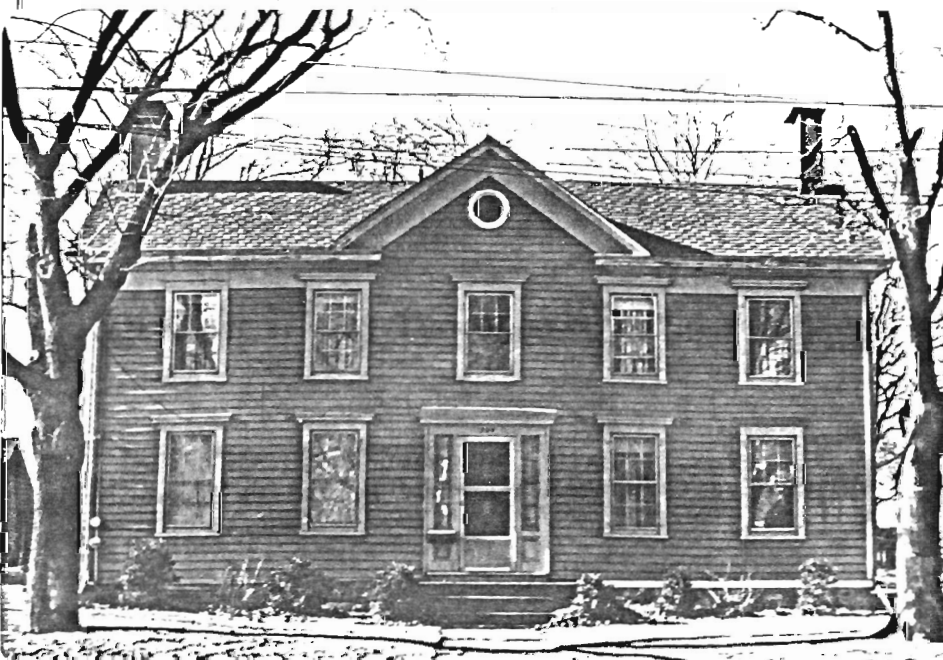
Negative File No. 3-7

This is a well-proportioned house with Greek Revival and later Victorian elements. Horizontal emphasis is achieved through the use of a shallow pitched roof, and second floor windows which are smaller than the first floor windows. The sash is 6/6. The projecting cornices above the windows may be later additions; two were missing at the time of the photograph. Door is flanked by sidelights and surmounted by a projecting cornice. The center gable and circular window are probably later additions. Roof has projecting eaves with gable returns.

Faces east on city lot. Small plantings around foundation of house, scattered trees in yard.

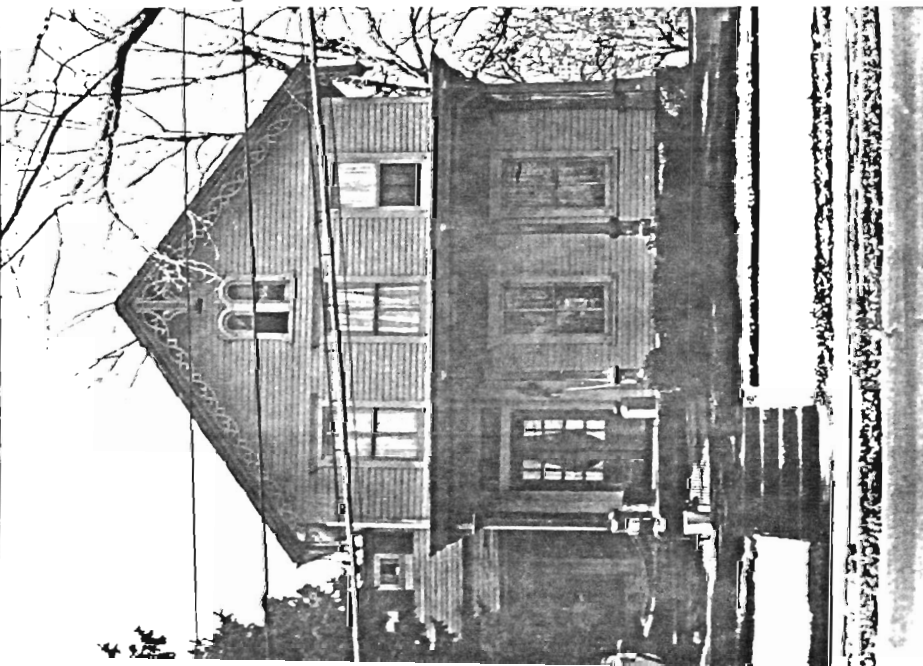
3-8

Italianate elements include: double front doors with a wide transom light; 2/2 sash windows with projecting lintels; a 3 bay porch with slender square posts and bracketed cornice; and paired round head windows in the gable. The eaves have vergeboard on the front facade with pendants in the peak and the corners. The age of the ell relative to the main block is undetermined. The condition of the house has improved substantially since the photo was taken.

Faces east on city lot, small bank, set close to the road. Low shrubs line the house.

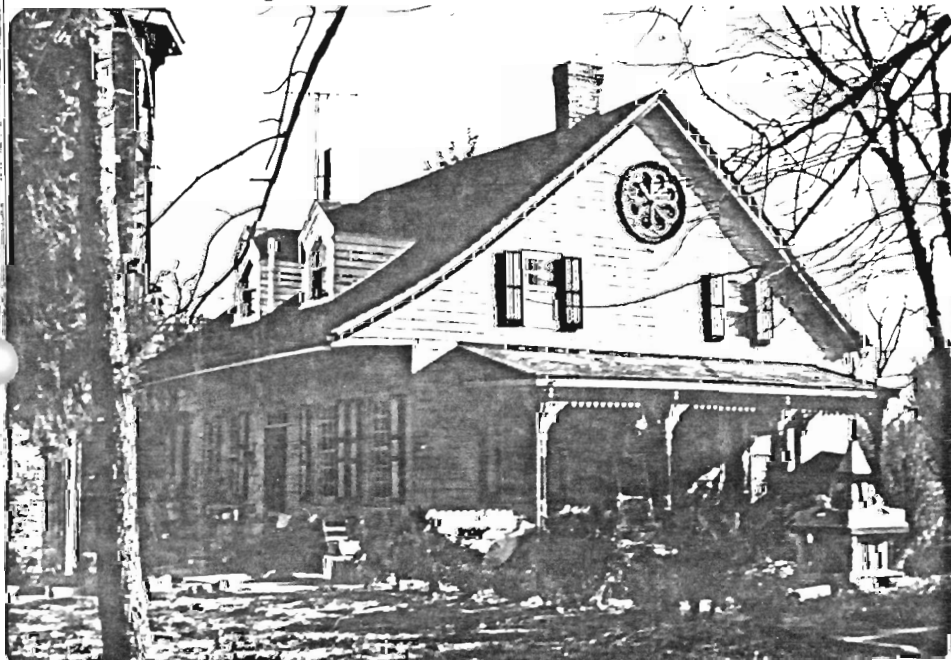
Negative File No. 3-13, 14, 15, 16*

DESCRIPTION Late 17th-early 18th c.;
Construction Date: 18th & 19th c. alterations Source of Date: Stylistic; Ref. 1,2
Architect: Builder:
Style: Dutch Colonial w/ alterations Form/Plan Type: Rectangle, connected by
passage to 2-story brick
and wood-sided building
Number of Stories: 1½
Foundation: Fieldstone
Exterior Wall Fabric: Wood shingle
Fenestration: 5 symmetrical bays (west facade)
Roof/Chimneys: Gable, with flare; 2 internal end chimneys
Additional Architectural Description:
Dutch house with many changes in design, although the form remains
largely intact. Original cottage was probably only two or three bays
of the existing structure. Dutch characteristics include a steeply pitched
roof with a flared eave and large overhang on the west facade. First
floor sash is 9/9. Sash, five bay symmetrical fenestration, and doorway
with four-light transom are Georgian additions and alterations from the
mid to late 18th century. 19th century alterations include the pointed

head dormers, and the porch and circular gable window on the south wall.
The 6/6 sash on the south wall may have replaced smaller windows in the
same location. The earlier roof had eaves flush with the end wall. The
passage to the adjacent building is a recent 20th century addition.

House faces west, away from the road, into a small yard. House is situated on a short, steep bluff above the road. The two other buildings on the site are highly decorated in a fanciful Elizabethan Revival style. The building attached to the house is a two-story dwelling; the other across the yard is a cinder block garage with applied decoration. Both have probably been built within the last twenty years.

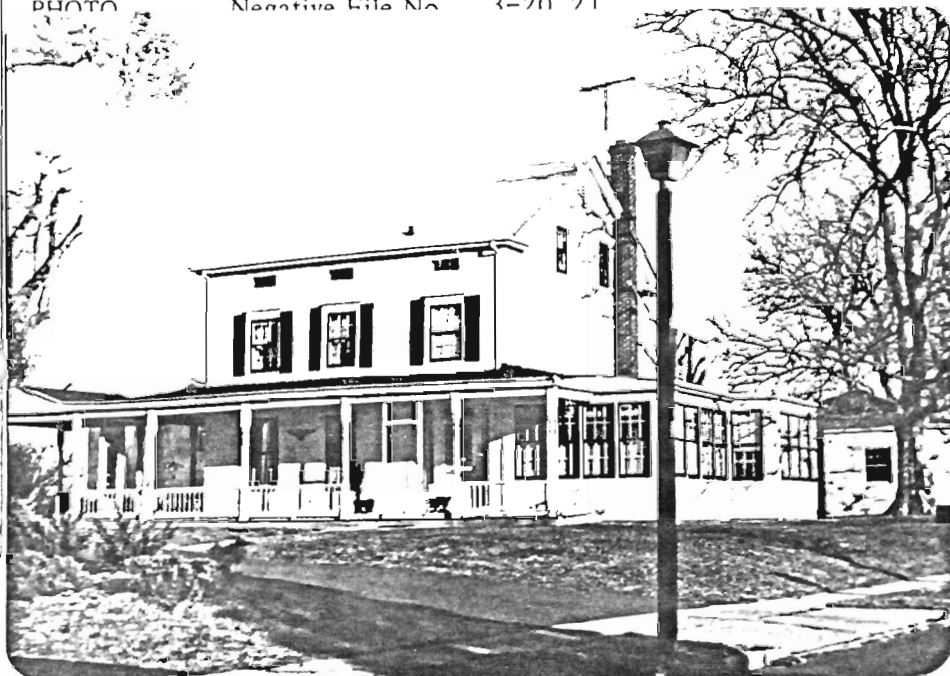
PHOTO Negative File No. 3-20 21

Although this house has been substantially altered, it retains some of its Federal characteristics in the small transom light and slender sidelights, and in the small knee-wall windows in the third floor. Additions include the Victorian porch and porte-cochere, and the enclosed porch on the south side. The original chimney(s), probably on the north wall, has been removed. The house included Philip Freneau's printing shop as late as 1936; it is difficult to determine from the current house if it still exists. Sash is 6/6; first floor windows may be replacements.

Faces west on suburban lot, on brink of hill which falls off from the rear of property. Philip Freneau's grave is a short distance to the southwest, across the street.

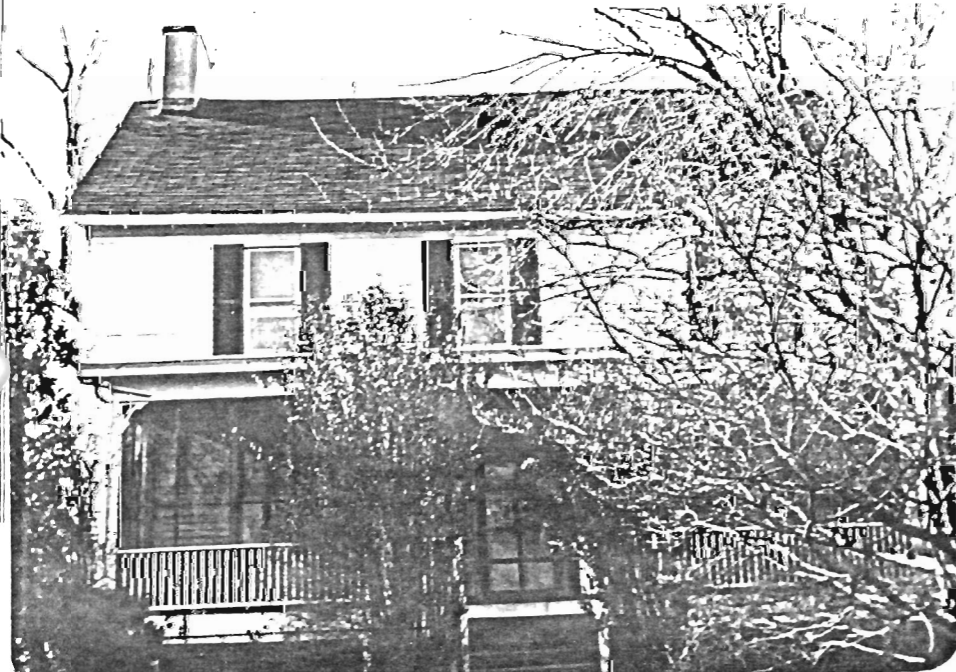
PHOTO Negative File No. 2-31

Faces NE on city lot which rises sharply from Ravine Drive. The approximately 40' setback is larger than most in the built up section of Matawan.

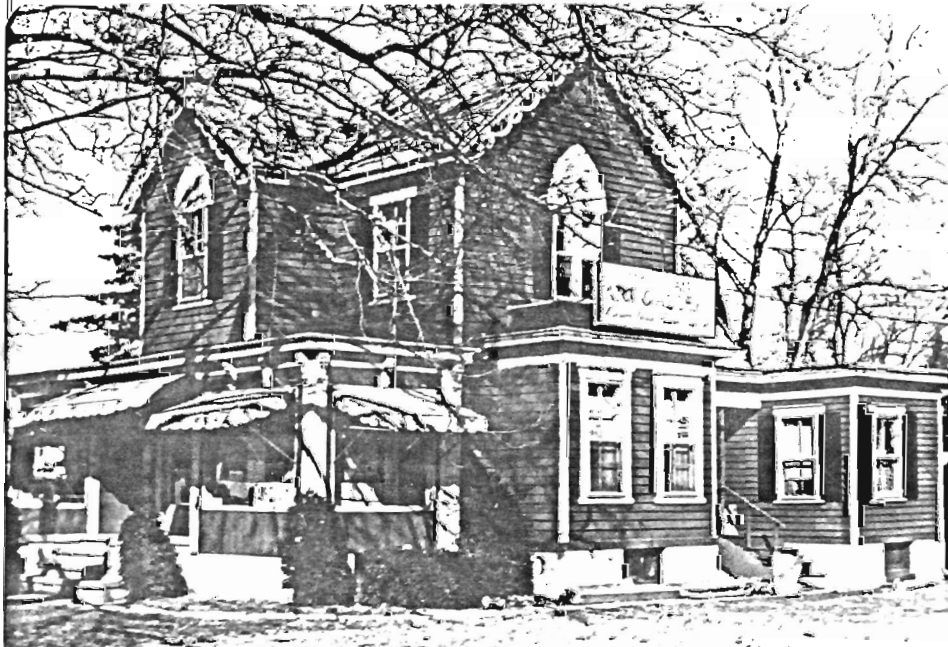
PHOTO Negative File No. 3-5

Faces south on open lot, with parking area

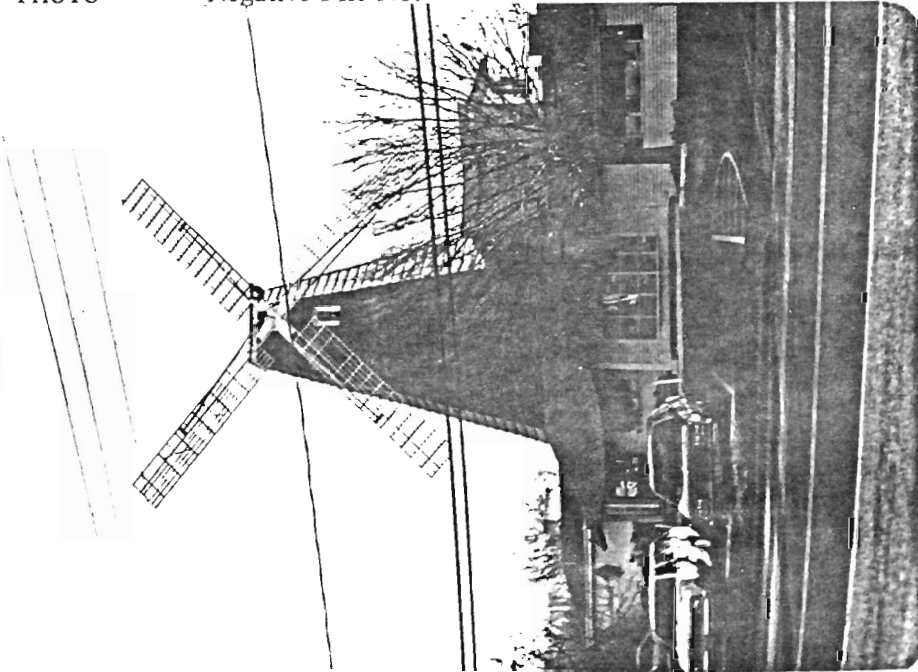
Negative File No. 3-22

On large lot, along major highway, has large parking area.

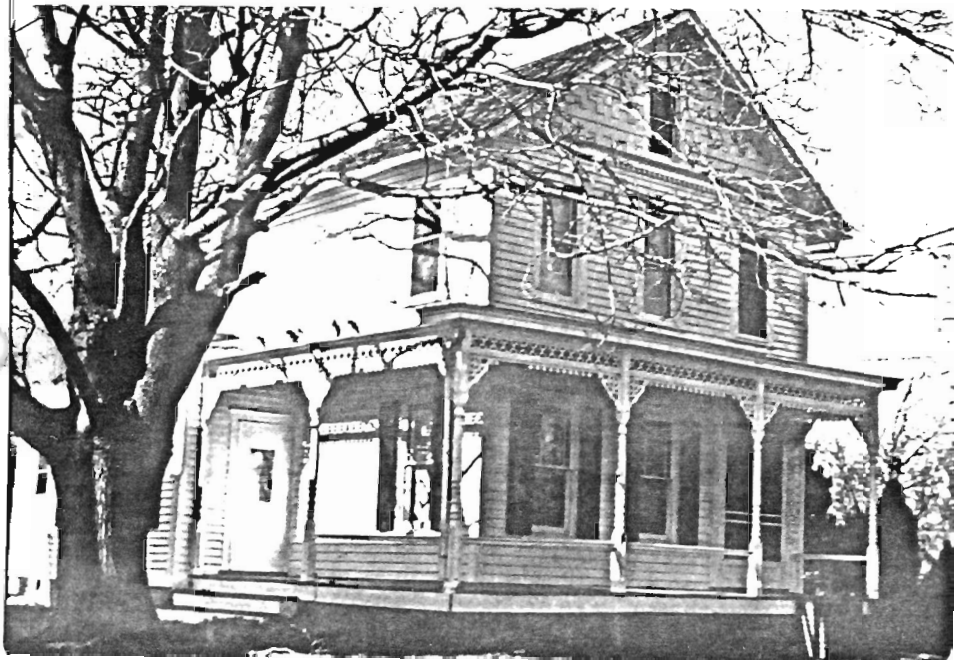
2-34

Faces northeast on corner lot with modest setback. A small garage is in the rear, and scattered trees and shrubs dot the lot.
