# NJ FACE INVESTIGATION REPORT

**FACE 06-NJ-063**

## **Worker Pinned Between Forklift and Boom Truck in Industrial Yard**

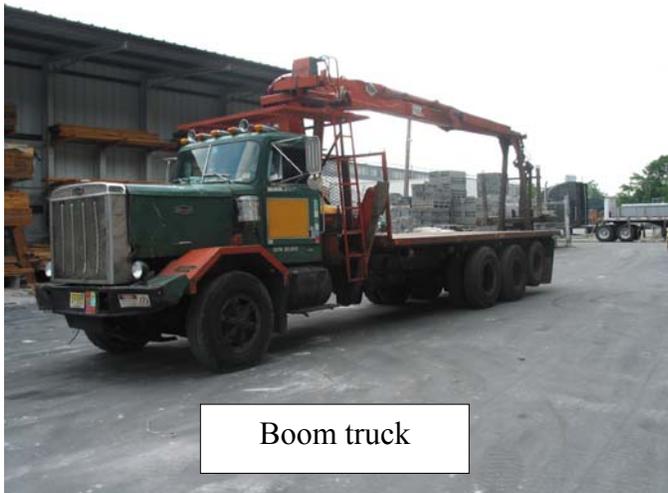
Boom truck

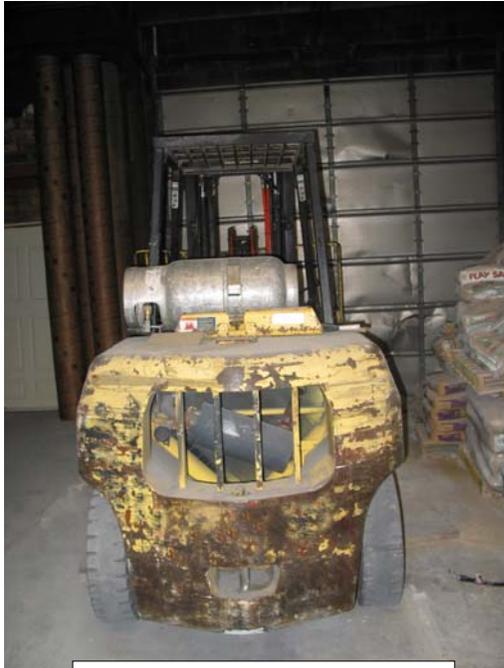
Forklift involved in the incident (rear view)

Two operators reported a history of failure of the emergency brake on the involved forklift. Service was performed four times in the previous year and the brakes were serviced twice. The forklift was examined by representatives from the forklift supplier and insurance company. FACE staff could not obtain a report on this examination. Therefore, no recommendations can be made addressing the presence or absence of mechanical defects.
