Work Zone Intrusion Alarm Effectiveness

FINAL REPORT
September 2010

Cathy Krupa
Cambridge Systematics, Inc.
Princeton Junction, New Jersey

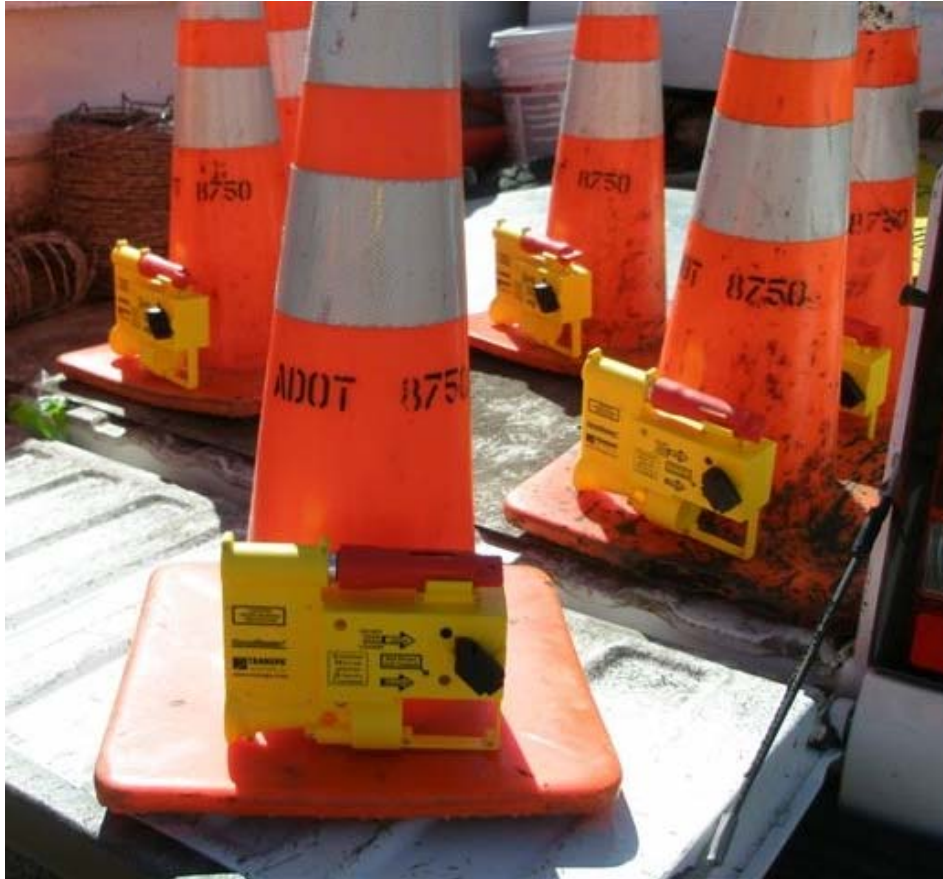
⁵ Eight alarms were defective and could not be used. Defects are described in the next section. Note that the alarm shown in the figure is an older version with a different mounting method. The alarm used by NJDOT has an improved mounting bracket that allows the cones to be stacked with the device mounted in place.

Figure 1. Close-Up of SonoBlaster!® Work Zone Intrusion Alarm.

The SonoBlaster![®] Work Zone Intrusion Alarm is an impact- or tilt-activated safety device that is mounted on work zone barriers such as traffic cones, drums, and delineators. When activated by direct impact of an errant vehicle, the device emits an alarm that warns roadway workers and the driver of an errant vehicle that the buffer zone has been violated.⁽¹⁾ FHWA has accepted the SonoBlaster![®] as a National Cooperative Highway Research Program (NCHRP) 350 Category II Safety Device, acceptable for use when attached to the base of conventional traffic cones, plastic drums, or large base road tubes or delineators. Test results emphasized that in all

The mounting bracket supplied with the unit allows alarmed cones to stack for storage with the device mounted in place. The mounting bracket is installed on a standard traffic cone using supplied screws in holes that are drilled by the user in the cone base.
